TOWN OF SHREWSBURY
FACILITIES CONDITION ASSESSMENT OF
TOWN BUILDINGS

FINAL REPORT

June 01, 2016

**Shrewsbury
Fire Station**

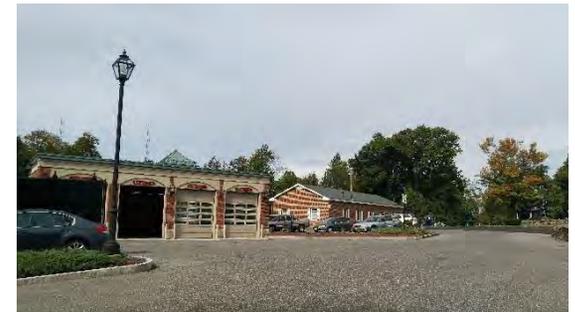
SFS E1

- i. The pavement condition of the vehicular entrances and interior circulation system ranges from good to fair throughout the site.

- i. Implement a program of replacing damaged or worn pavement throughout the site.

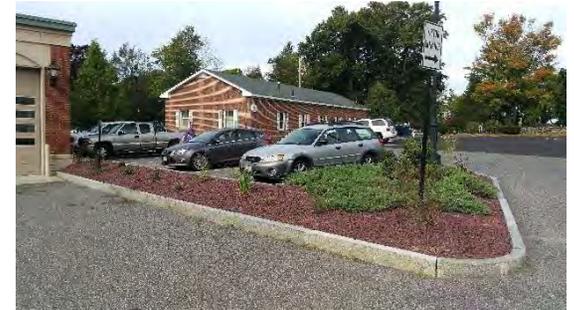
SFS E2

- i. The pavement condition of the parking area ranges from good to fair throughout the site.
- ii. The accessible parking spaces adjacent to the main entrance do not appear to comply with current MAAB standards.

- i. Implement a program to bring accessible parking spaces throughout the site into compliance with current MAAB standards.
- ii. Implement a program of replacing damaged or worn pavement throughout the site.

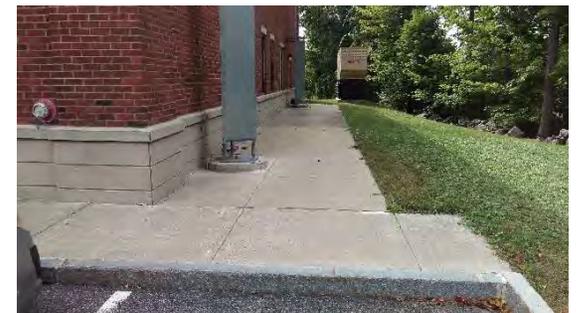
SFS E3

- i. The condition of the Portland cement concrete pavement throughout the site ranges from good to fair.
- ii. The existing pedestrian circulation system on site is not contiguous with sidewalks on Route 140 or Main Street, forcing pedestrians to walk in vehicular travel lanes.

- i. Implement a program of replacing damaged or worn pavement throughout the site.
- ii. Implement a program to review accessible pedestrian routes throughout the site for safety and compliance with current MAAB standards.

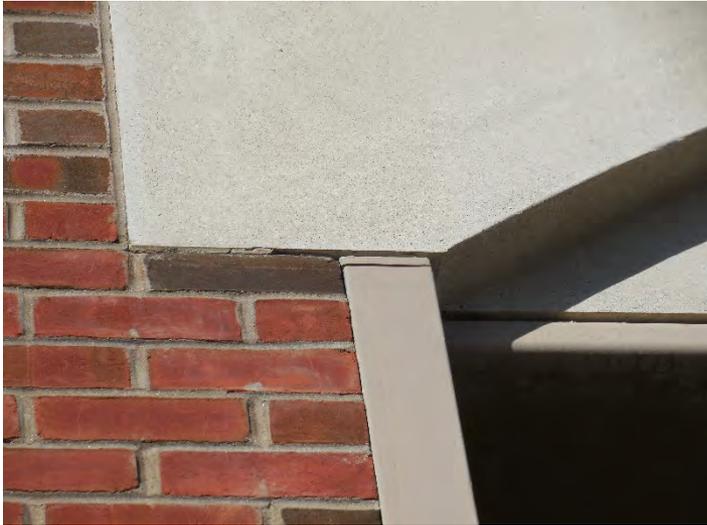
East Elevation, mortar deterioration at a lintel

- ii. Rout and point deteriorated mortar joints.
- iii. Investigate cracked and spalled cast stone to determine the cause of cracking and movement. Remove any loose masonry as an interim measure. Repair cracks by routing and sealing (moving cracks) or pointing (static cracks).
- iv. Investigate stained areas to determine causes of staining. Address causes and clean masonry.

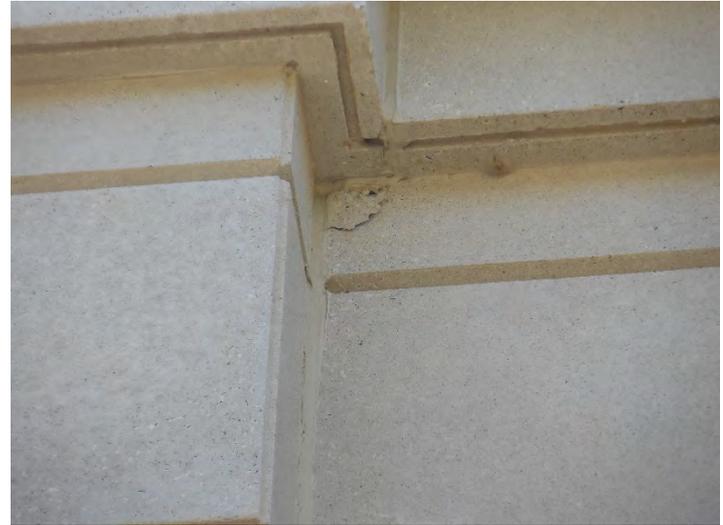
North Elevation, spalled concrete

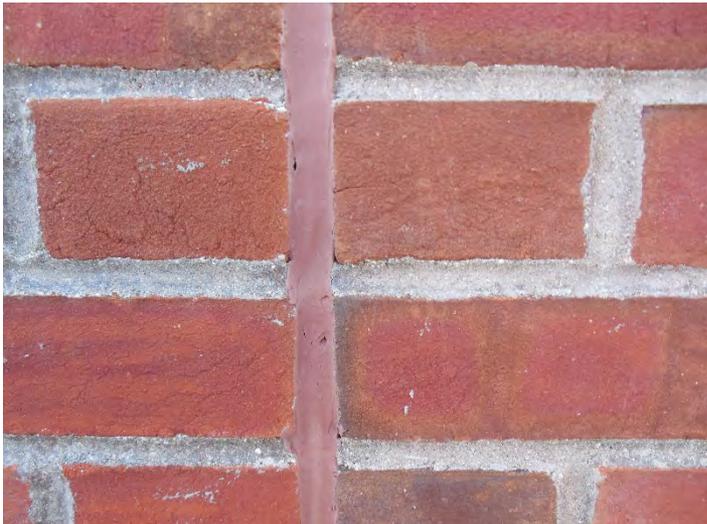
North Elevation, gaps and voids in sealant at an expansion joint

- i. Replace failed sealants; plan ongoing replacement approximately every 5-10 years.

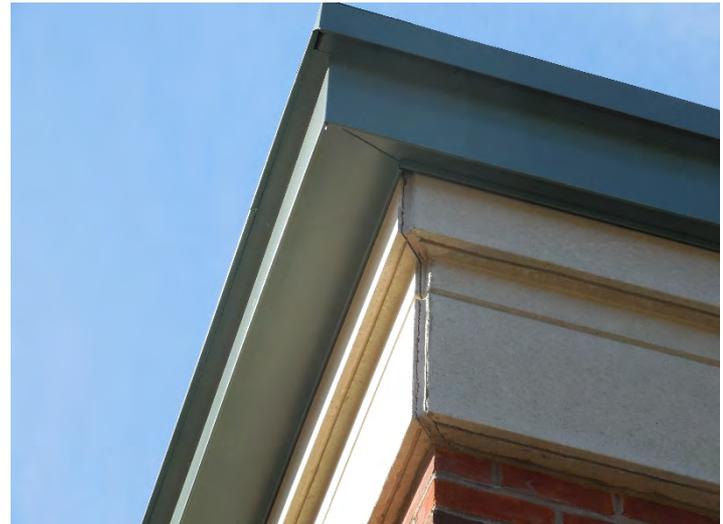
North Elevation (Northeast corner), crack in mortar joint

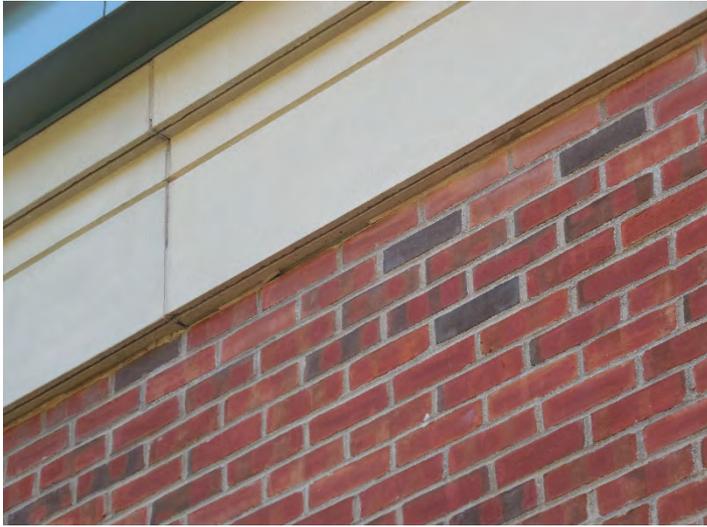
North Elevation, deteriorated mortar

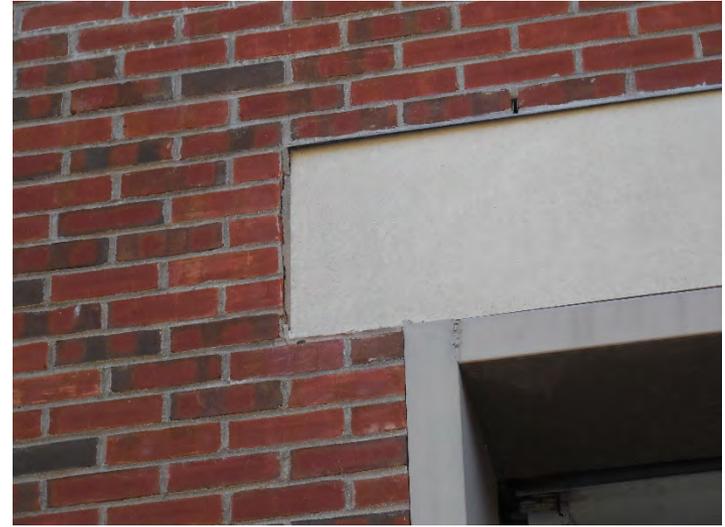
North Elevation, deteriorated mortar

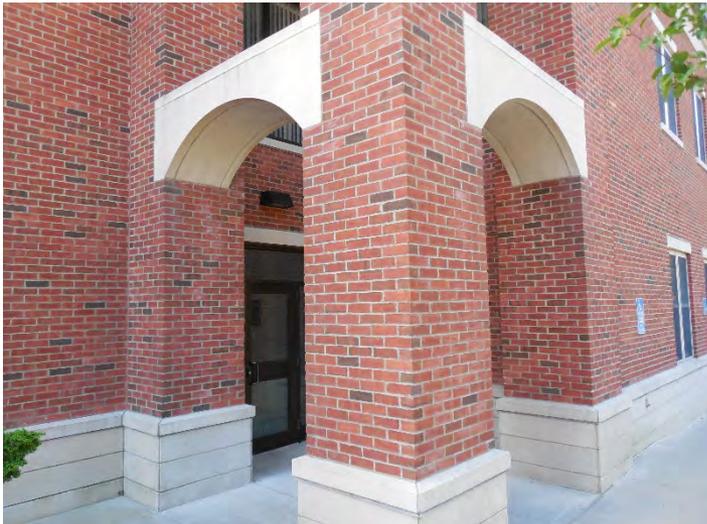
North Elevation, efflorescence on brick

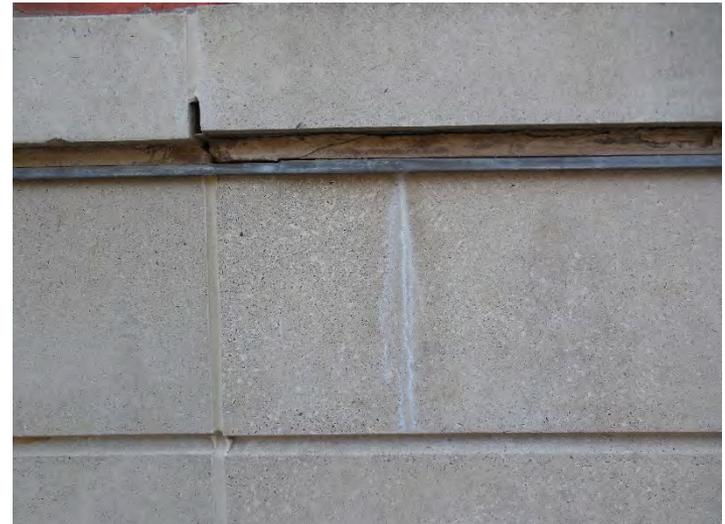
North Elevation, deteriorated mortar and efflorescence

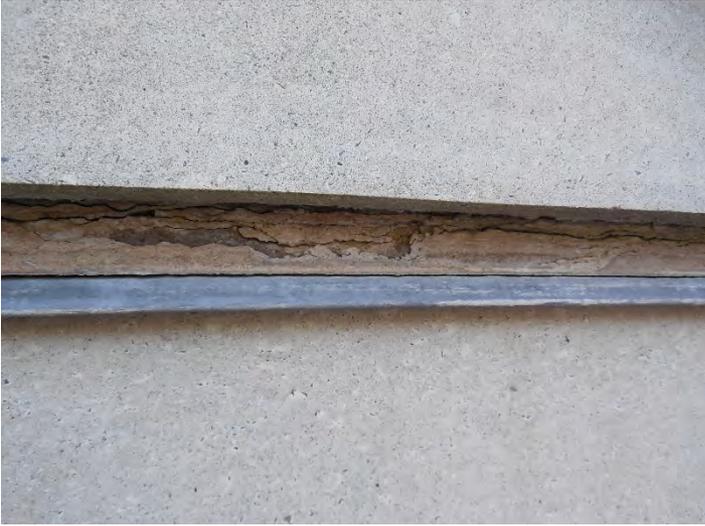
North Elevation, deteriorated mortar under a windowsill

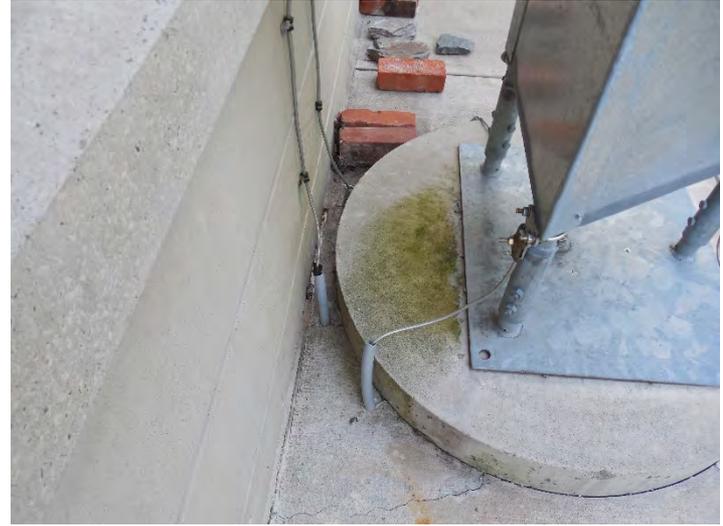
West Elevation, open conduits and stained and cracked concrete

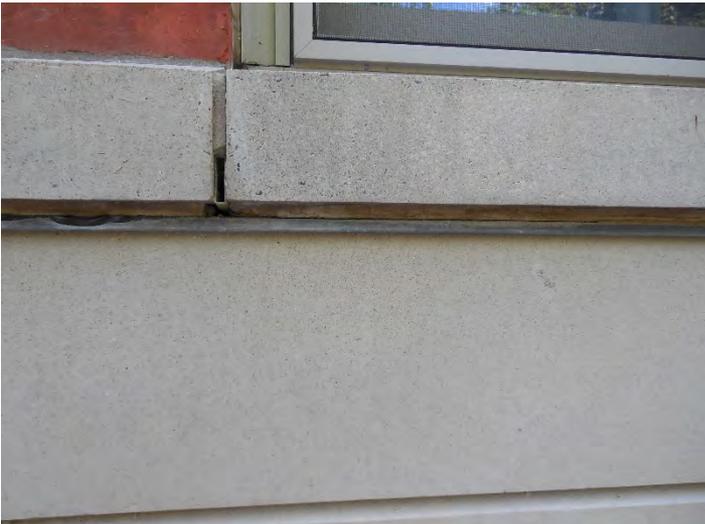
West Elevation, deteriorated mortar under a windowsill

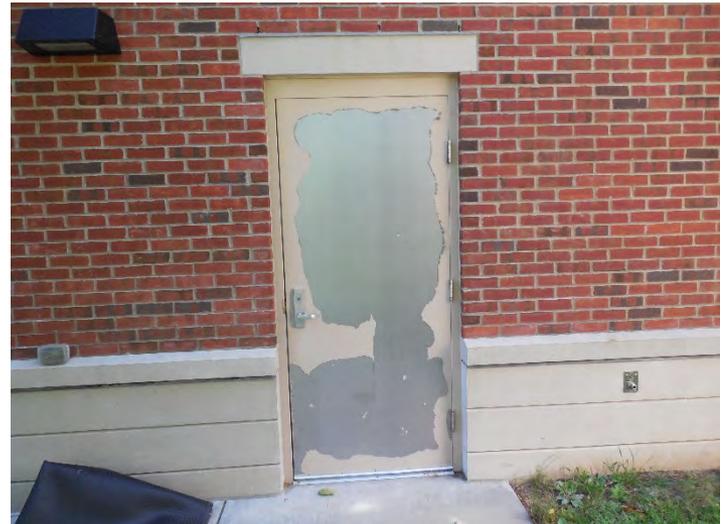
West Elevation, peeling paint at exterior doors

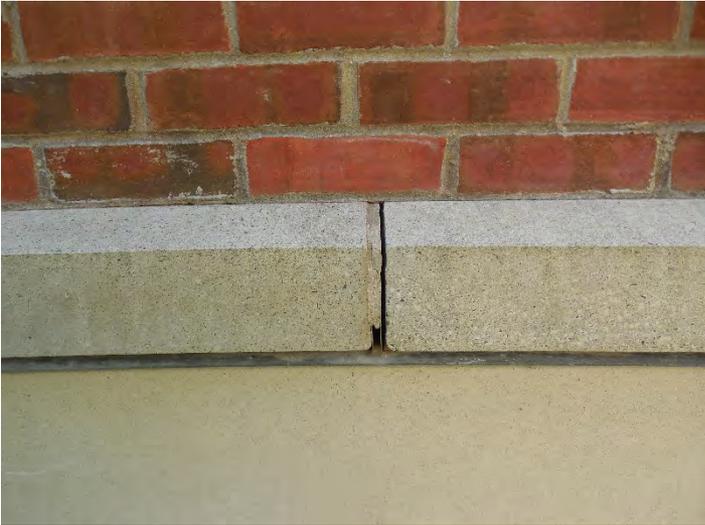
West Elevation, crack in a mortar joint

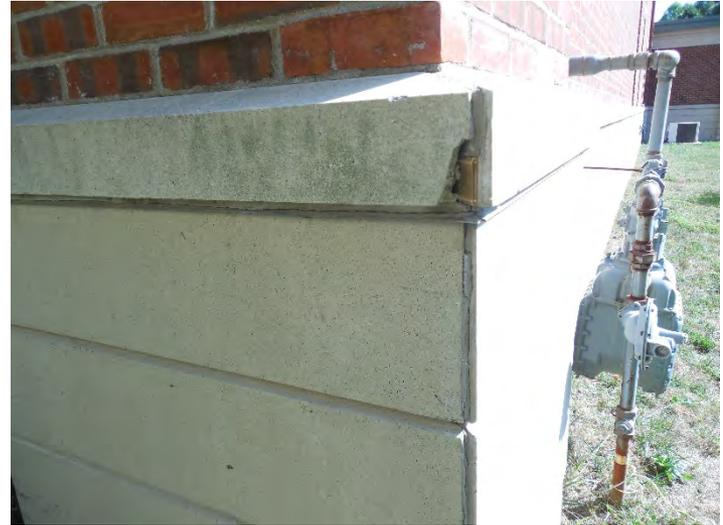
South Elevation, spall at cast stone

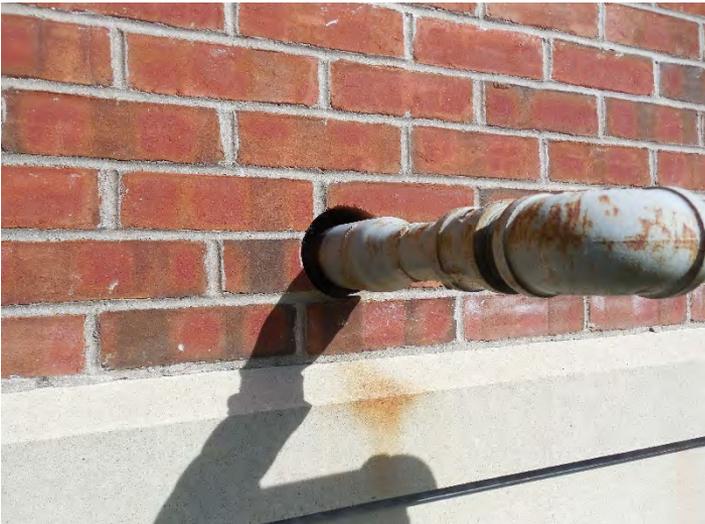
South Elevation, open pipe penetration

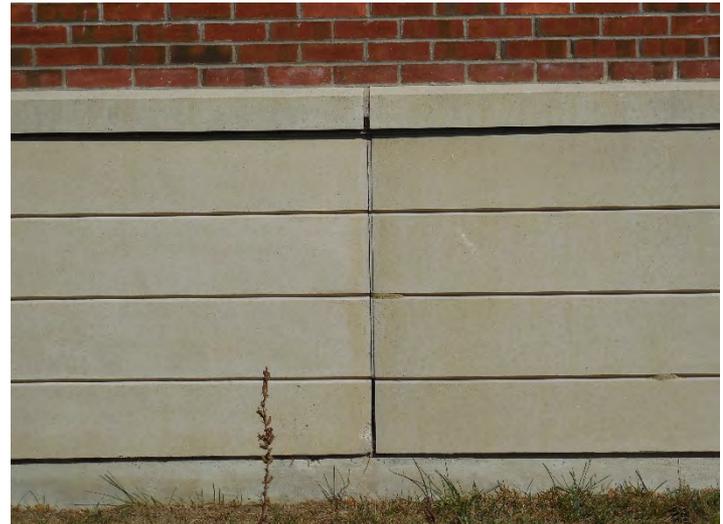
South Elevation, deteriorated mortar

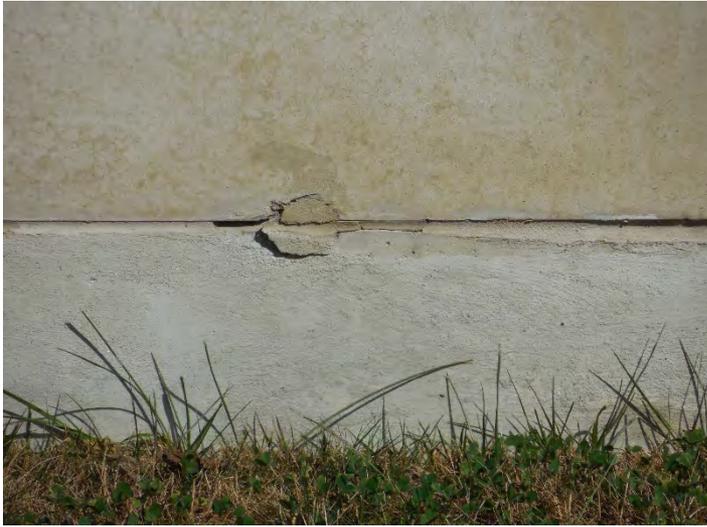
South Elevation, deteriorated mortar and spalled concrete

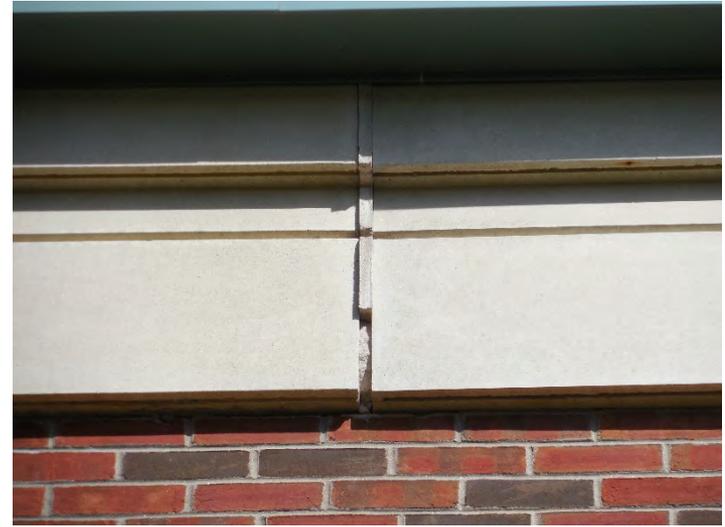
South Elevation, deteriorated mortar

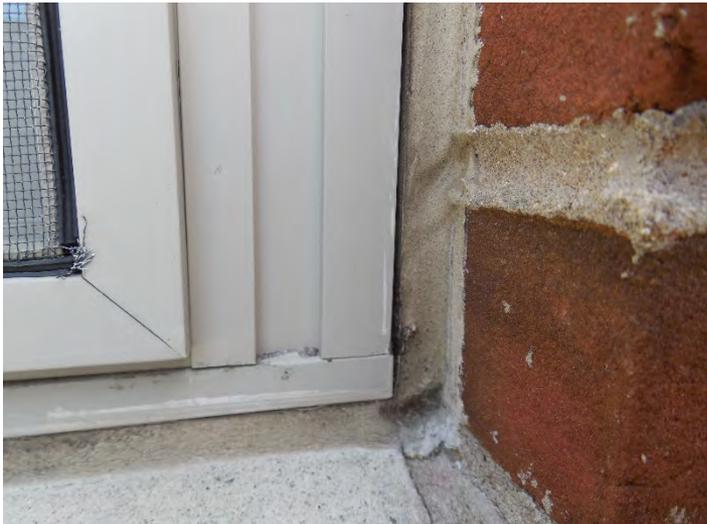
South Elevation, deteriorated window perimeter sealant

- i. Replace failed sealants; plan ongoing replacement approximately every 5-10 years.

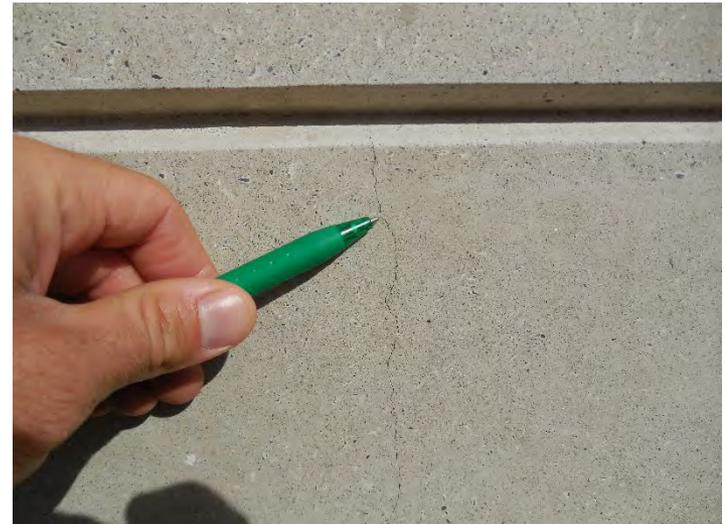
South Elevation, crack at cast stone base

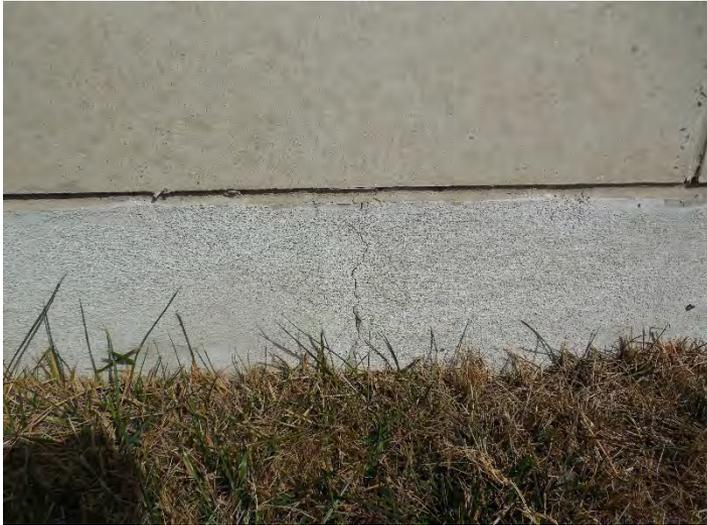
South Elevation, crack at foundation

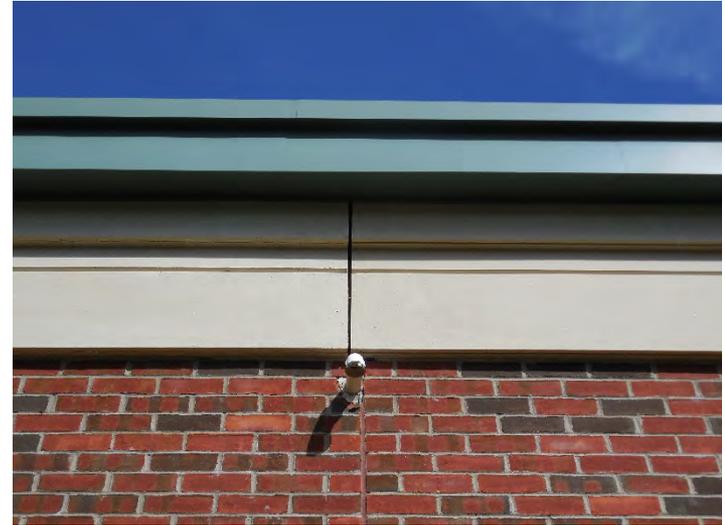
South Elevation, open joint (no mortar visible)

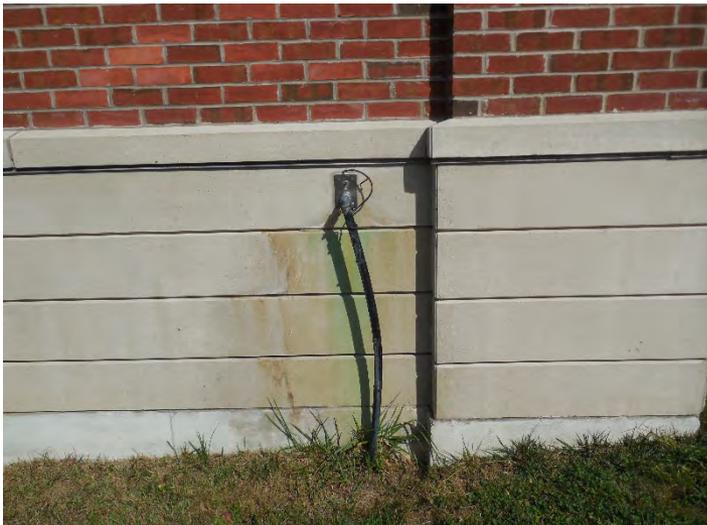
South Elevation, staining under a hose bib

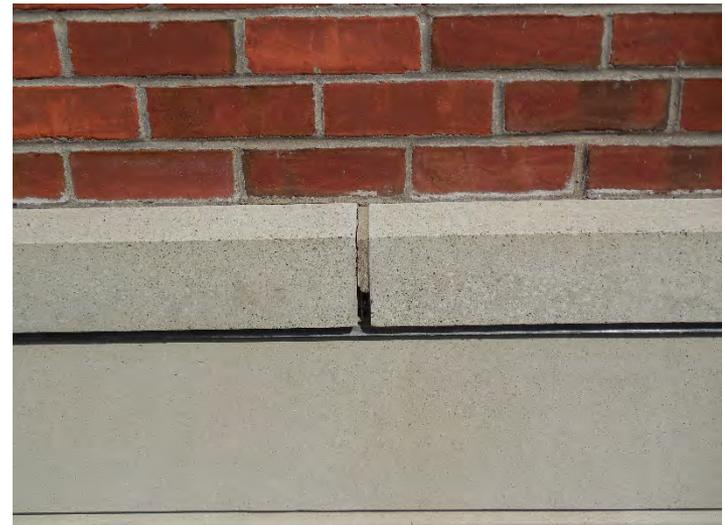
South Elevation, crack at mortar joint

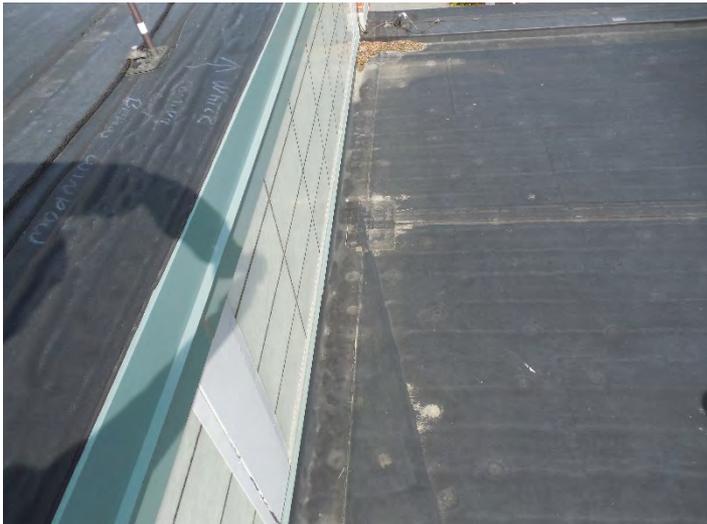
Transition between upper and lower roof; note on roof: "WATER COMING OUT BELOW WINDOW".

- i. Investigate source(s) of leak and make necessary repairs. Implement a program of annual inspections.
- ii. Provide watertight conduit flashing.
- iii. Cut and flatten blisters. Provide EPDM patches.

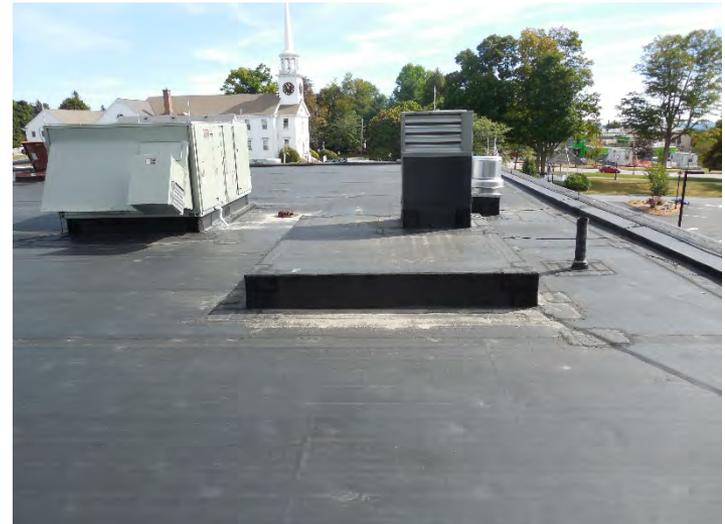
Upper roof, evidence of ponding

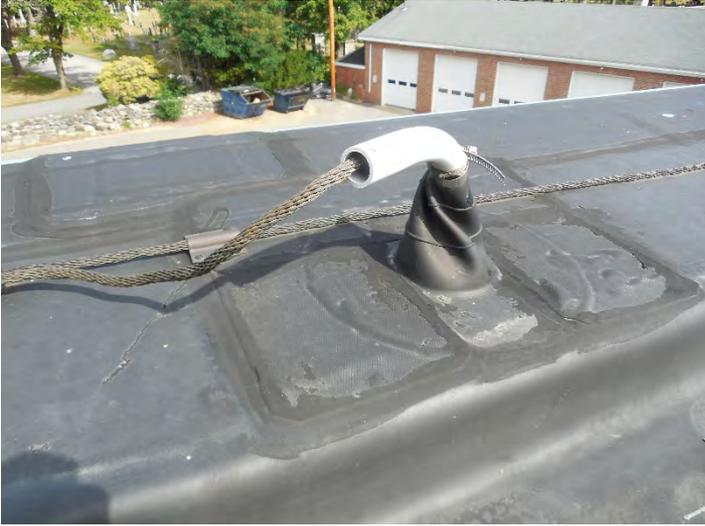
Upper roof, open lightning protection conduit

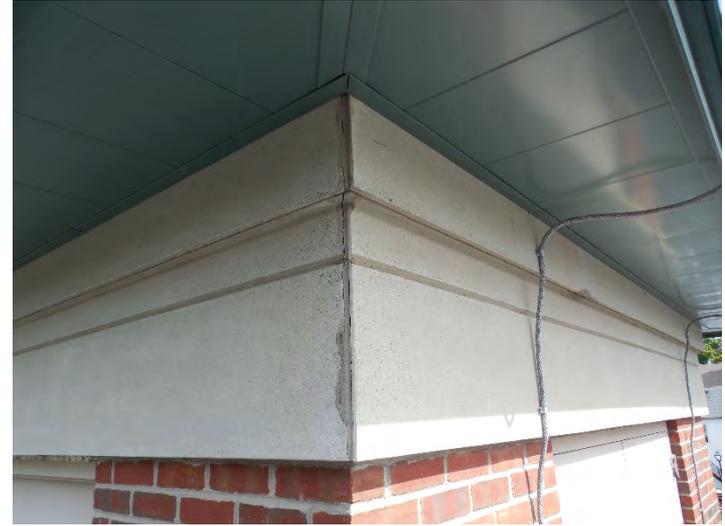
Southeast corner of tower, deteriorated mortar
