TOWN OF SHREWSBURY
FACILITIES CONDITION ASSESSMENT OF
TOWN BUILDINGS

FINAL REPORT

June 01, 2016

**Shrewsbury
High School**

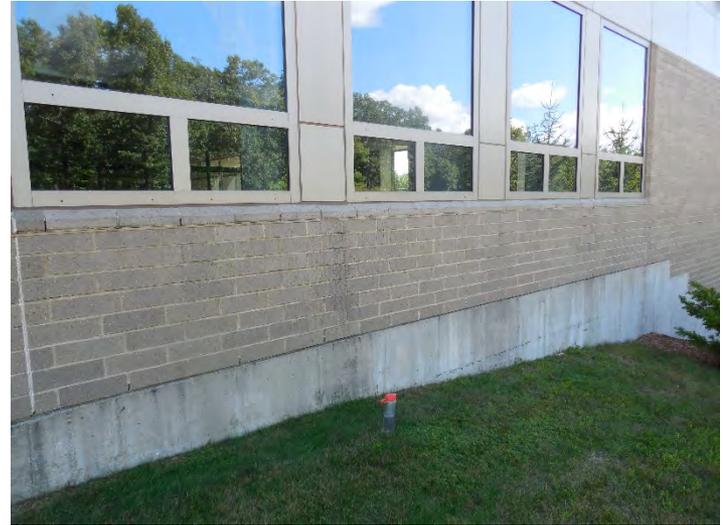
North Elevation, staining on masonry below windows

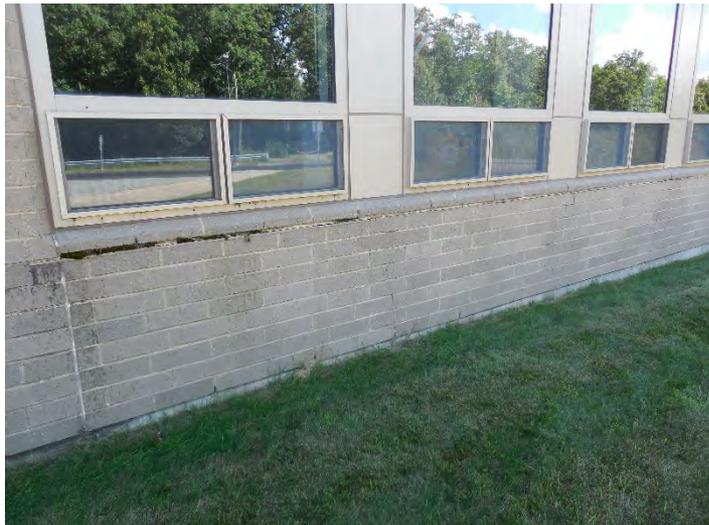
North Elevation, staining on masonry and deteriorated mortar;
moss growth in mortar joint

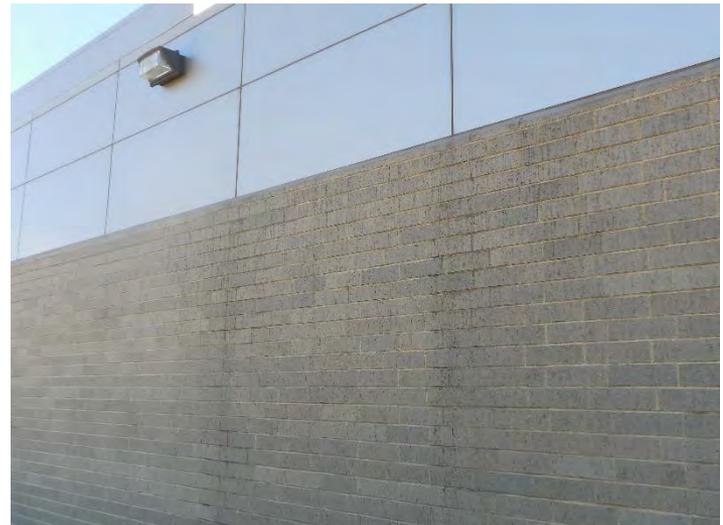
North Elevation, staining on masonry below metal panel joints

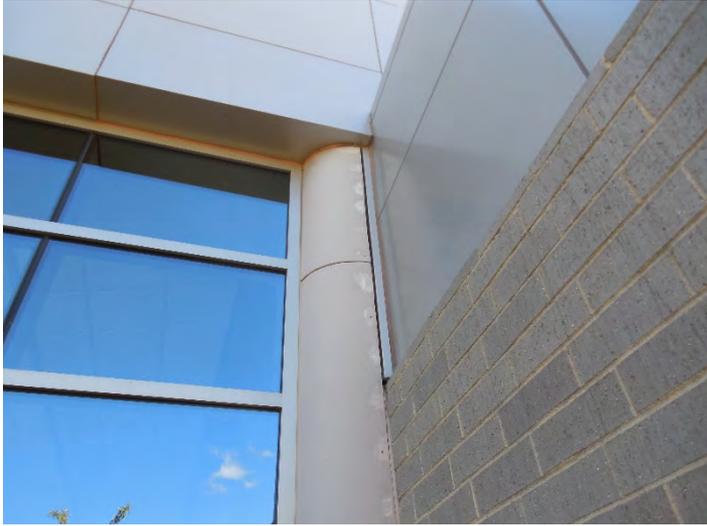
North Elevation, no sealant at column-to-metal panel juncture; staining/damage to column wrap

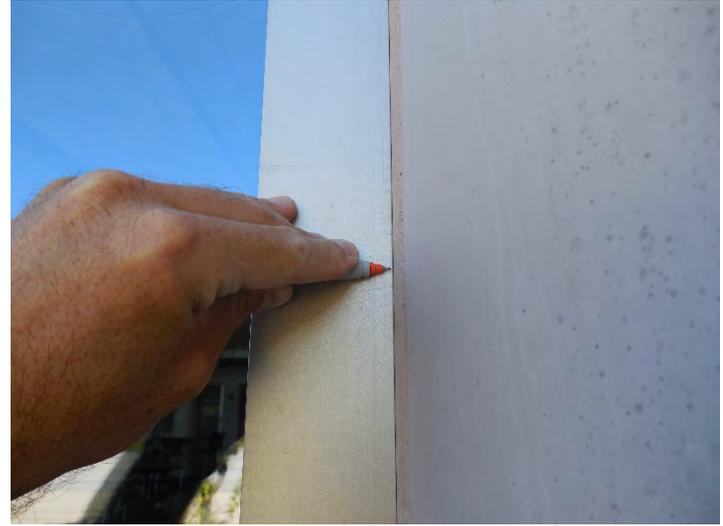
North Elevation, failed sealant at curtain wall jamb

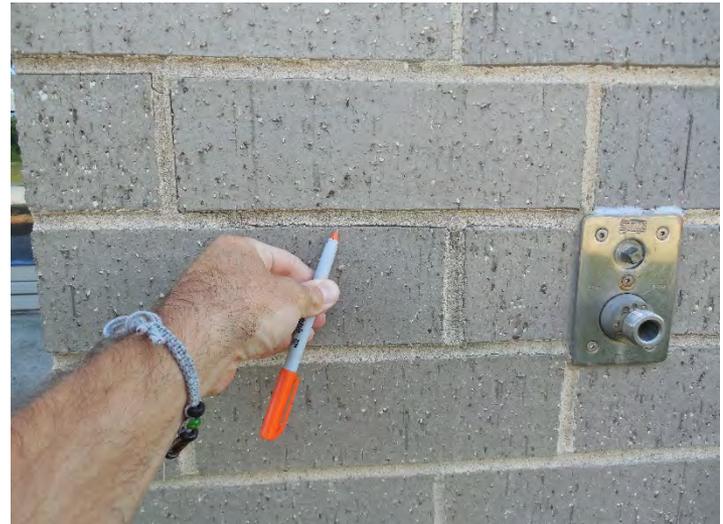
North Elevation, cracks in mortar joints above brick overhang

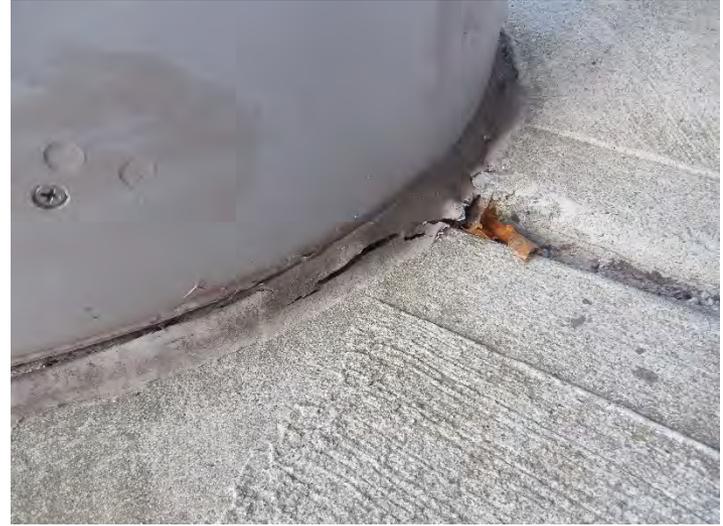
North Elevation, failed sealant at column cover-to-walkway juncture

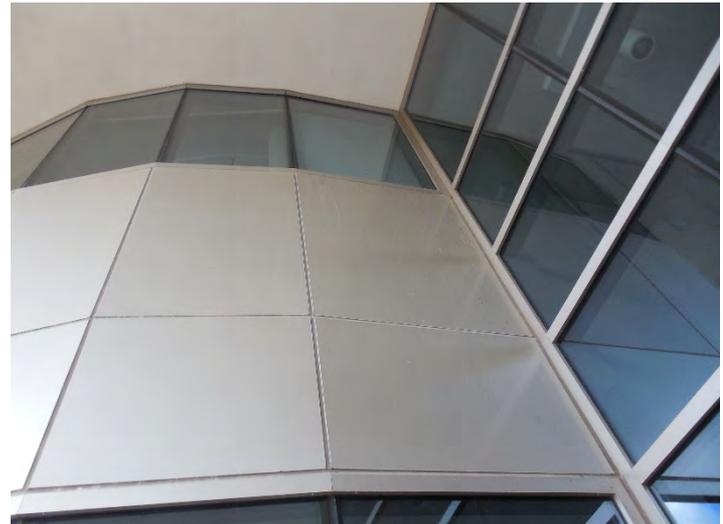
North Elevation, staining on metal panel below a window

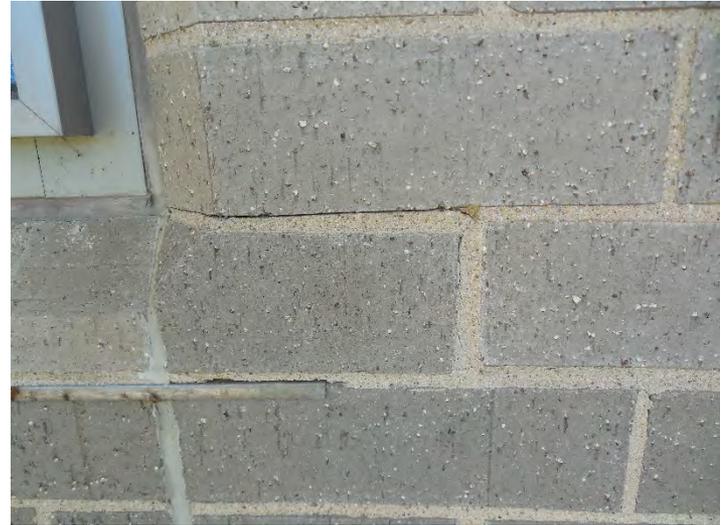
North Elevation, cracked mortar joints at a window corner

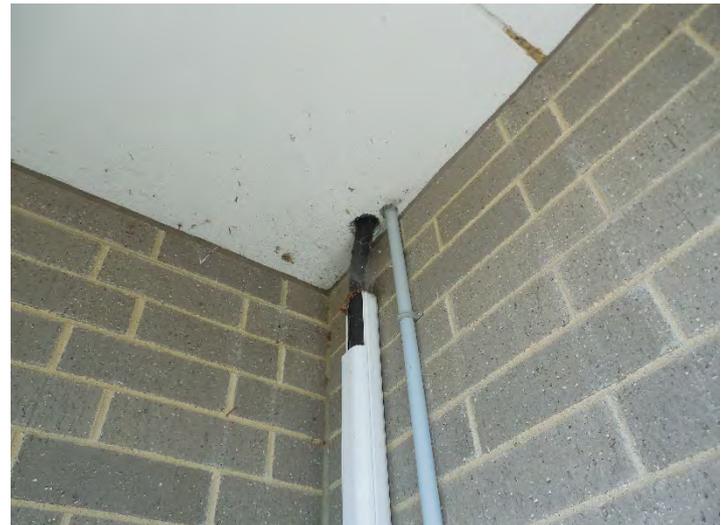
North Elevation, unsealed conduit penetration through EIFS

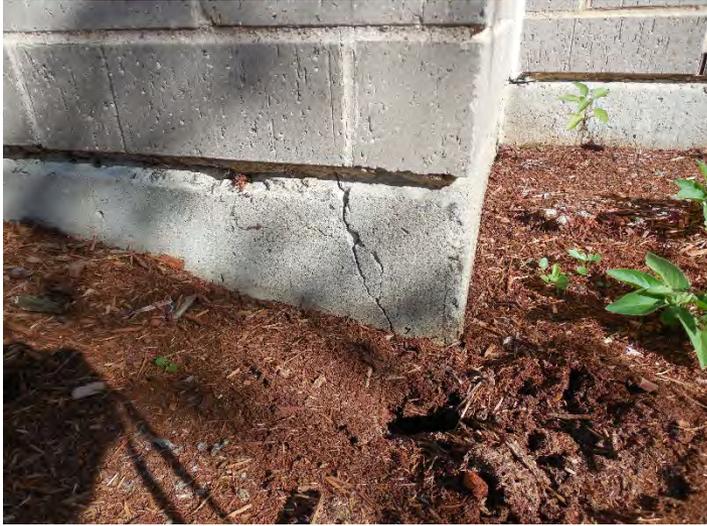
North Elevation, crack in concrete foundation

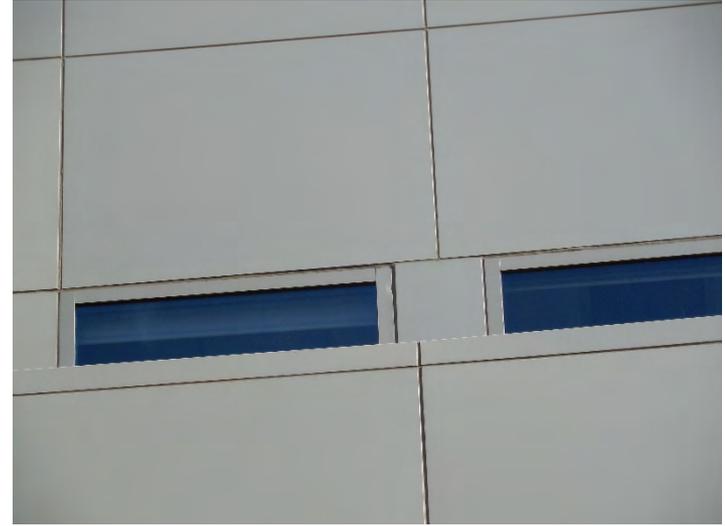
North Elevation, dented third floor window frame

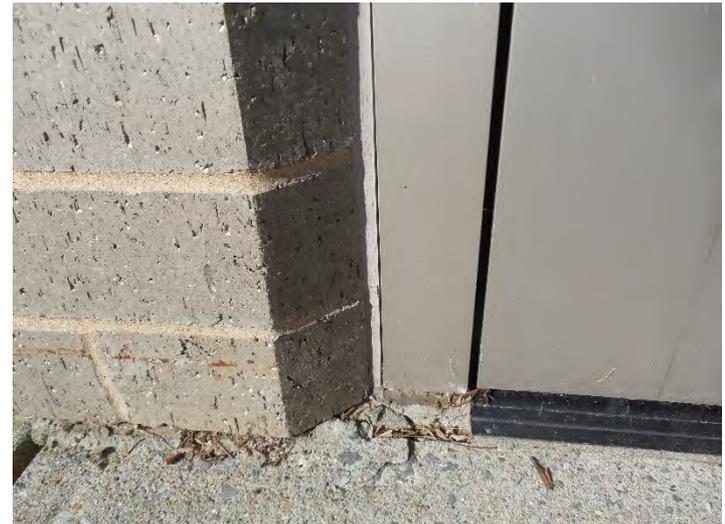
'A' Wing, East Elevation, failed door perimeter sealant

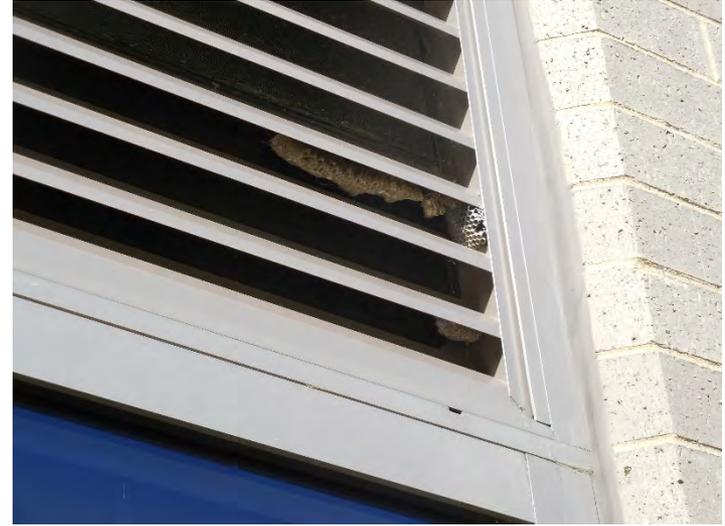
'A' Wing, East Elevation, wasp nest in louver

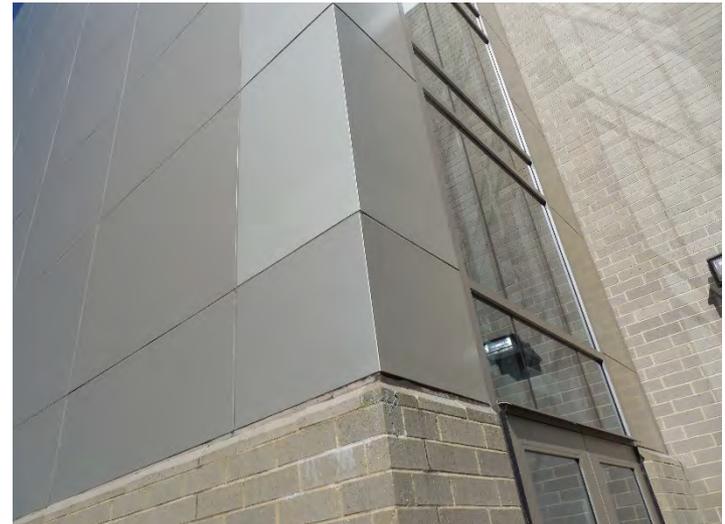
'A' Wing, South Elevation, crack in sealant joint at metal panel-to-
masonry juncture; staining on masonry

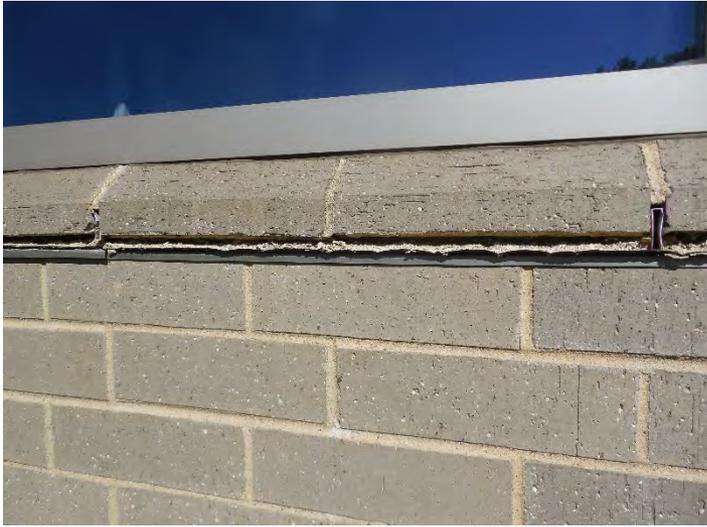
'A' Wing, South Elevation, deteriorated mortar joints

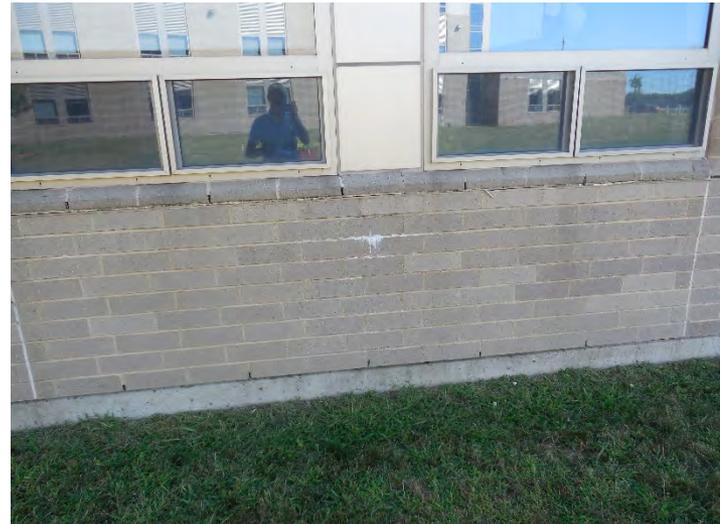
'A' Wing, West Elevation, efflorescence below a window

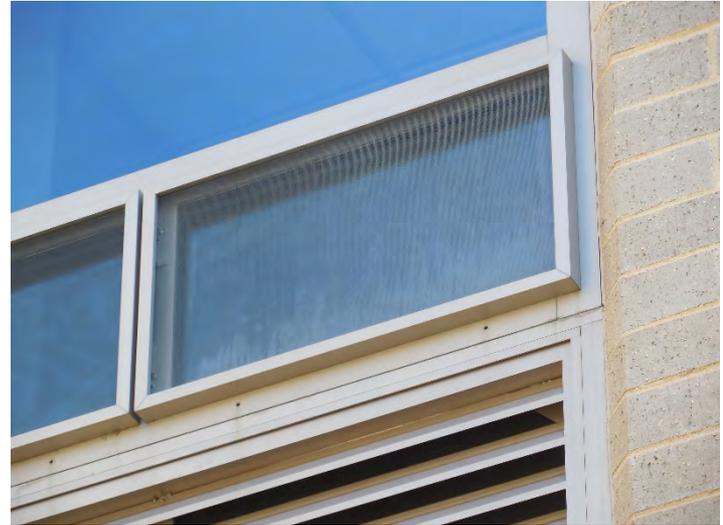
'A' Wing, West Elevation, fogged insulated glazing unit (second floor)

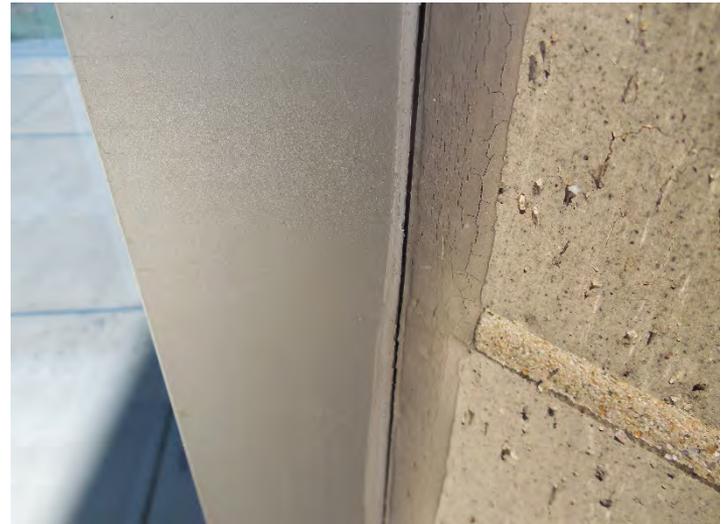
'M' Wing, South Elevation, window perimeter sealant

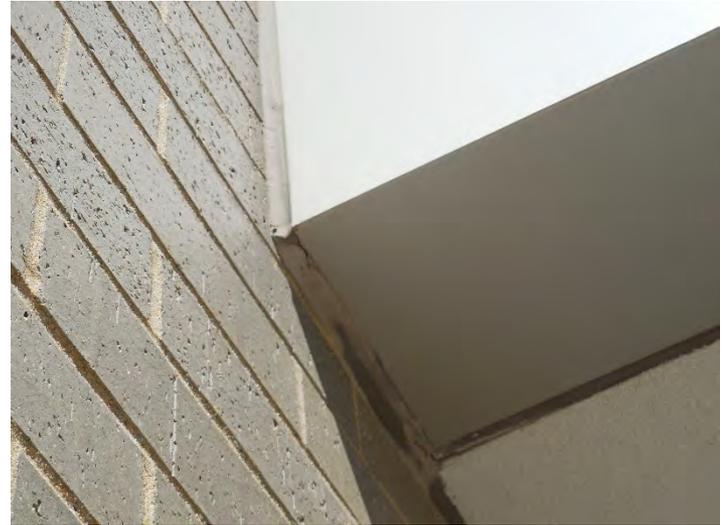
'M' Wing, South Elevation, sealant failure at metal panel-to-masonry juncture

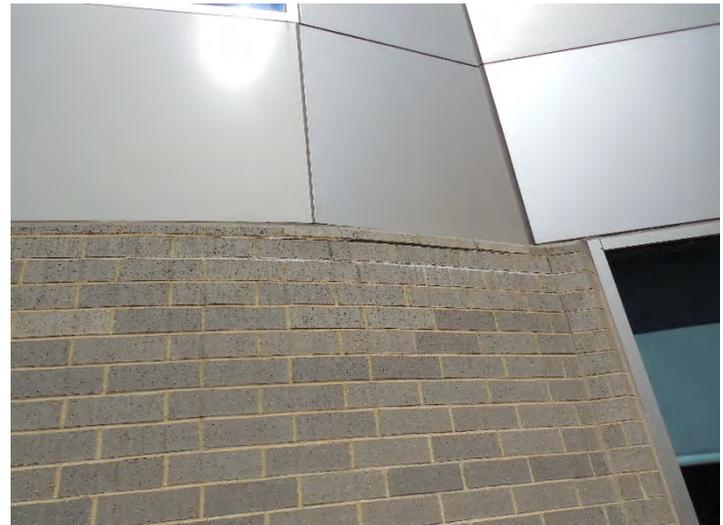
'M' Wing, South Elevation, mortar deterioration and efflorescence

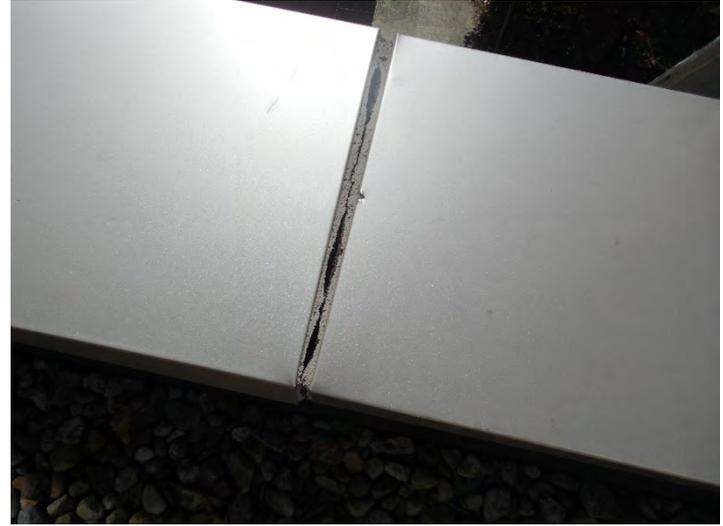
'M' Wing, South Elevation parapet wall, sealant failure at coping joint

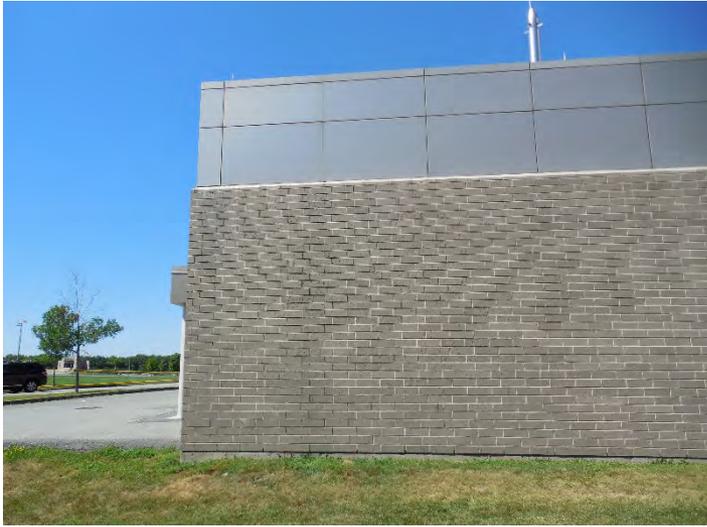
'B' Wing, East Elevation, staining on masonry below metal panel joints

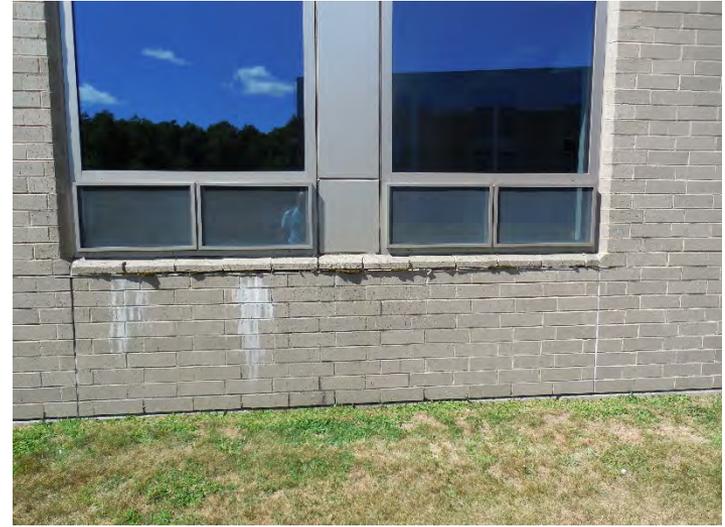
'B' Wing, East Elevation, deteriorated mortar and efflorescence below a windowsill; moss growth in mortar joint

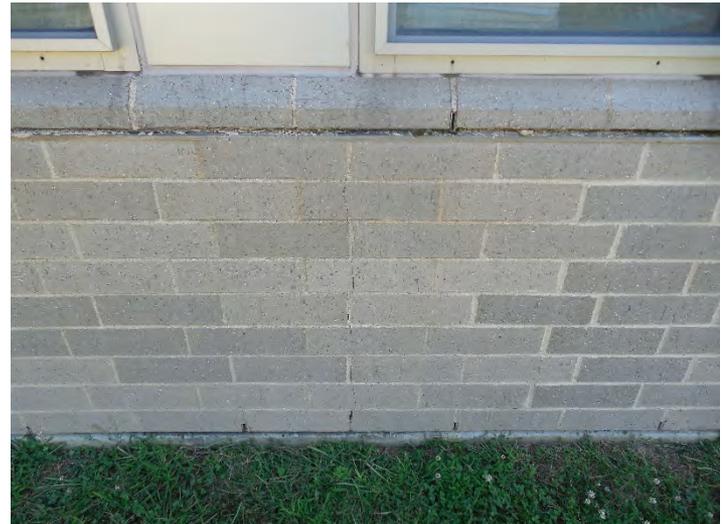
'B' Wing, West Elevation, crack through brick and mortar from windowsill to grade; deteriorated and cracked mortar joints

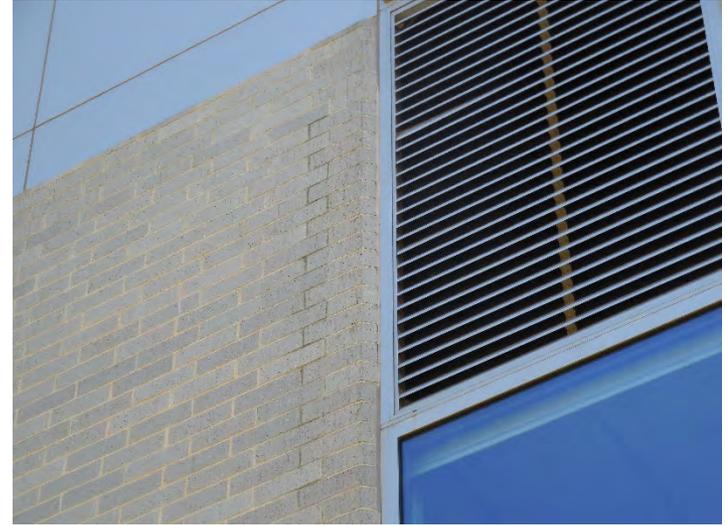
'B' Wing, West Elevation, staining on brick masonry and deteriorated mortar joints

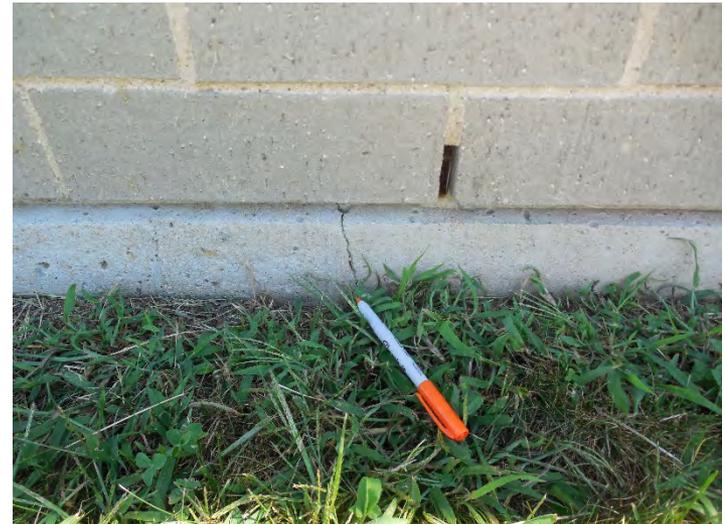
'B' Wing, West Elevation, crack in concrete foundation

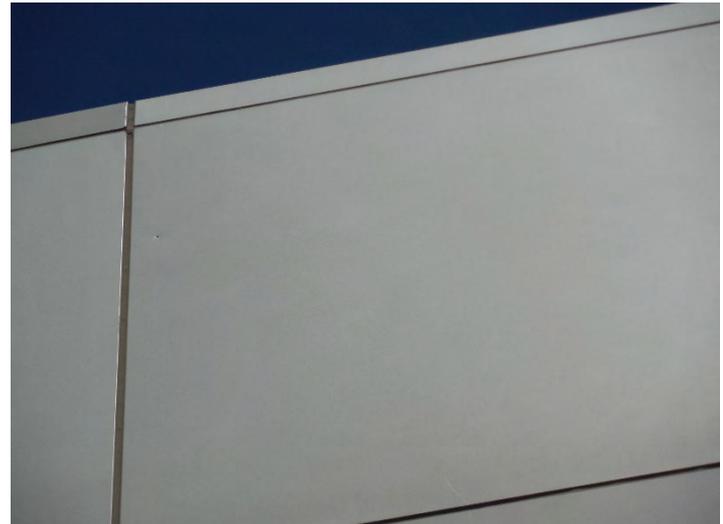
South Elevation at Lobby, dent or hole in metal panel

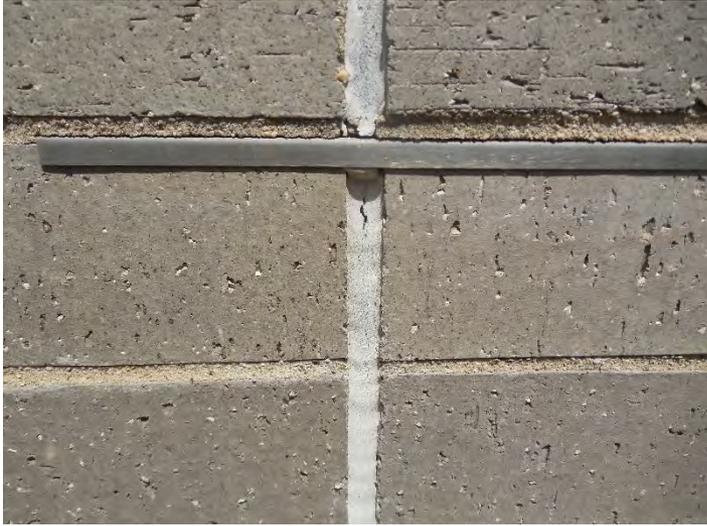
Auditorium Wing, South Elevation, failed sealant at an expansion joint

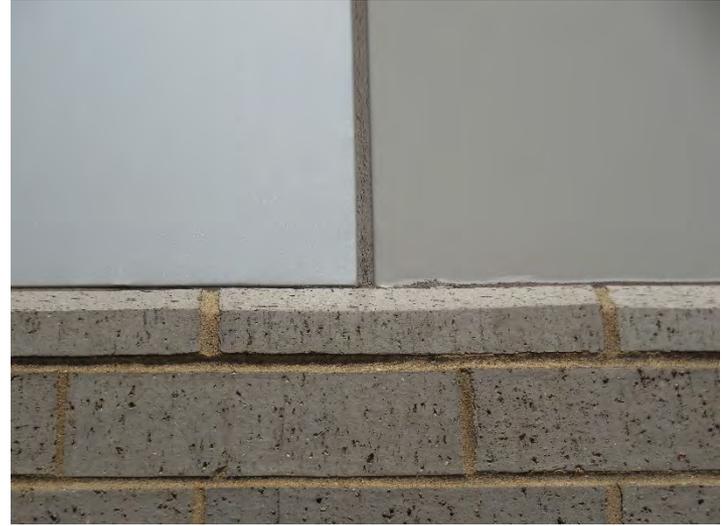
Auditorium Wing, South Elevation, failed sealant at a metal panel joint

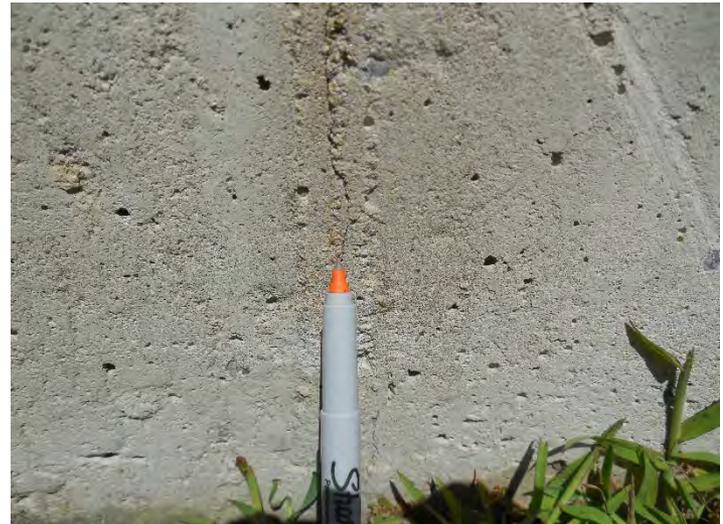
Auditorium Wing, South Elevation, crack in foundation wall

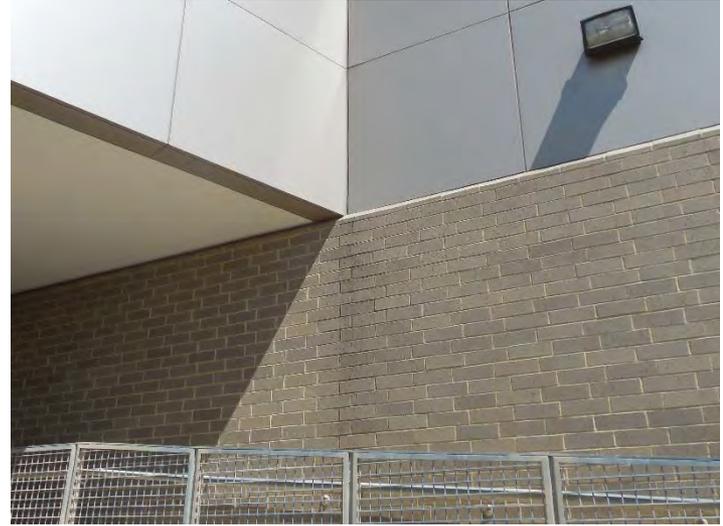
Loading Dock, South Elevation, staining on brick masonry

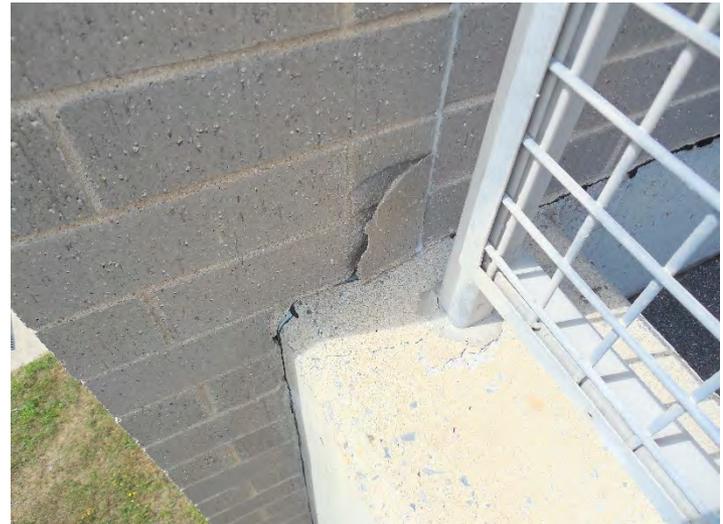
Loading Dock, spalled brick and cracks in concrete and sealant joints

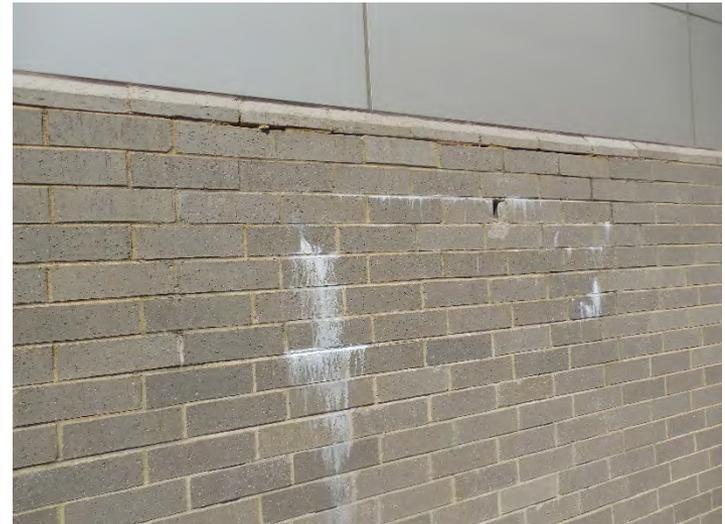
Gymnasium Wing, West Elevation, efflorescence on brick masonry, mortar deterioration at top course, and spalled bricks

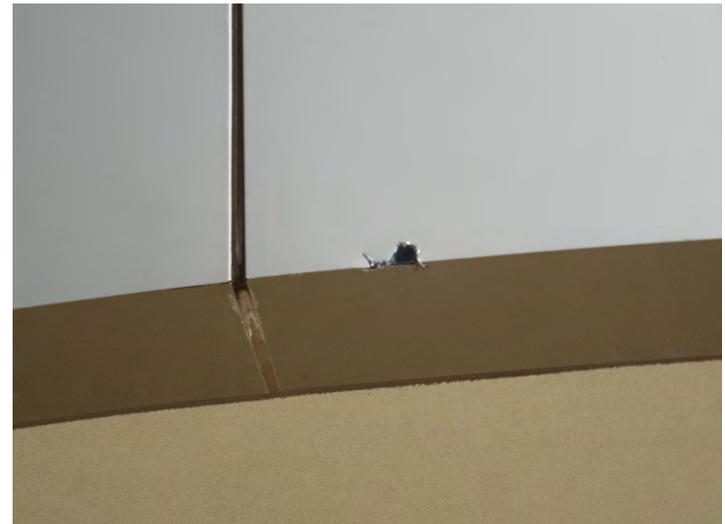
Gymnasium Wing, West Elevation, damaged metal panel and sealant failure at entrance canopy

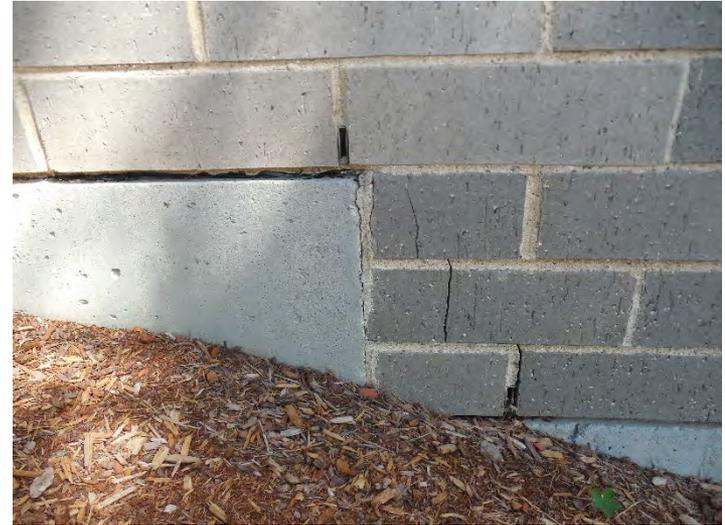
Gymnasium Wing, West Elevation, open mortar joints and cracked bricks

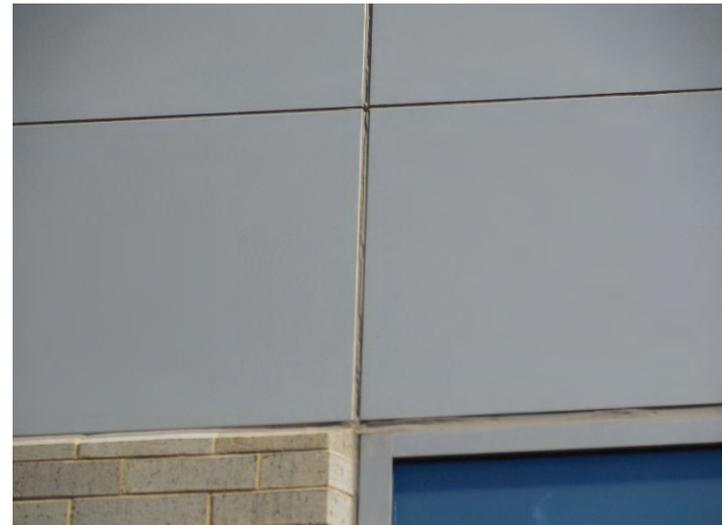
Gymnasium Wing, West Elevation, bulged and wrinkled sealant at metal panel joints

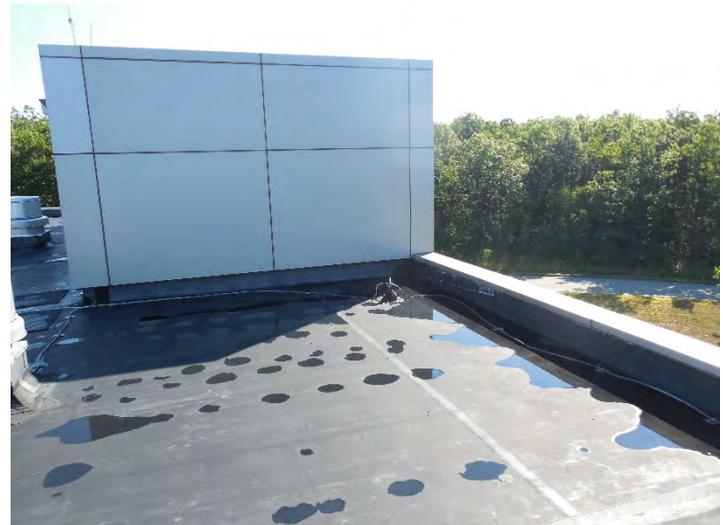
'A' Wing roof, ponded water

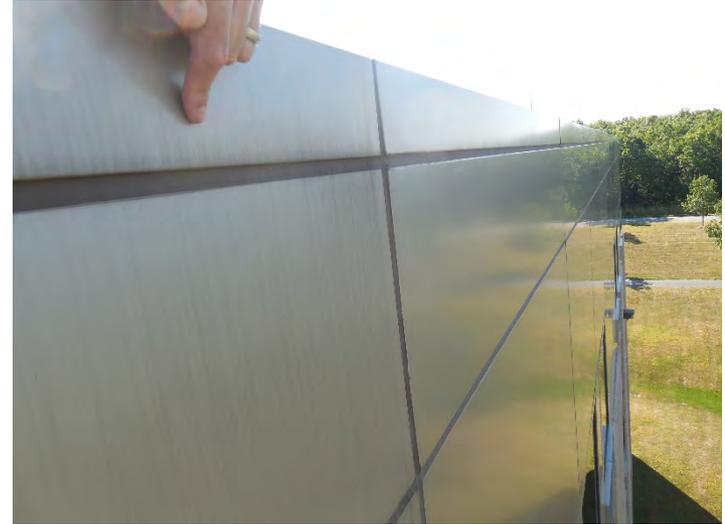
'A' Wing roof, water staining on metal coping

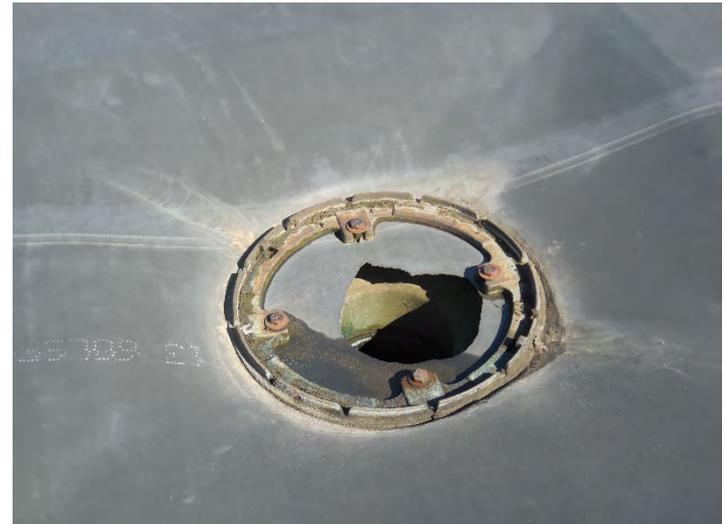
'A' Wing roof, hole in EPDM for drain is smaller than drain bowl

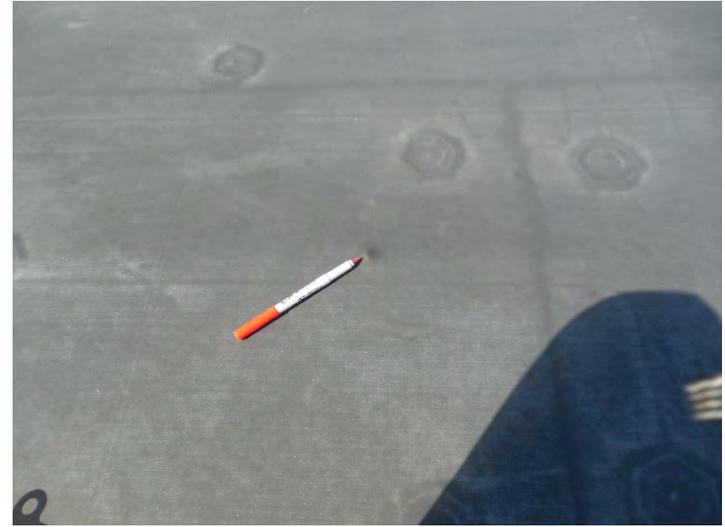
'A' Wing roof, object below EPDM not yet protruding through

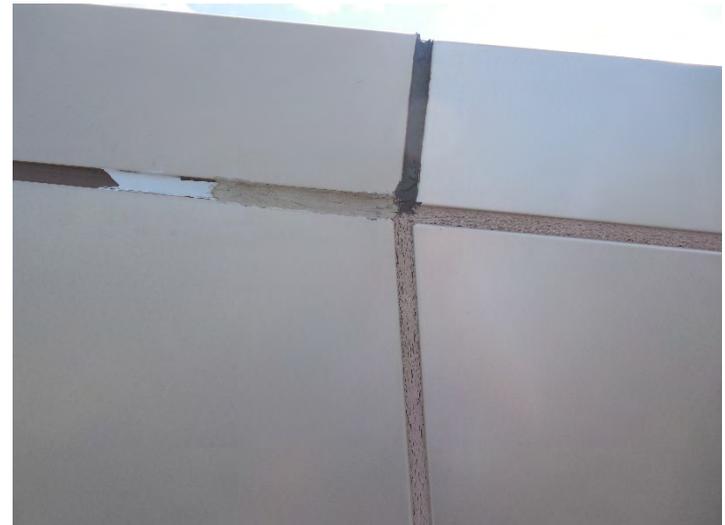
'M' Wing roof, sealant failure at a dormer

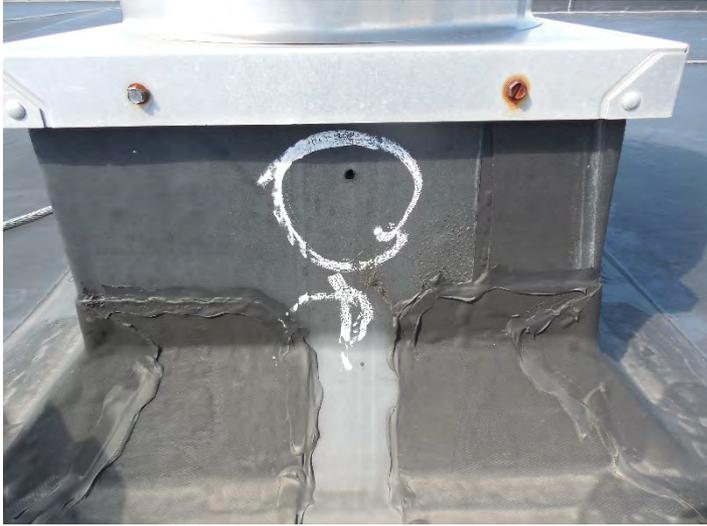
'M' Wing roof, hole in EPDM at a mechanical vent curb

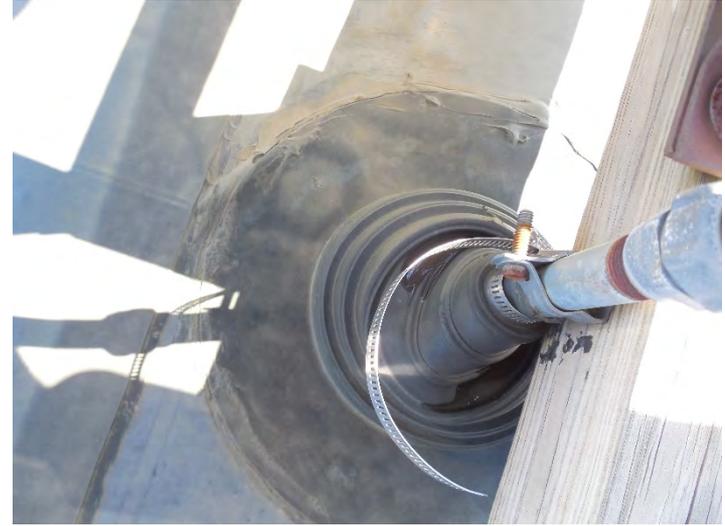
'A' Wing roof, loose hose clamp at conduit

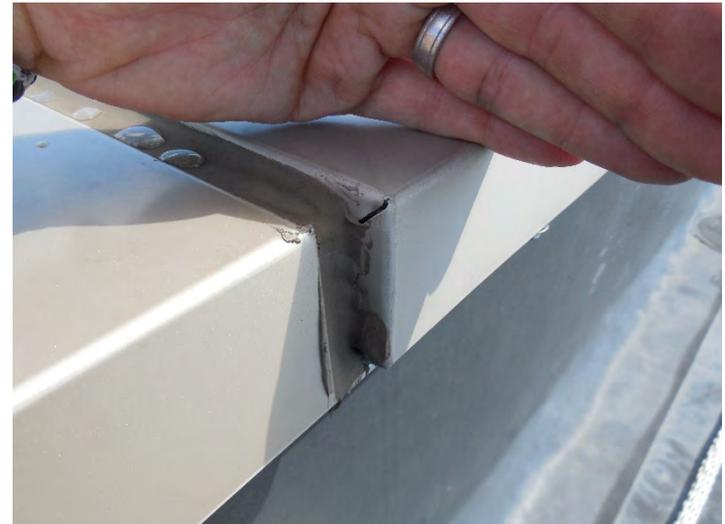
'A' Wing roof, sealant does not cover pinholes at coping outside corners

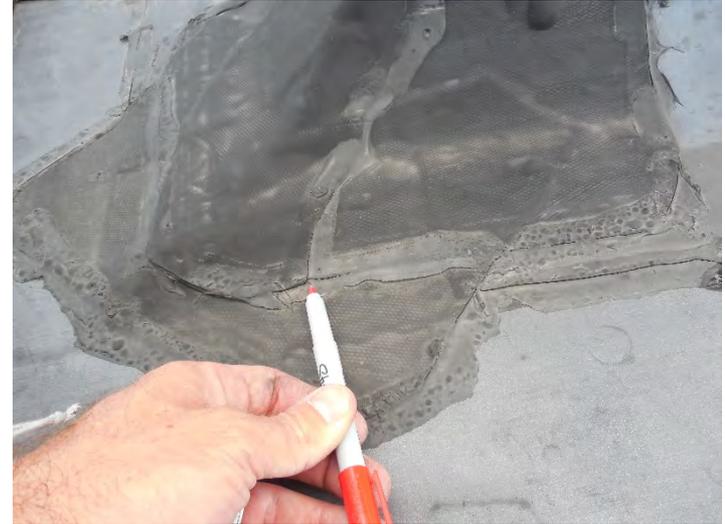
'B' Wing roof, flashing seams and lap seal starting to fail

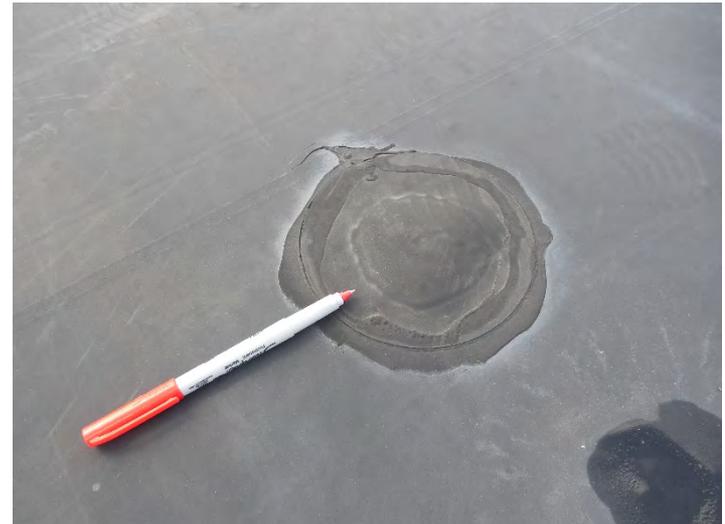
'M' Wing roof, blister in EPDM patch

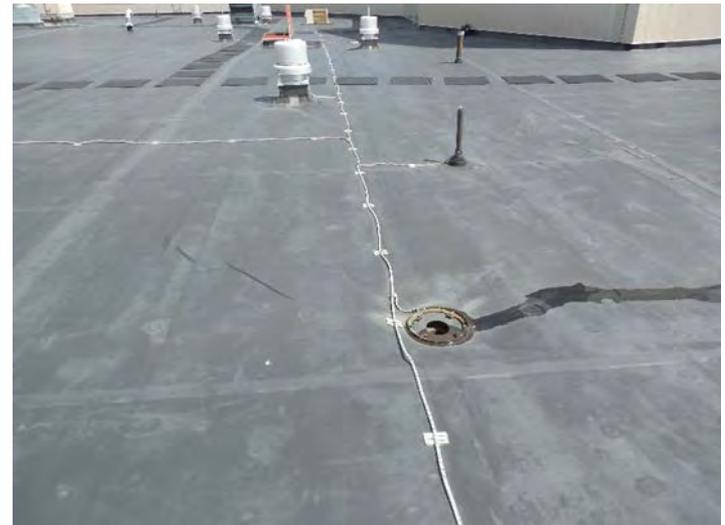
Auditorium wing roof, missing roof drain dome

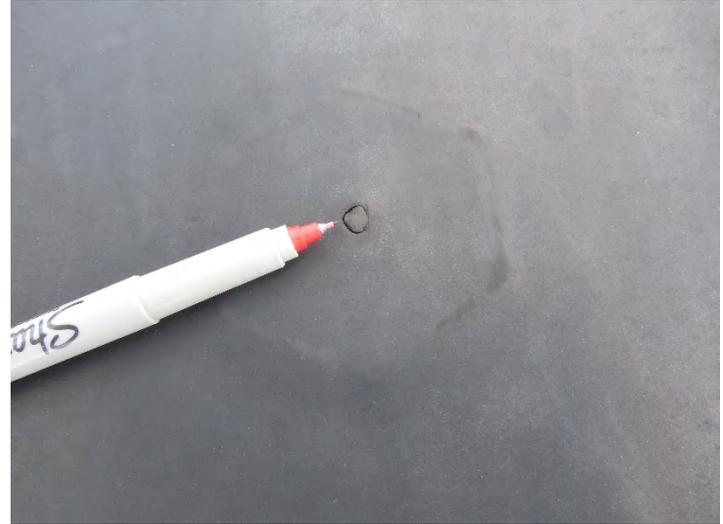
Auditorium wing roof, EPDM damaged at insulation fastener

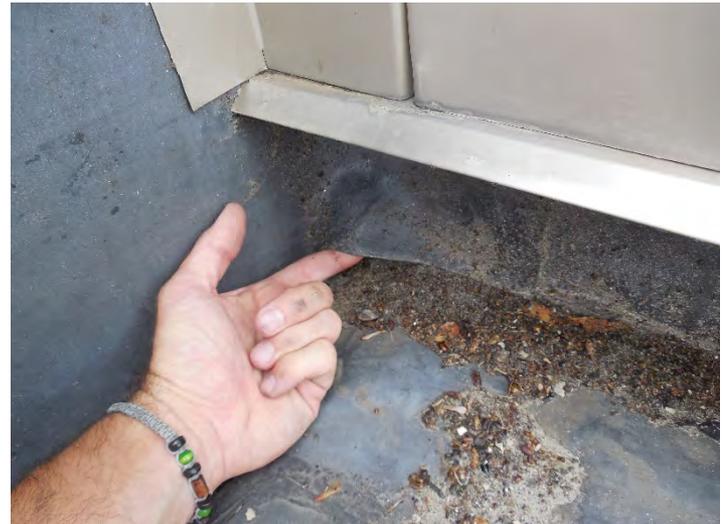
Auditorium wing roof, open seam in EPDM flashing

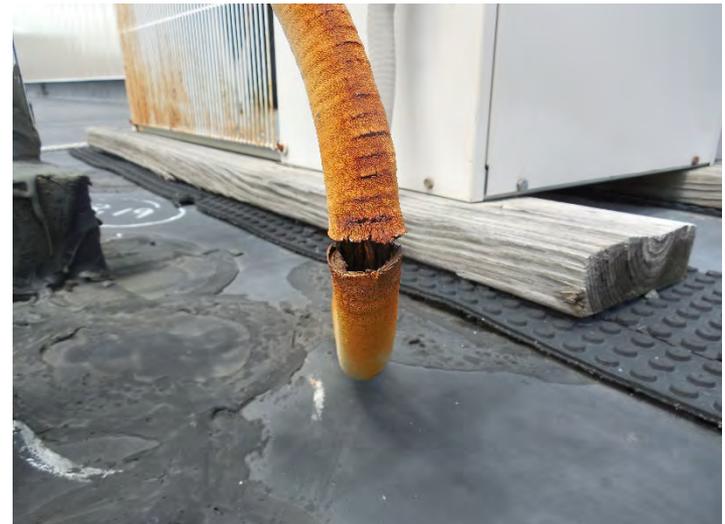
Auditorium wing roof, damaged conduit

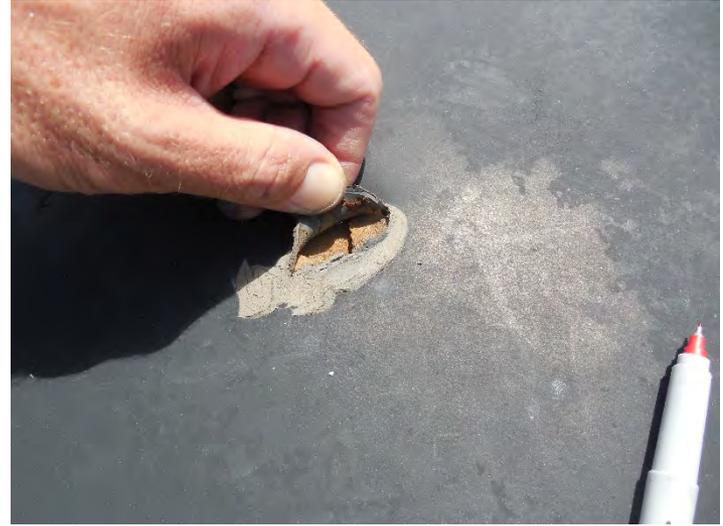
Auditorium wing roof, hole in EPDM with deteriorated cover board beneath

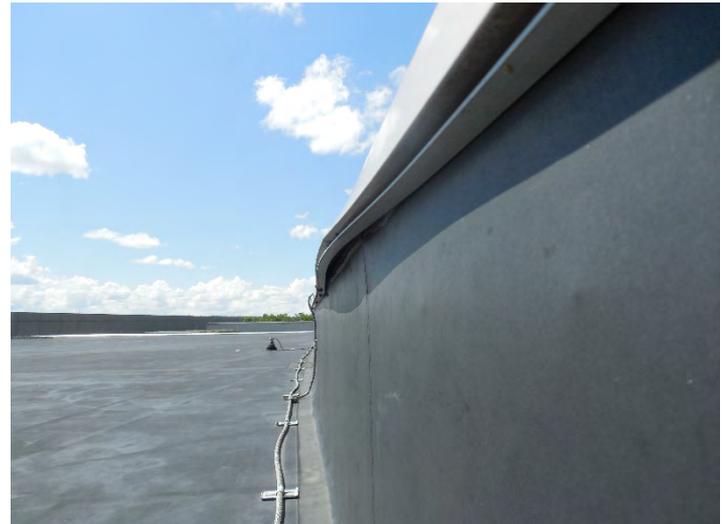
Auditorium wing parapet, damaged coping attachment strip

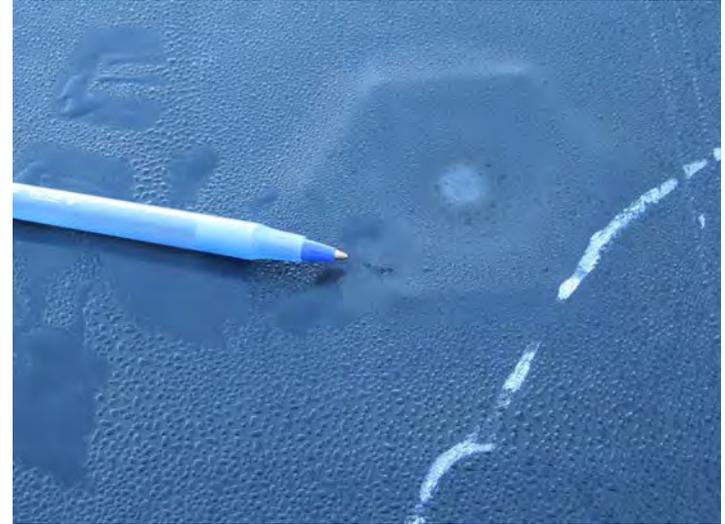
Auditorium roof, damage to EPDM from insulation fasteners

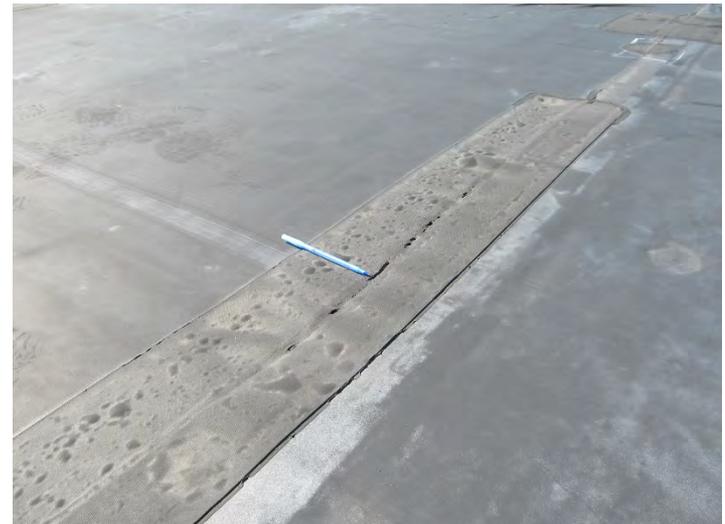
Gymnasium roof, open seam in EPDM

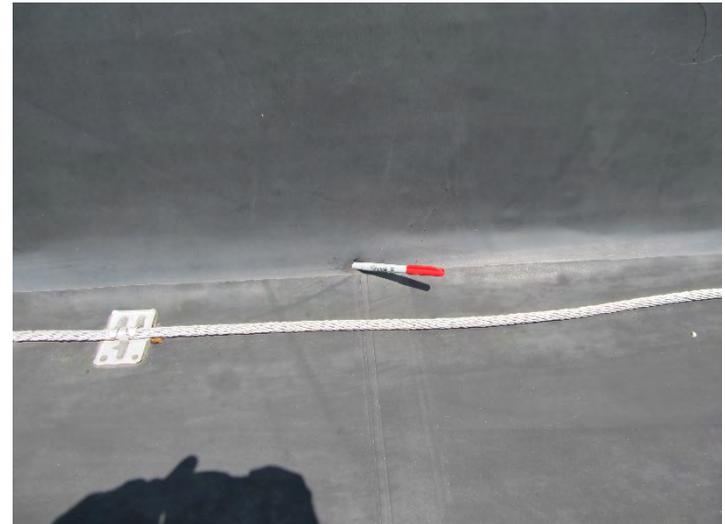
Main Entrance roof, hole in EPDM

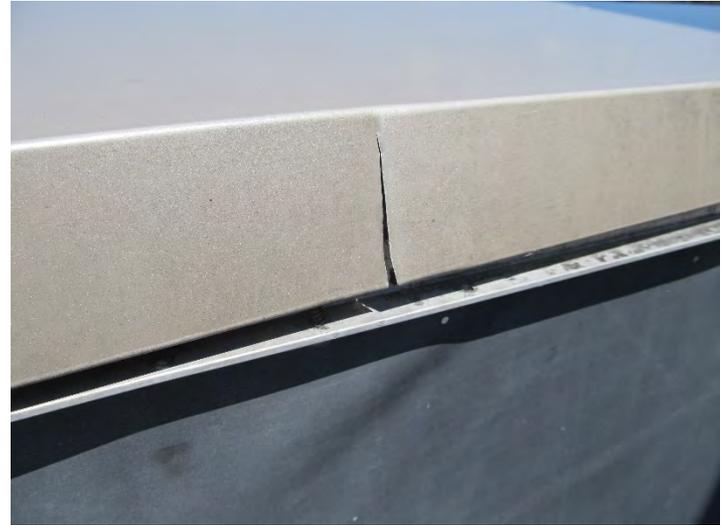
Main Entrance parapet, broken section of metal coping

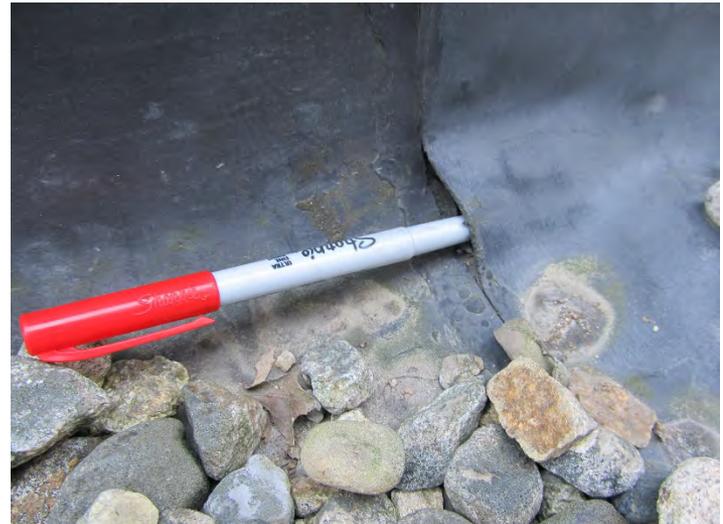
Ballasted roof at North 'A' Wing, open EPDM lap seam
