TOWN OF SHREWSBURY
FACILITIES CONDITION ASSESSMENT
OF
TOWN BUILDINGS

FINAL REPORT

June 01, 2016

**Shrewsbury
Oak Middle School**

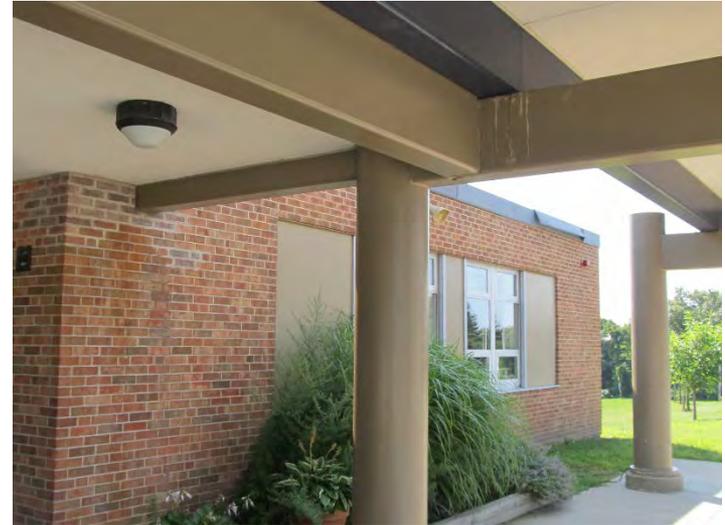
West Elevation, stains and dripping water at steel canopy framing

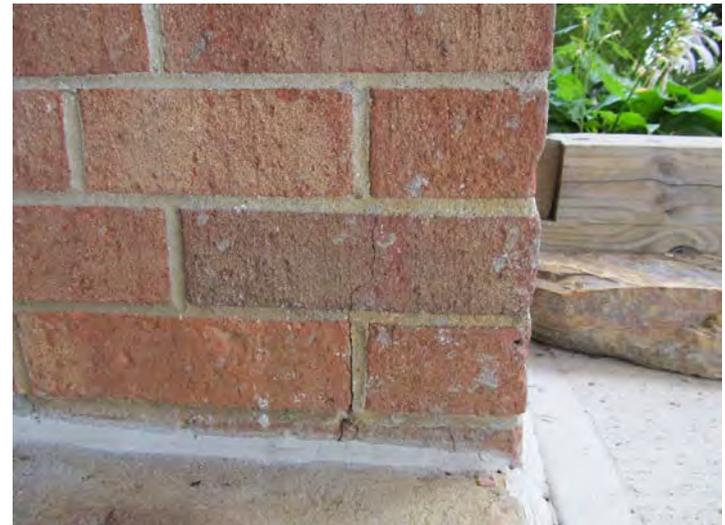
West Elevation, crack through brick and mortar joint

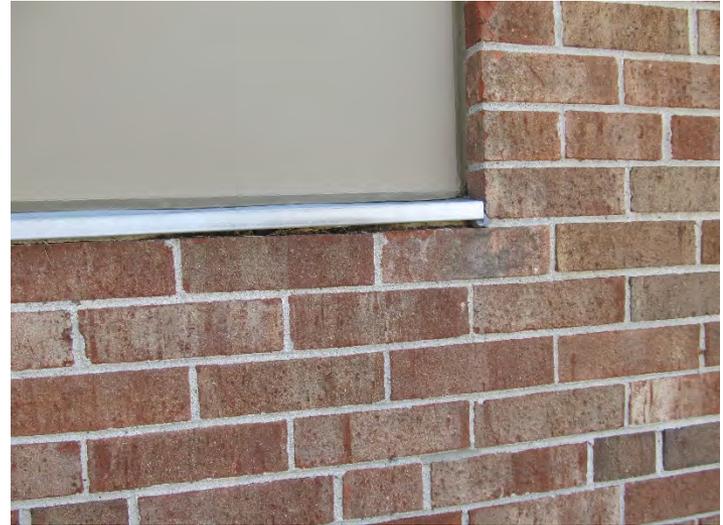
West Elevation, displaced sill trim/flashing

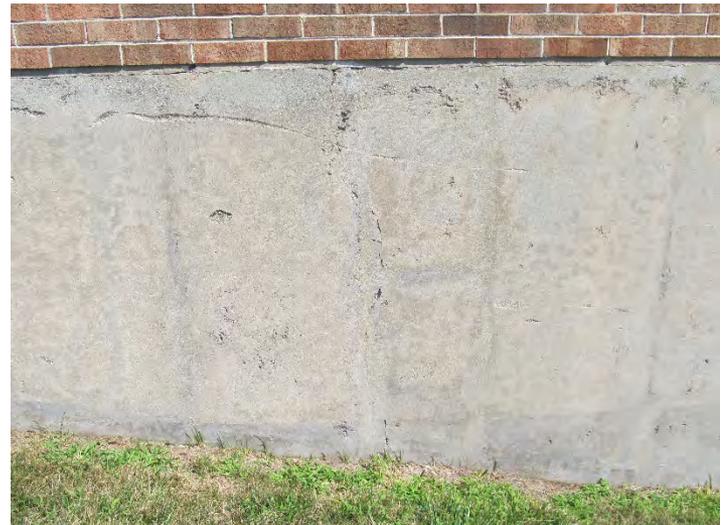
West Elevation, cracks in foundation wall

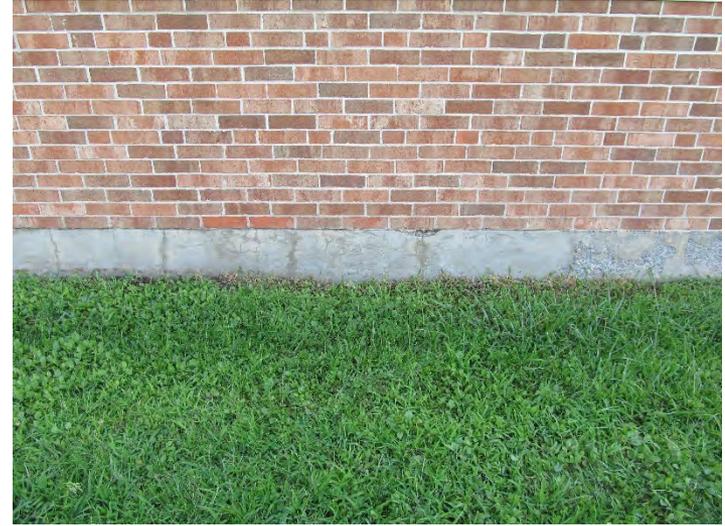
West Elevation, spalling foundation wall

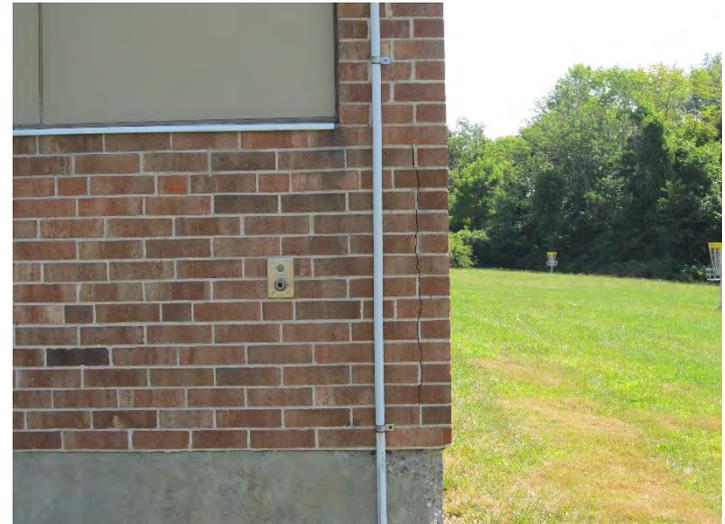
West Elevation, crack through bricks and mortar joints;
spalled foundation wall

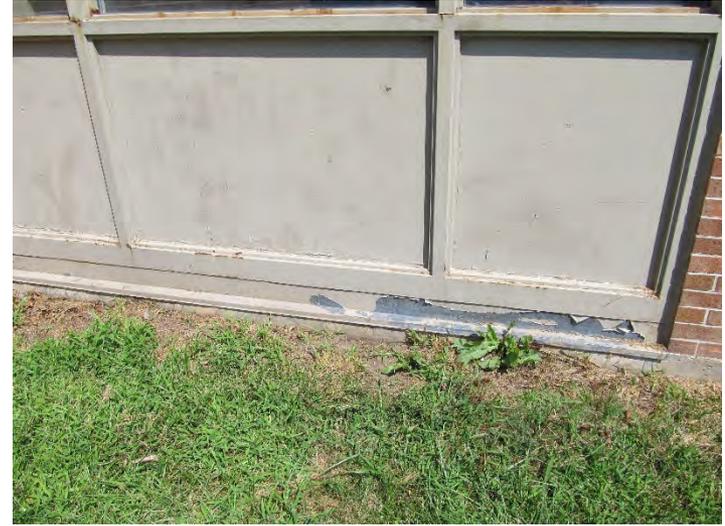
South Elevation, peeling paint and corrosion at a window

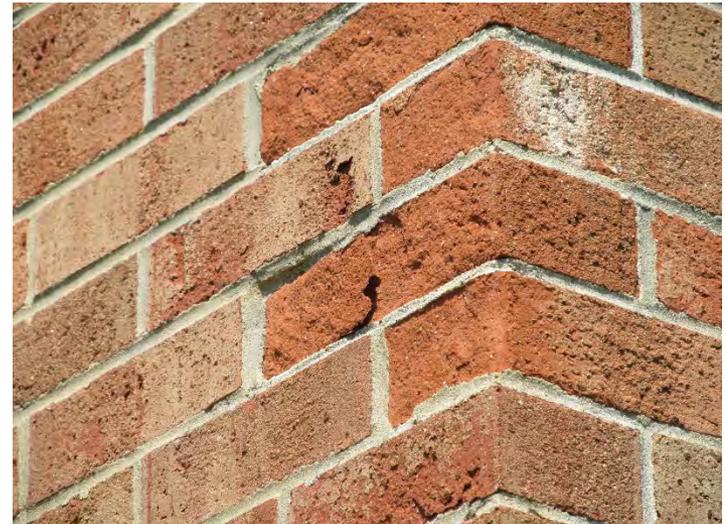
South Elevation, spalled bricks and deteriorated mortar

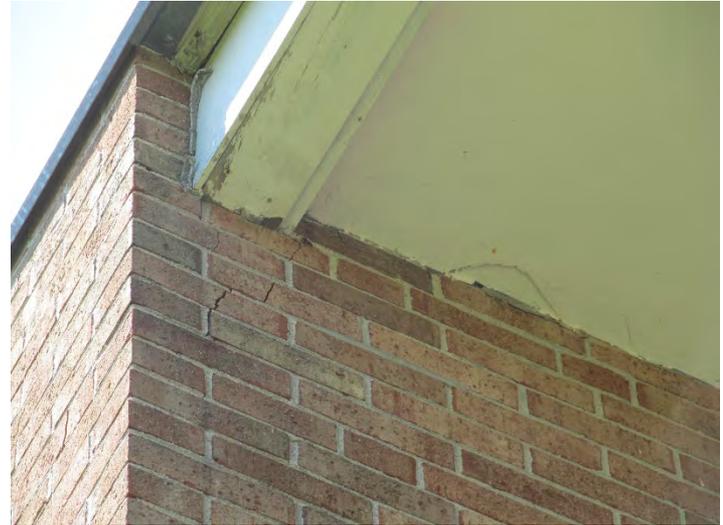
East Elevation, crack through bricks and mortar; peeling paint

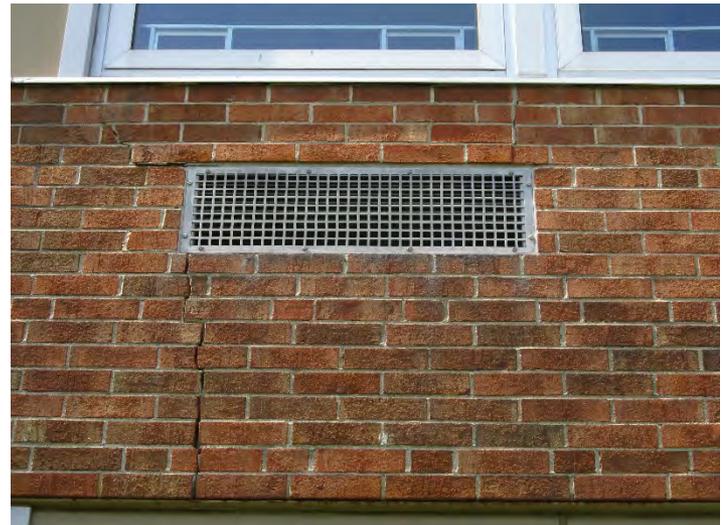
East Elevation, crack through bricks and mortar; corroded lintel; stained brick masonry

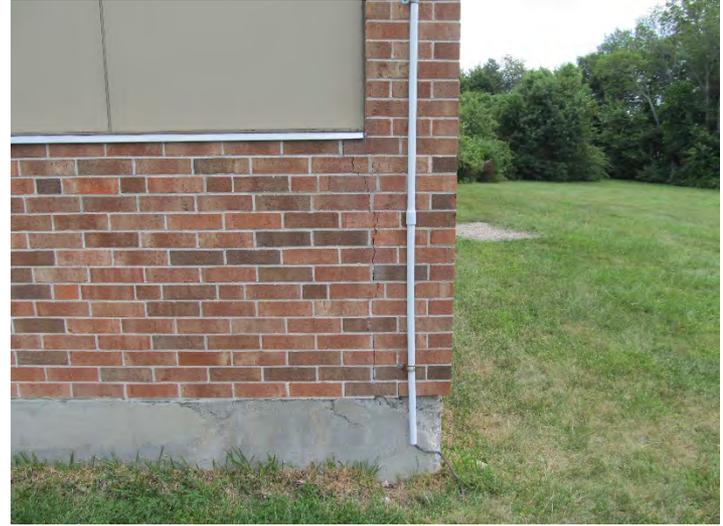
West Elevation, crack through brick and mortar; spalled concrete at foundation

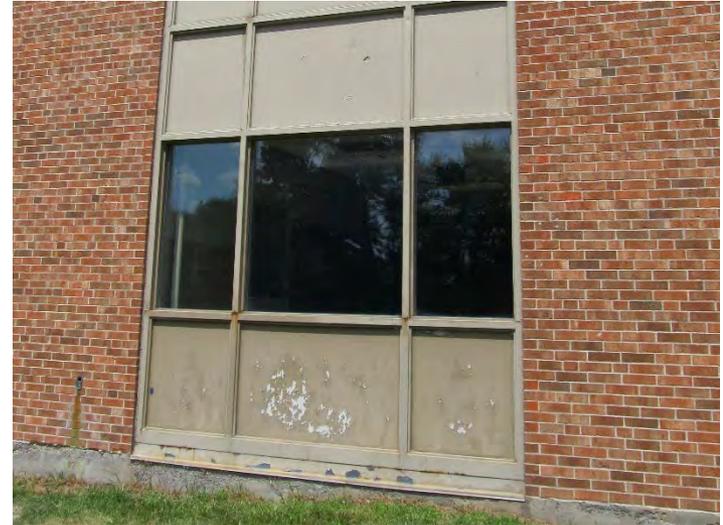
South Elevation, peeling paint and corrosion at a window frame

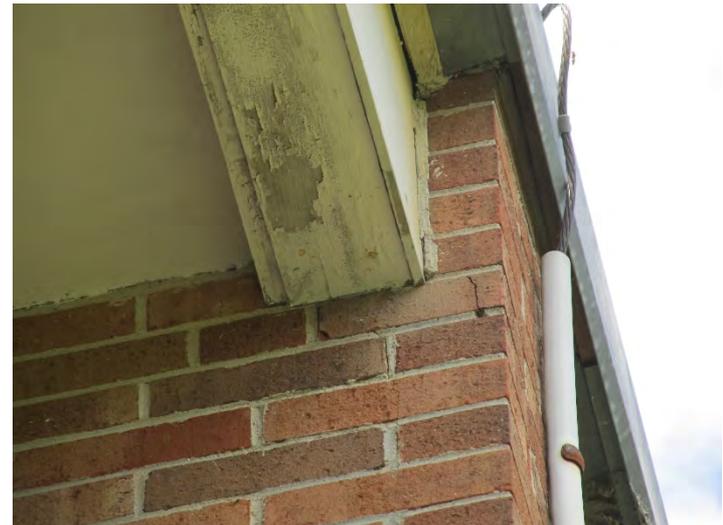
East Elevation, peeling paint, failed sealant joints, and crack brick at a soffit

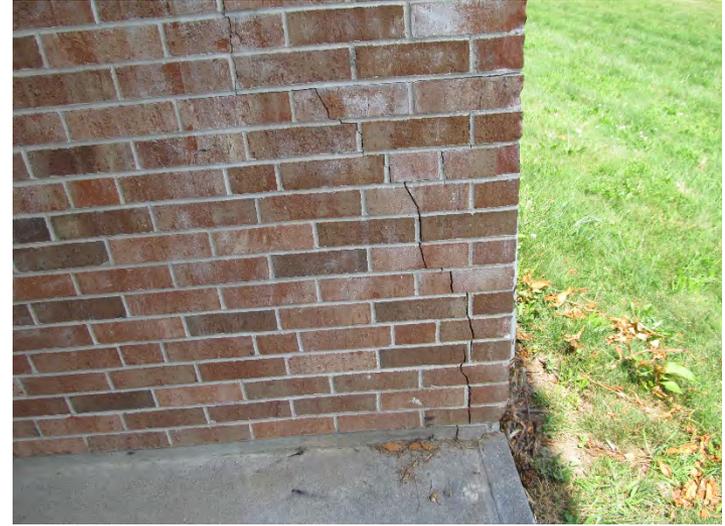
East Elevation, crack through brick and mortar joints; staining on brick

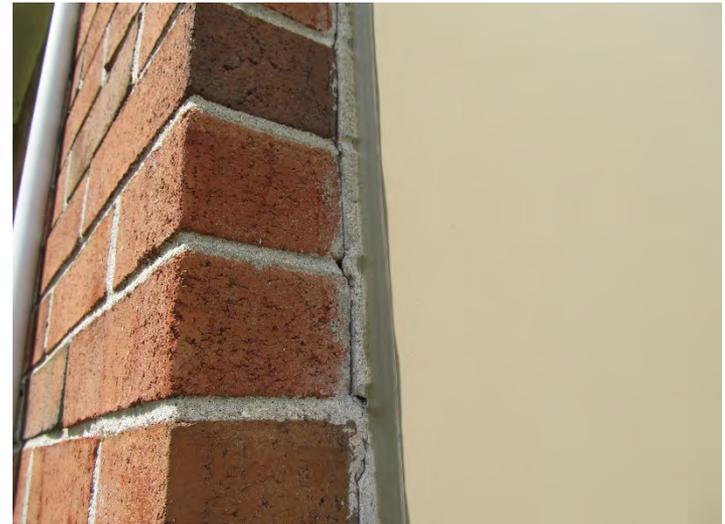
South Elevation, mortar/sealant failure

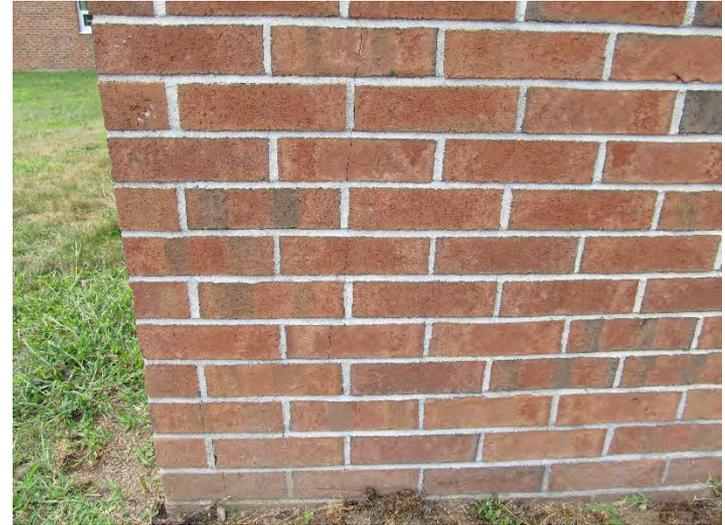
East Elevation, crack through brick and mortar joints

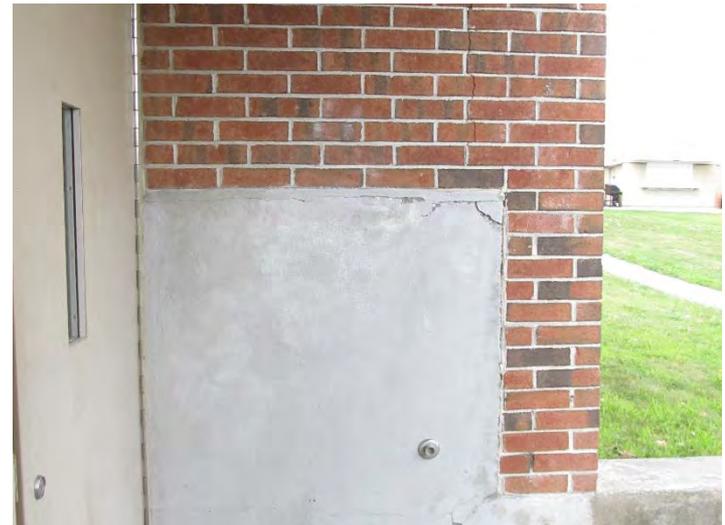
East Elevation, crack through brick and concrete

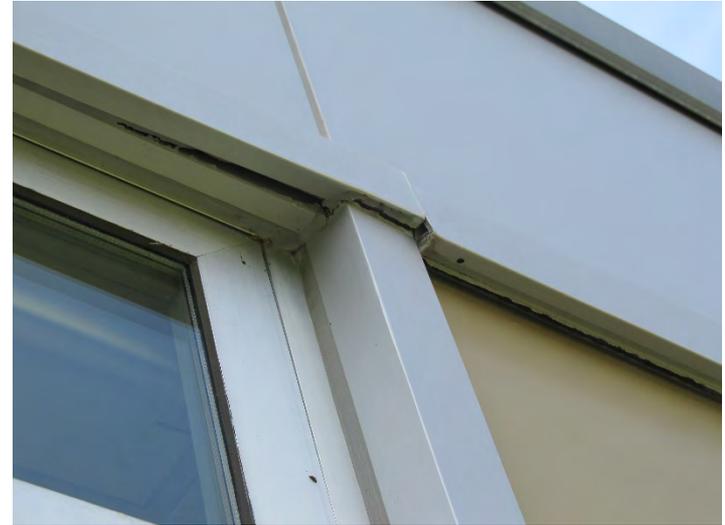
East Elevation, failed sealant at window trim

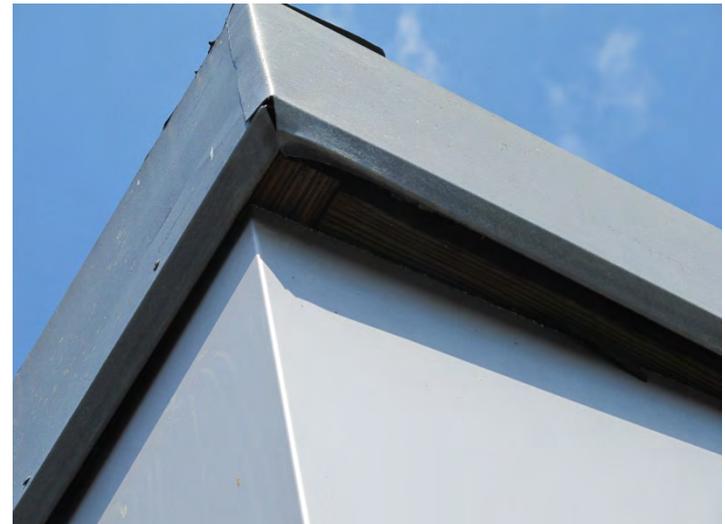
South Elevation, exposed wood blocking

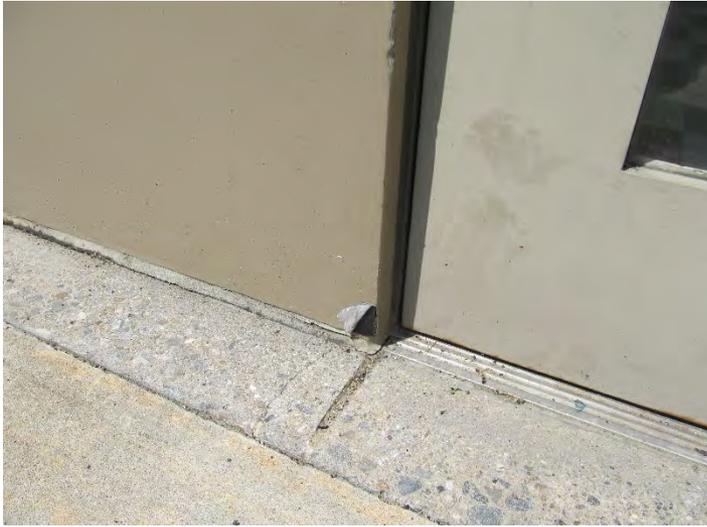
South Elevation, damaged metal panel

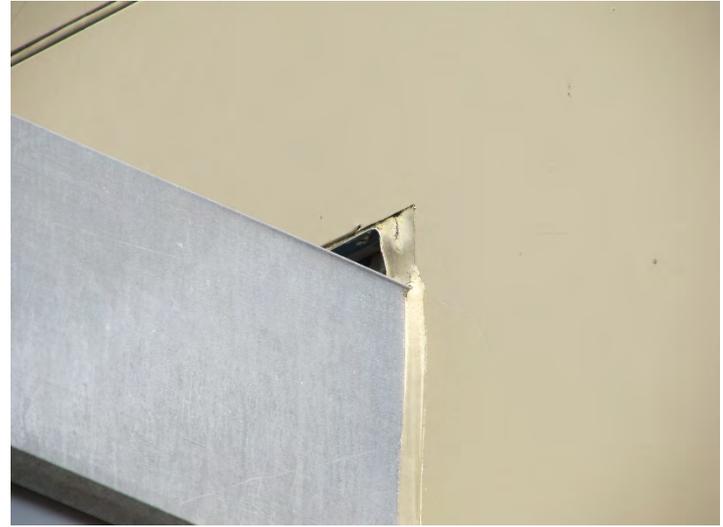
South Elevation, failed sealant joint at metal panel termination

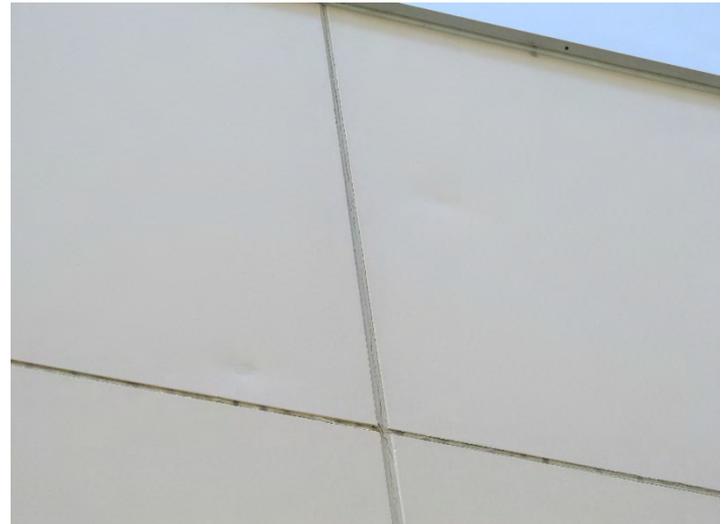
East Elevation, failed sealant at metal panel joints

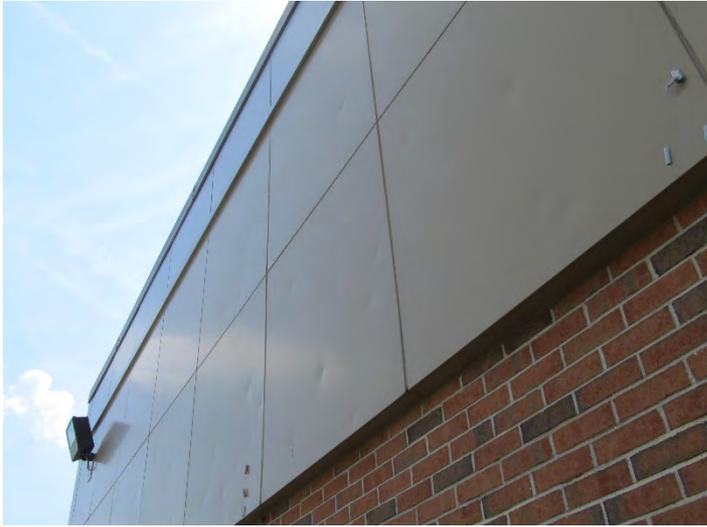
East Elevation, dented metal panels

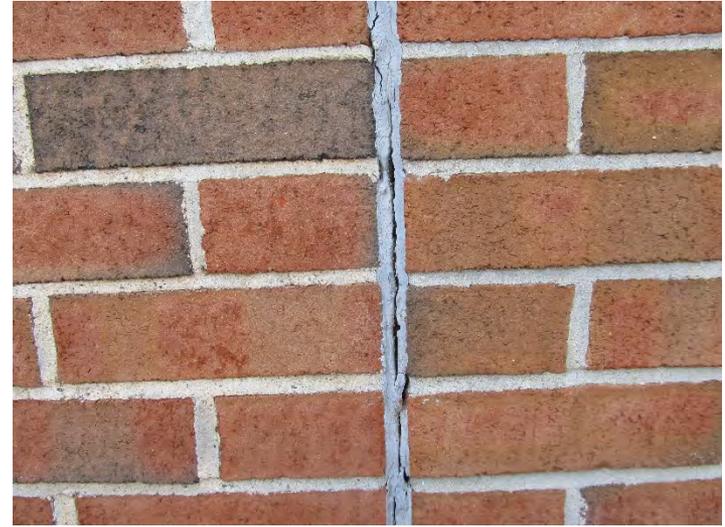
East Elevation, failed sealant at an expansion joint

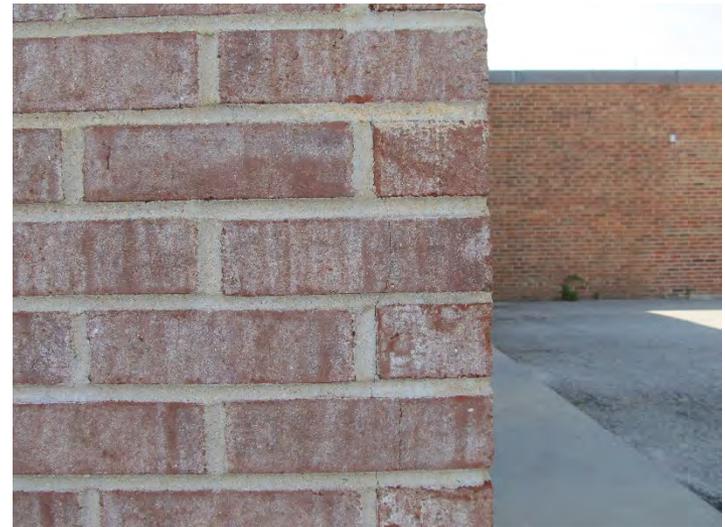
East Elevation, discolored and cracked brick

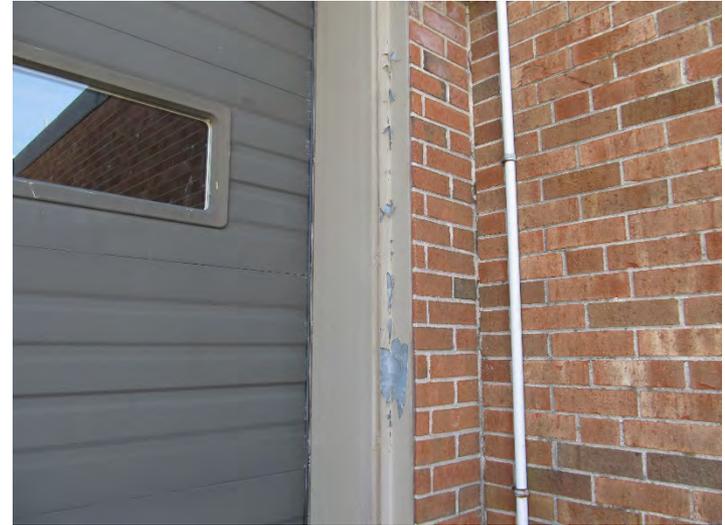
North Elevation, peeling paint at overhead door frame

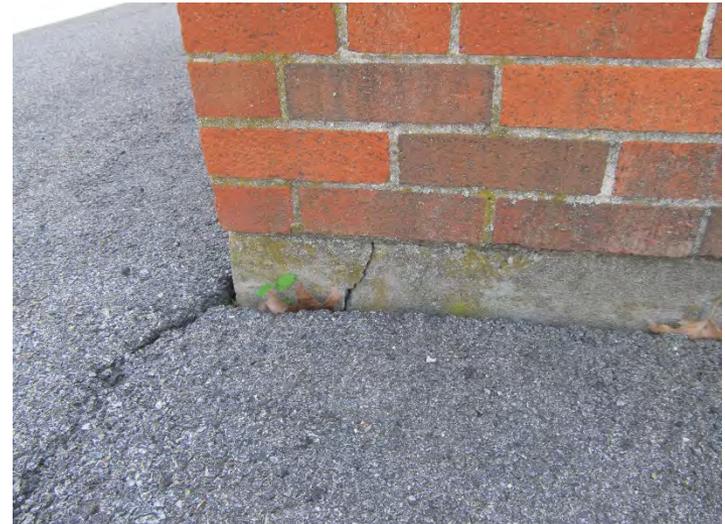
North Elevation, crack at foundation wall

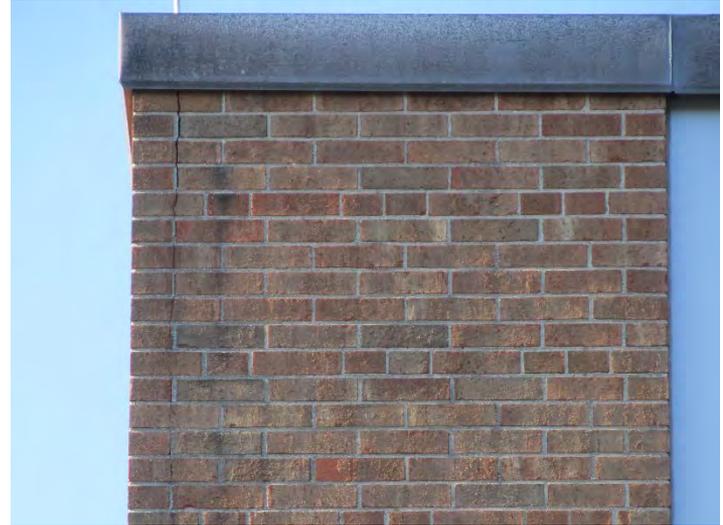
North Elevation, crack through brick and mortar

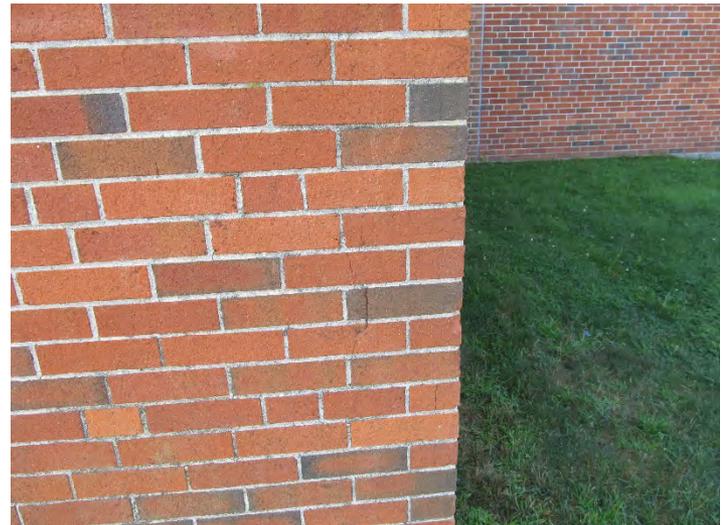
North Elevation, cracked bricks

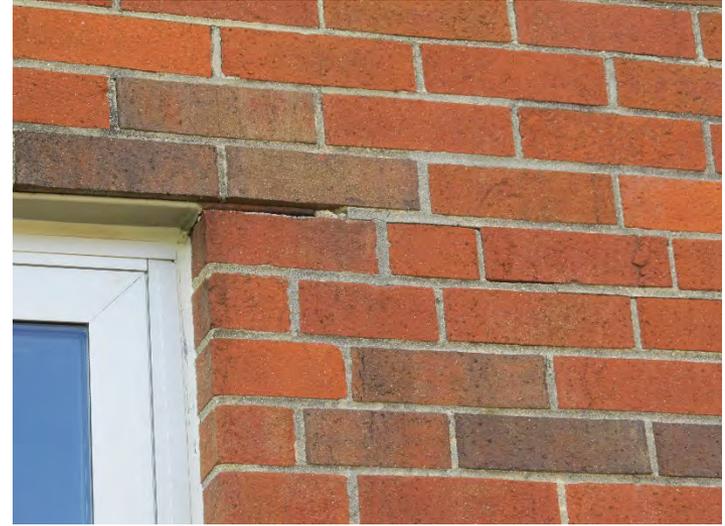
North Elevation, corroded lintel and cracked mortar

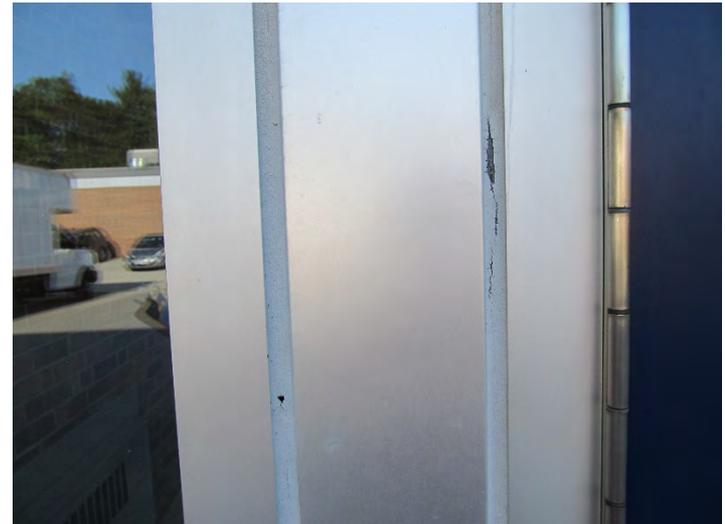
North Elevation, failed door perimeter sealant

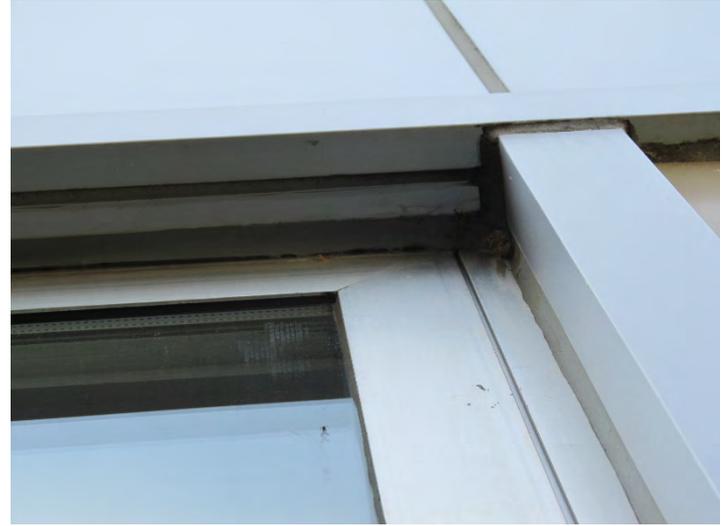
North Elevation, failed window perimeter sealant

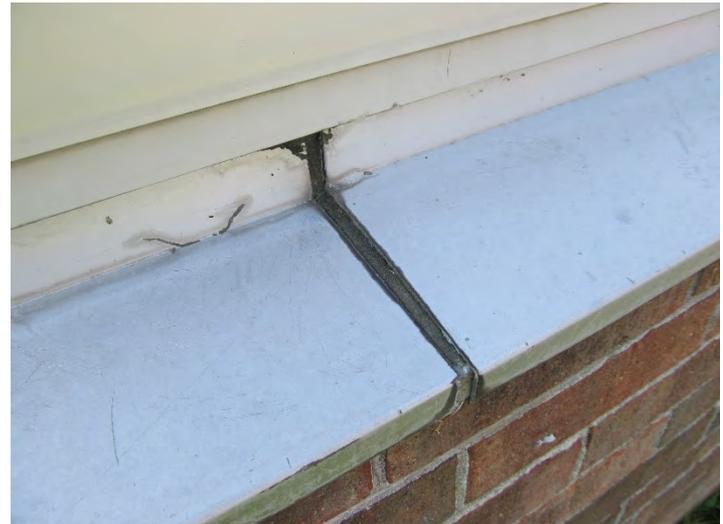
North Elevation, deteriorated sealant at sill flashing lap joint

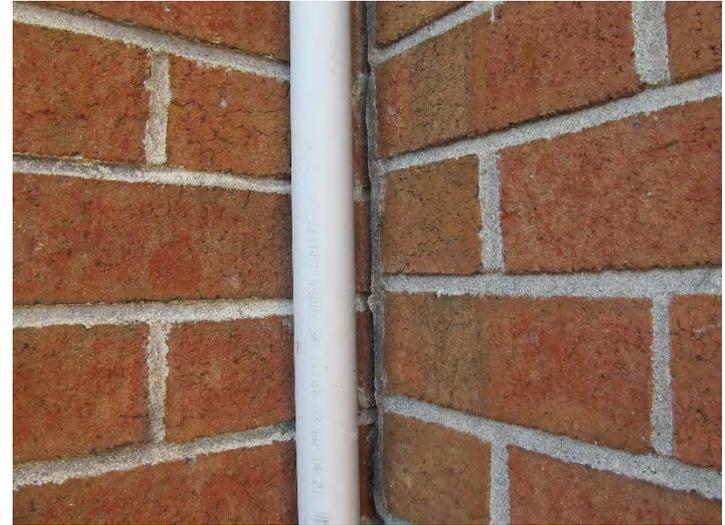
North Elevation, open mortar joint at corner

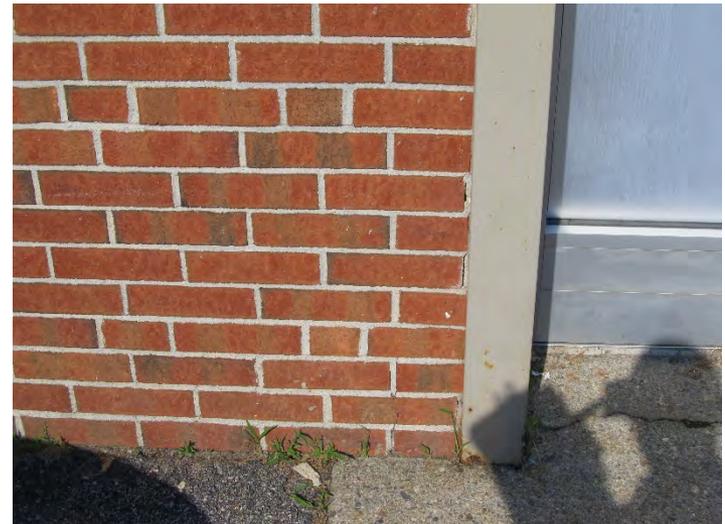
East Elevation, crack in brick and mortar joints

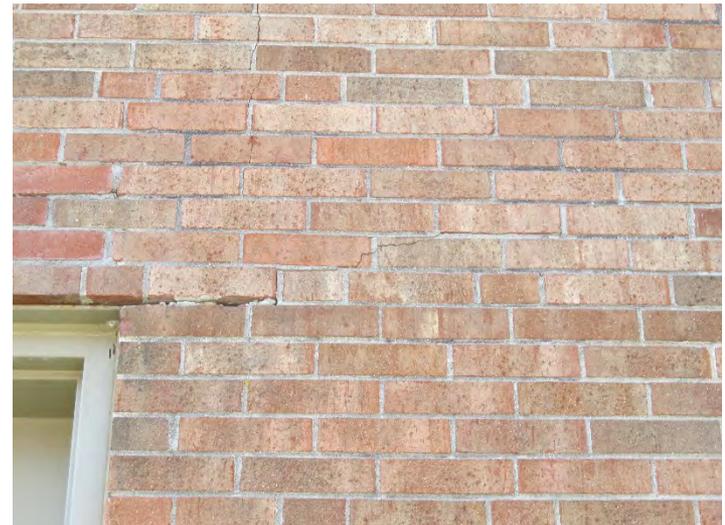
North Elevation, cracked brick and deteriorated mortar at a lintel

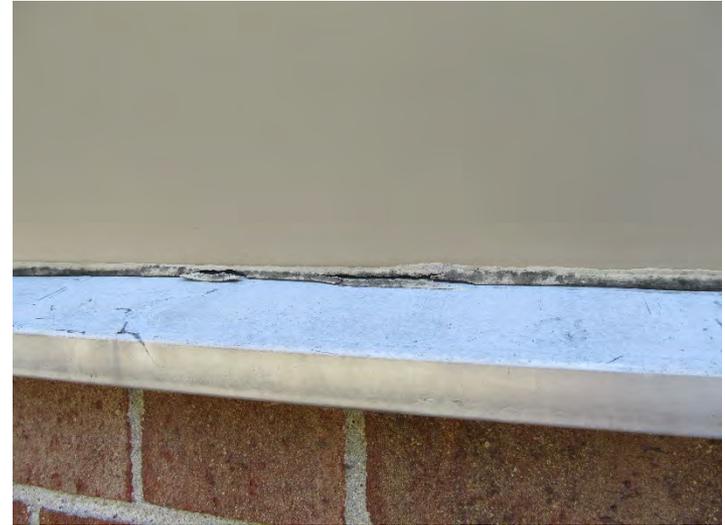
West Elevation, failed sill sealant

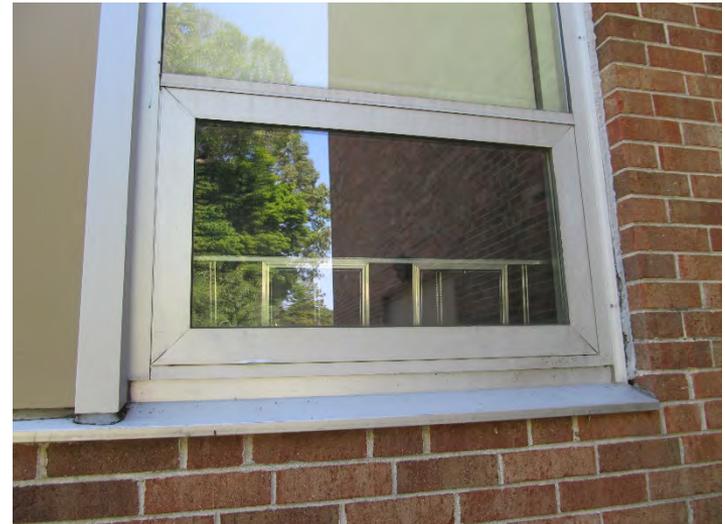
West Elevation, damaged window sash and failed perimeter sealant

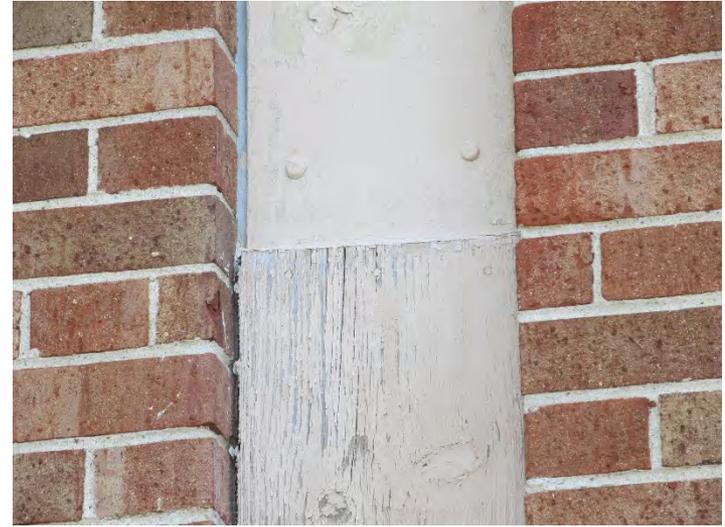
West Elevation, damaged wall accent panel and failed perimeter sealant

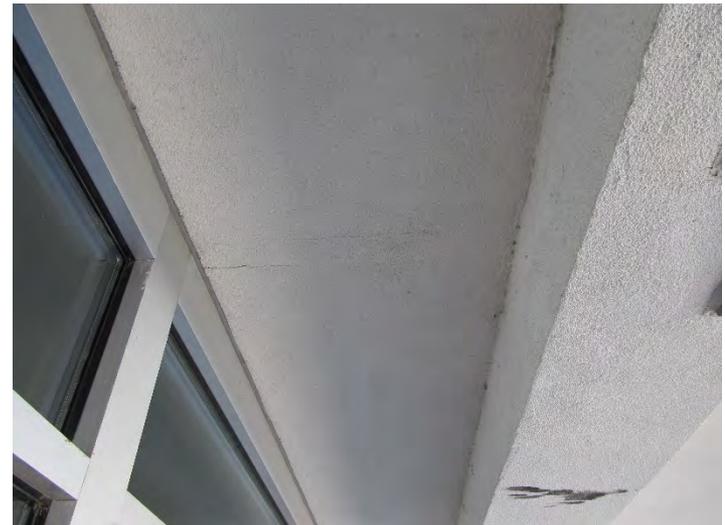
West Elevation, crack in EIFS ceiling

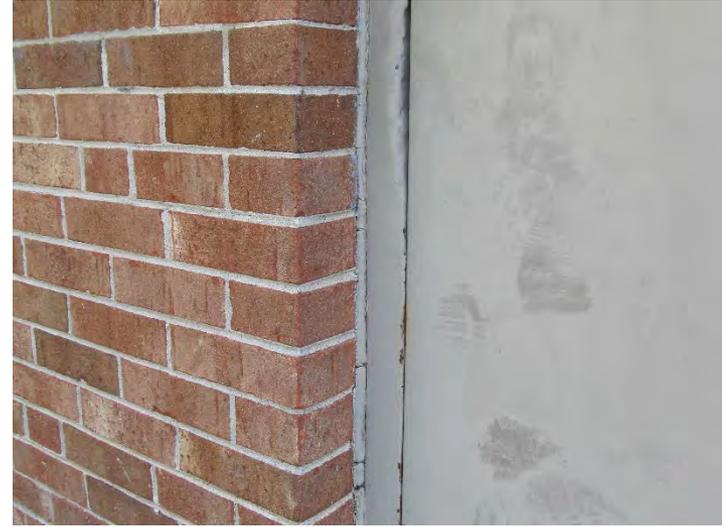
West Elevation, damaged door frame and failed perimeter sealant

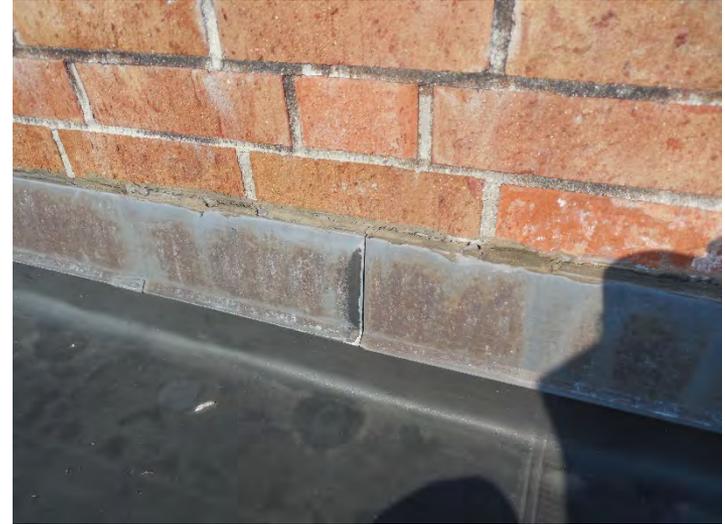
Northwest Wing roof, deteriorated mortar and failed reglet sealant

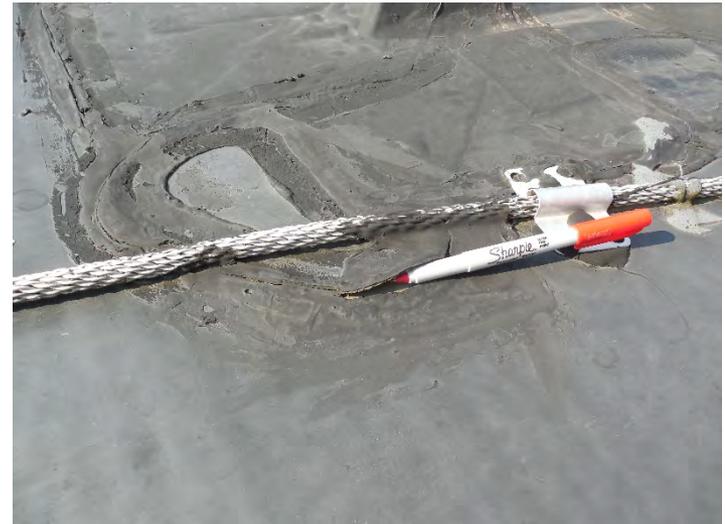
Northwest Wing roof, open joint in flashing

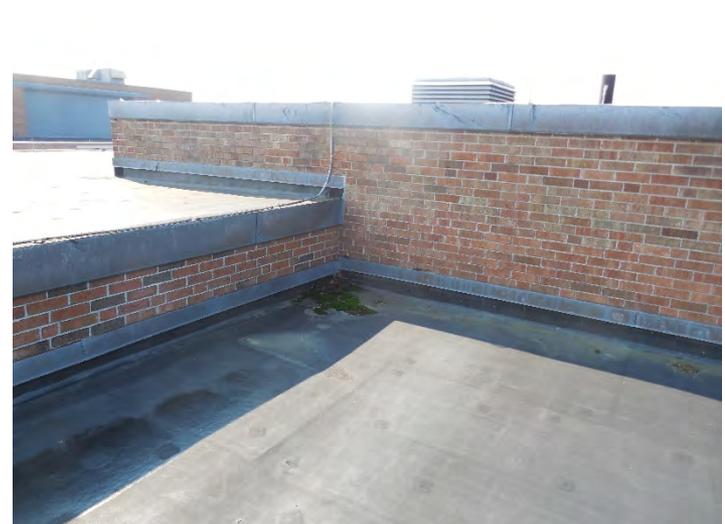
Northwest Wing roof, moss growth in a corner

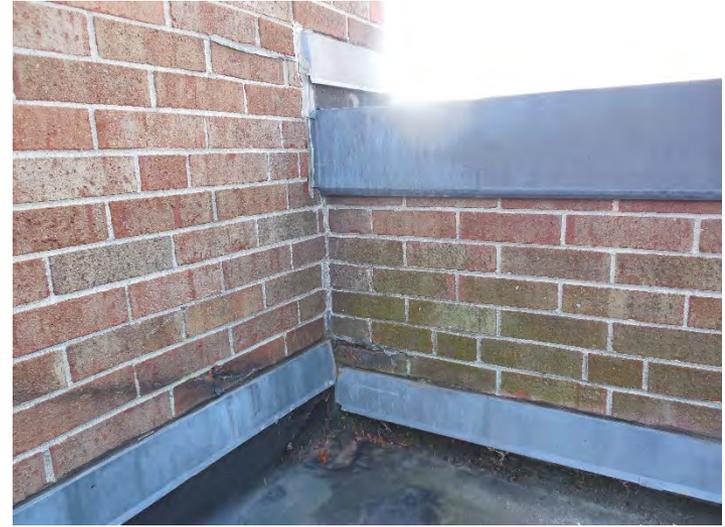
Northwest Wing roof, open (abandoned) reglet

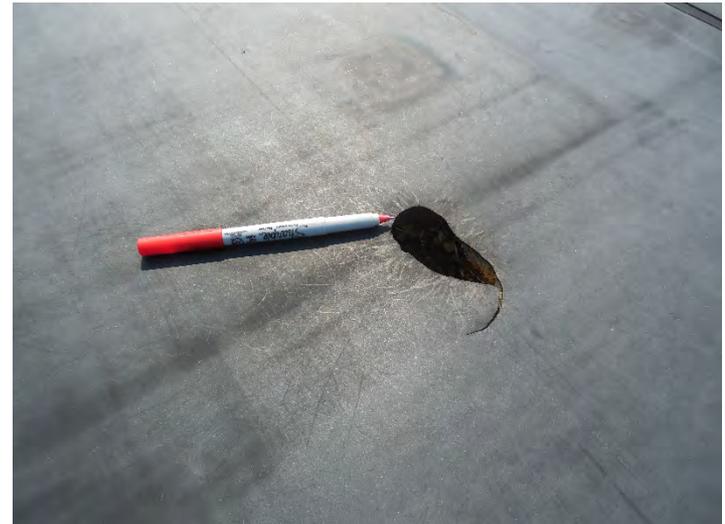
Auditorium roof, hole in EPDM and insulation

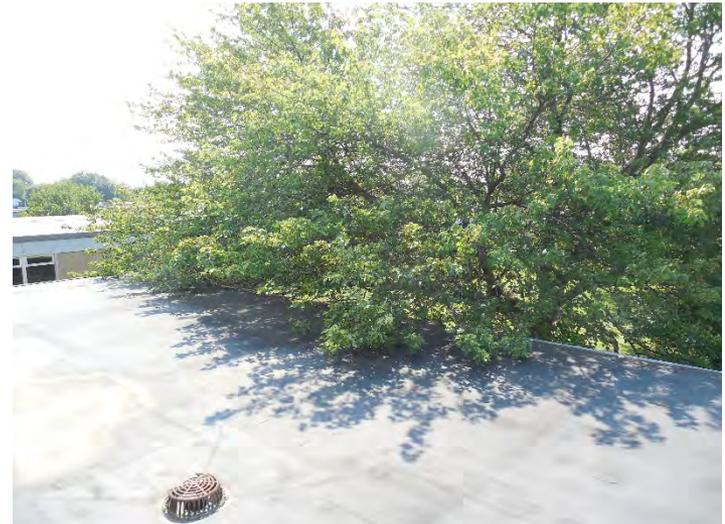
West roof edge, overgrown tree; broken drain bowl with EPDM extending too far into drain bowl

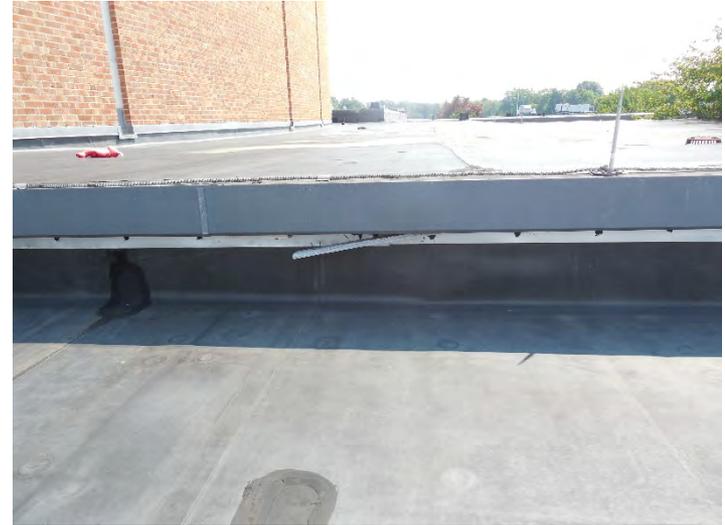
Northwest Wing roof, damaged wood trim; unadhered membrane along wall

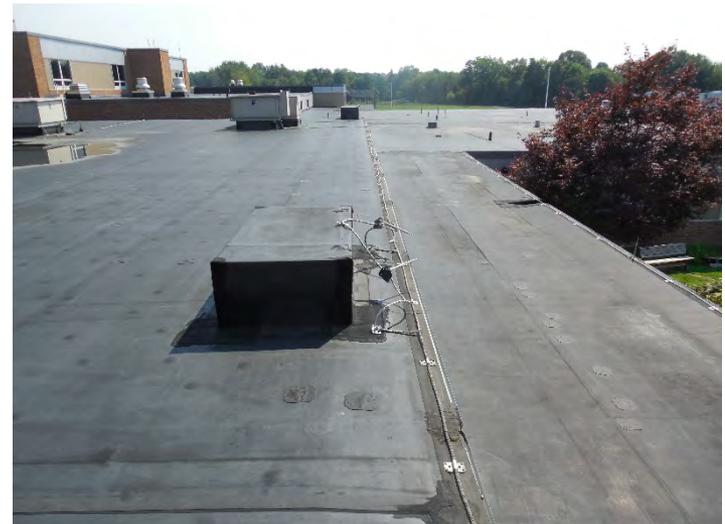
Main roof at North of courtyard, displaced lightning protection

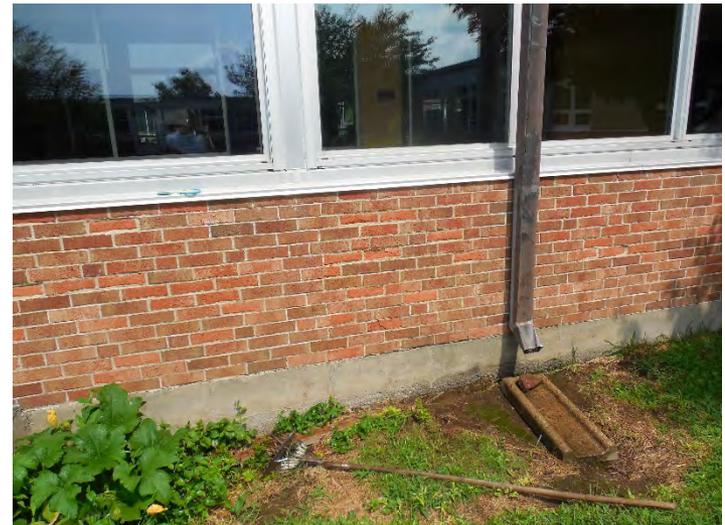
North Courtyard Elevation, spalled brick

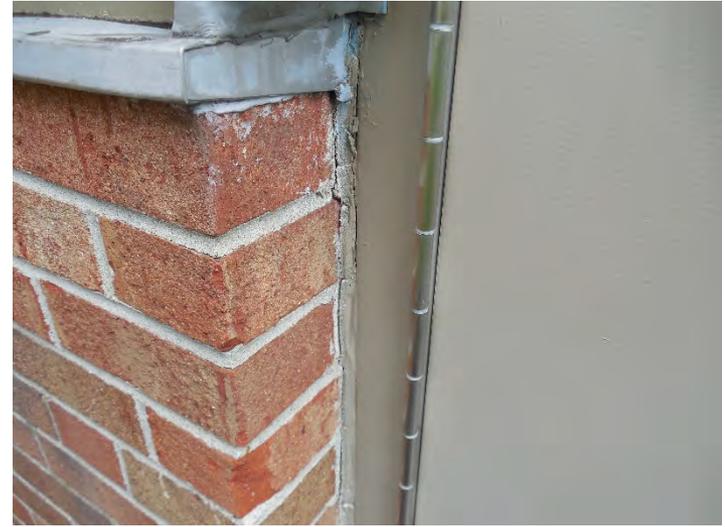
East Courtyard Elevation, failed door perimeter sealant

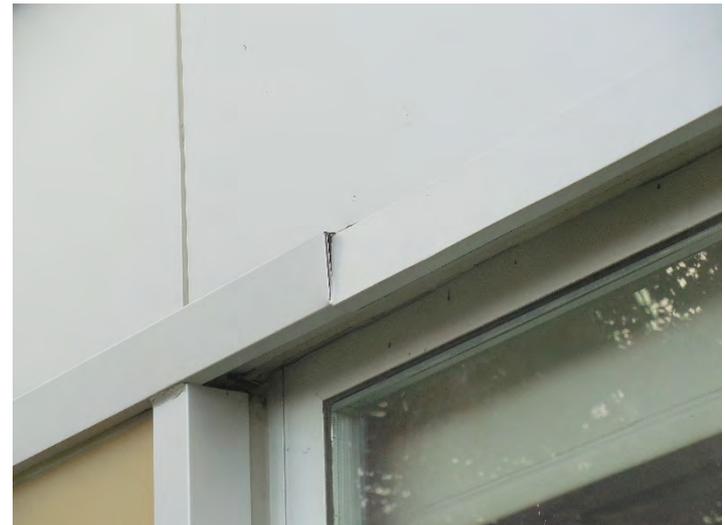
East Courtyard Elevation, damaged metal panel trim

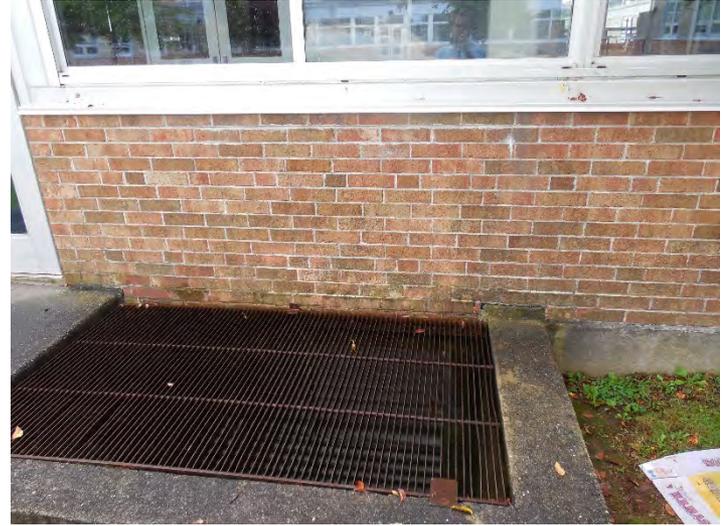
South Courtyard Elevation, deteriorated mortar and stained masonry

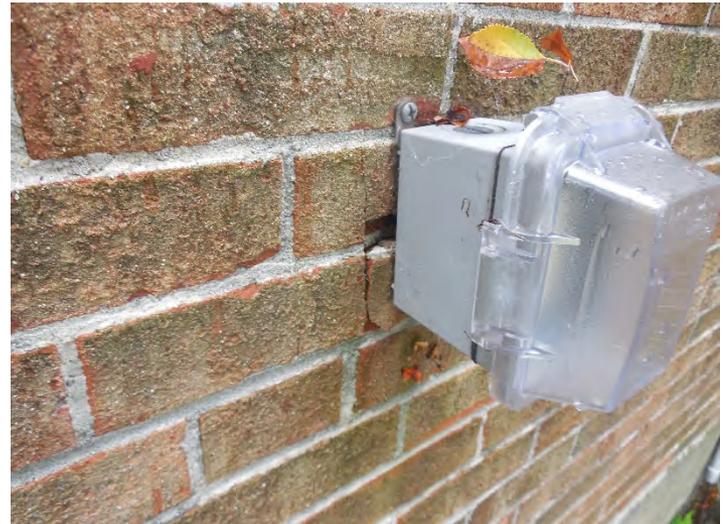
Southwest Courtyard Corner, damaged brick at receptacle attachment

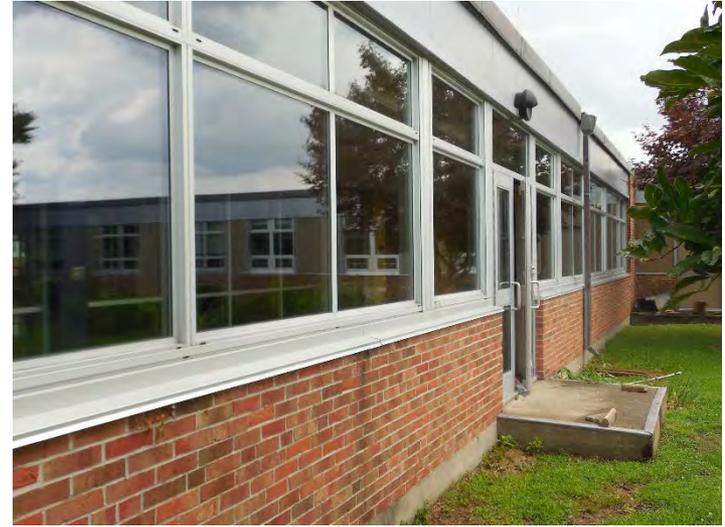
North Courtyard Elevation, missing downspout

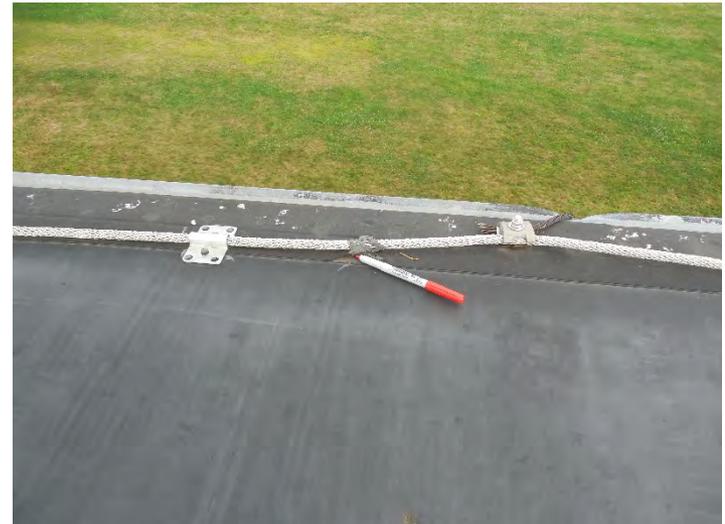
Southeast Wing Roof, damaged coping and open seam in EPDM membrane

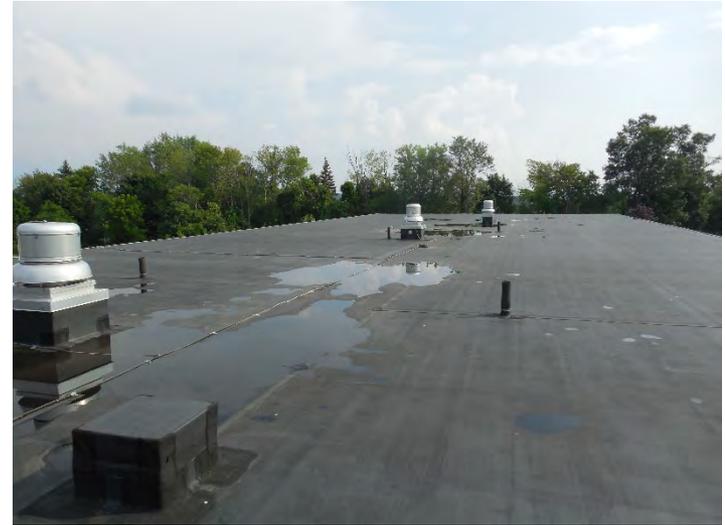
Southeast Wing roof partial view, ponded water

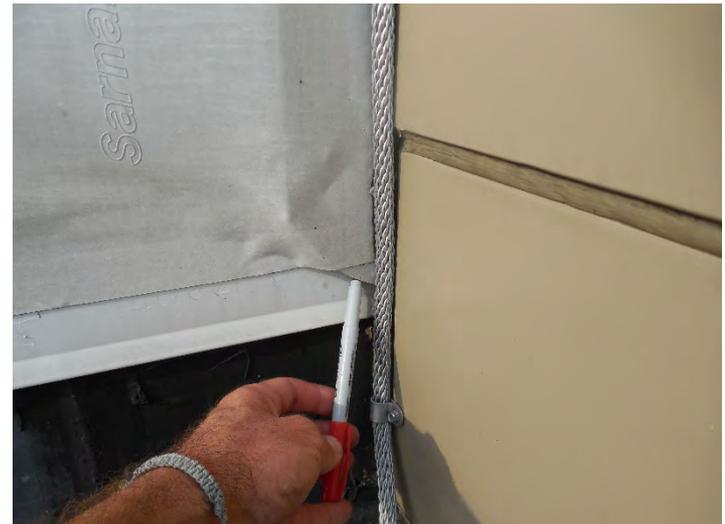
South wall of Gymnasium, open seam in Sarnafil membrane
