TOWN OF SHREWSBURY
FACILITIES CONDITION ASSESSMENT
OF
TOWN BUILDINGS

FINAL REPORT

June 01, 2016

**Shrewsbury
Oak Middle School**

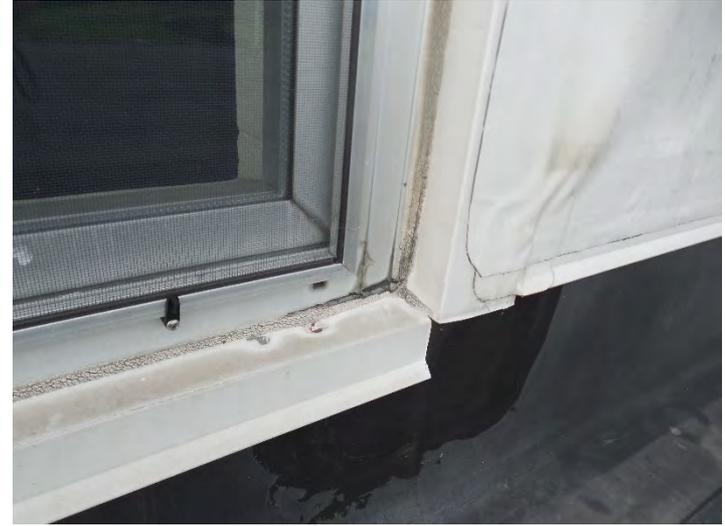
South wall of Gymnasium, failed window perimeter sealant

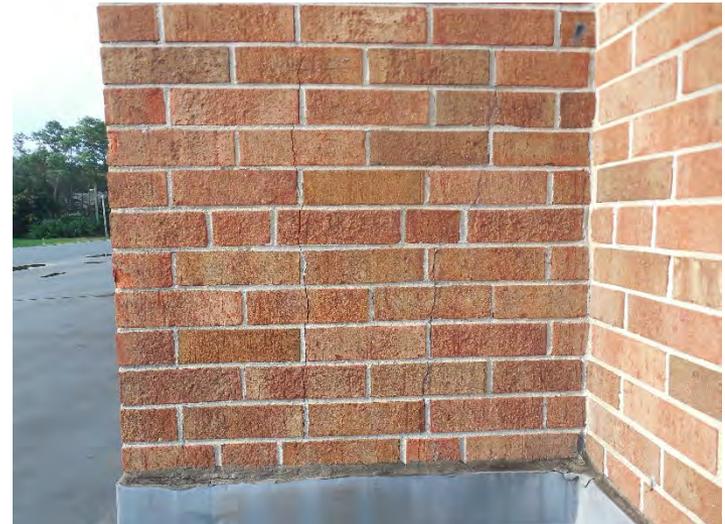
West Gymnasium wall, cracks in brick

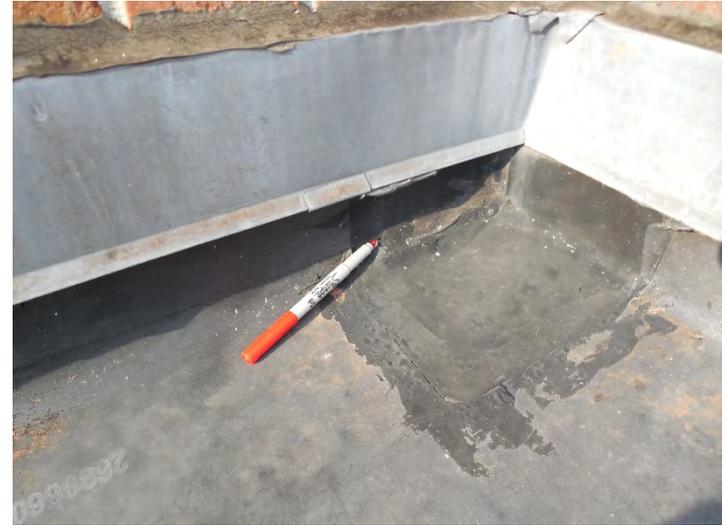
West Gymnasium wall, open seam in EPDM flashing

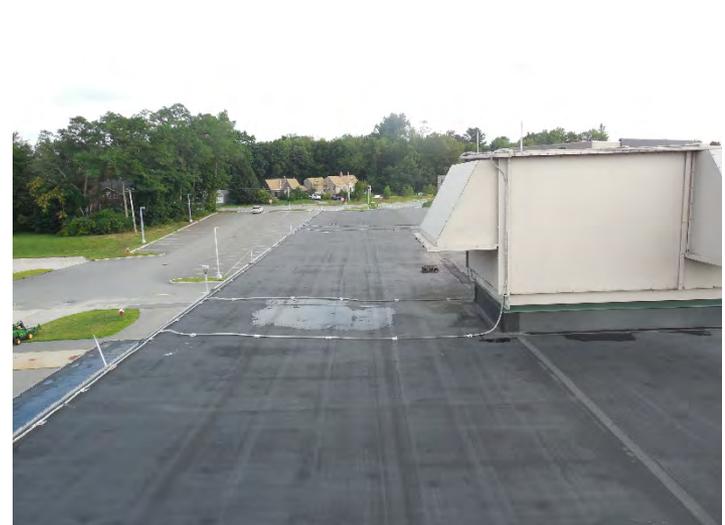
Gymnasium roof, HVAC unit close to roof edge

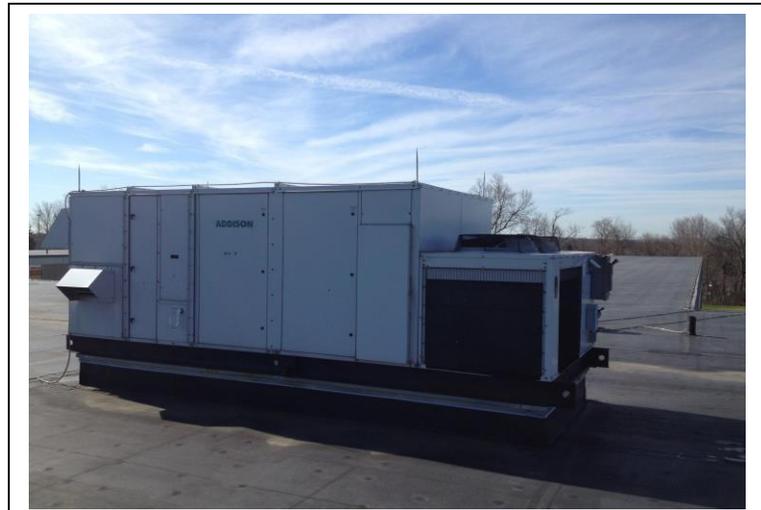
Typical Packaged Rooftop Unit

- iv. Rooftop units (RTU-1 thru RTU-7 – heating & cooling): These seven (7) units are manufactured by Addison and vary in size. These RTU's consist of a filter mixing section, heating coil, DX cooling coil and a supply fan. These units are VAV except for RTU-2 which is constant volume. Upon visual inspection of the interior of the units the belts and coils appear to be in good condition but the exterior and the interior of the units are showing signs of rust.

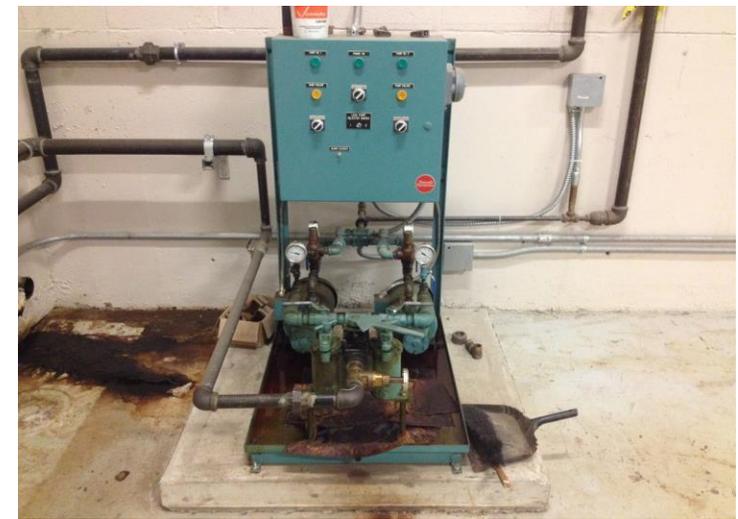
OMS M1 – Fuel Oil Pumps

- viii. Fuel Oil is provided by a 10,000 gallon underground storage tank with a leak detection system. The boilers have not run off the oil system since the school was built. The fuel oil pumps are in poor condition and appear to have leaked in the past.

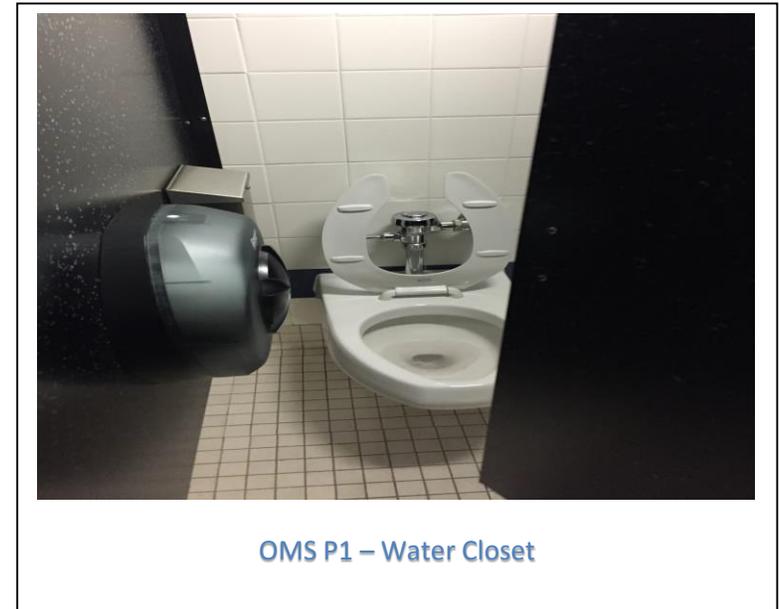
OMS P1 – Water Closet

- i. Domestic Water Service: The building is served by a 4" domestic water service.
- ii. Domestic Hot Water Service: The building's domestic hot water service is generated by (2) two 100 gallon gas fired hot water heaters.
- iii. Natural Gas: The building has two (2) gas services for the building. There is An 8" line that serves the boilers and domestic hot water heaters and a 4" line that serves the kitchen and other general uses.
- iv. Sanitary: the building is served with a 4" sanitary water line and an 8" special waste line and 6" rain water line
- v. Fixtures:
 - Water closets are wall mounted vitreous china with manual flush valves
 - Urinals are wall mounted vitreous china with manual flush valves.

- i. Replace existing water closets flush valves with automatic flush valves.
- ii. Replace existing urinals flush valves with automatic flush valves.
- iii. Replace existing lavatories faucets with automatic faucets
