TOWN OF SHREWSBURY
FACILITIES CONDITION ASSESSMENT OF
TOWN BUILDINGS

FINAL REPORT

June 01, 2016

**Shrewsbury
Senior Center**

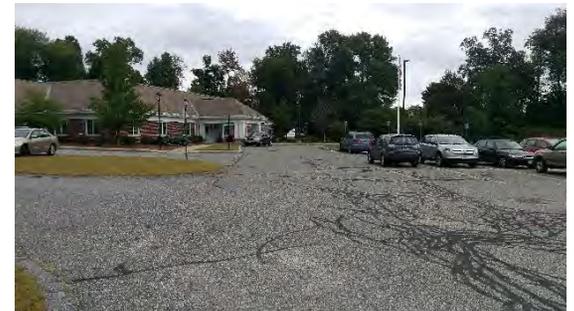
SSC E1

- i. The simple circulation route does not create any foreseeable traffic conflicts.
- ii. The pavement condition of the vehicular entrances and interior circulation system ranges from good to fair throughout the site.

- i. Implement a program of replacing damaged or worn pavement throughout the site.

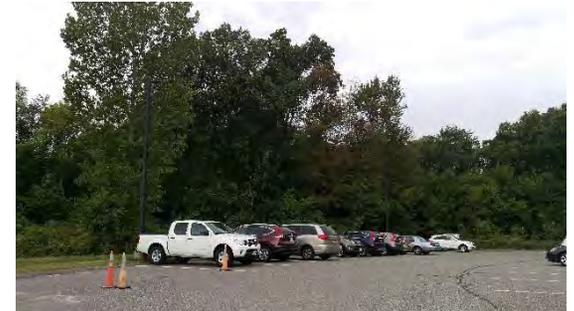
SSC E2

- i. The accessible parking spaces in the parking area north of the drop off drive do not appear to comply with current MAAB standards (see “Pedestrian Accessibility and MAAB Compliance” for further detail).
- ii. The pavement condition of the parking areas mirrors that of the vehicular entrances, ranging from good to fair throughout the site, with little evidence of recent repairs.

- i. Implement a program to bring accessible parking spaces throughout the site into compliance with current MAAB standards.
- ii. Implement a program of replacing damaged or worn pavement throughout the site.

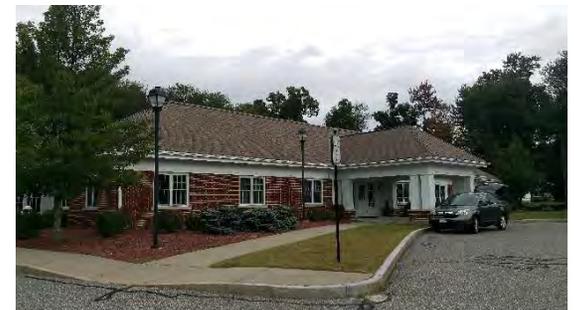
SSC E3

- i. The condition of the pavement on the site ranges from good to fair throughout.
- ii. There are no crosswalks both within the site, and leading to the site, that would indicate where pedestrians are to safely cross vehicular travel lanes.

- i. Implement a program of replacing damaged or worn pavement throughout the site.
- ii. Implement a program to review accessible pedestrian routes throughout the site for compliance with current MAAB standards.

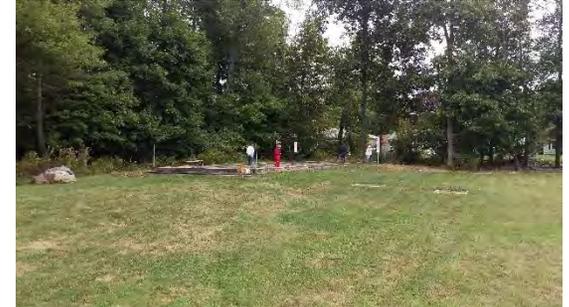
SSC E7

- i. The brick pavement surfacing and game court surfacing are in good condition.

- i. Maintain condition of the courtyard and game court areas.

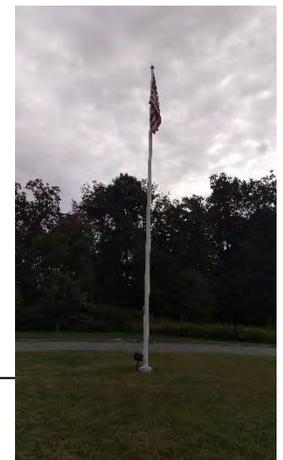
SSC E8

- i. The sign appears to be in good condition, but is not visible from Maple Ave.

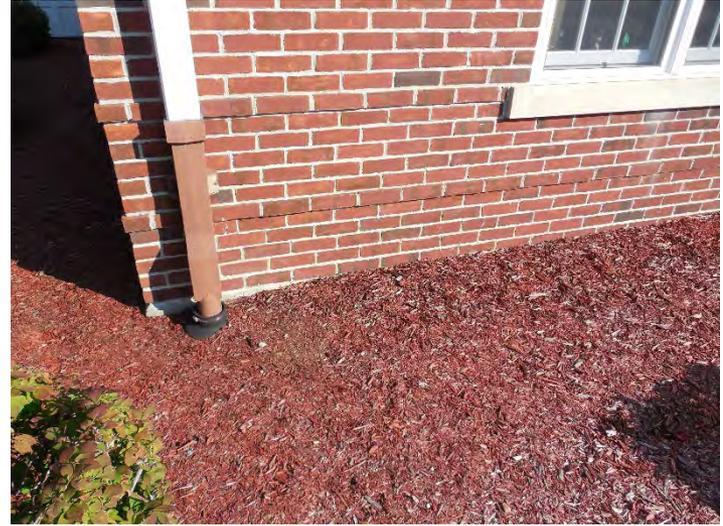
South Elevation at Southwest Corner, brick cavity wall weeps blocked by mulch

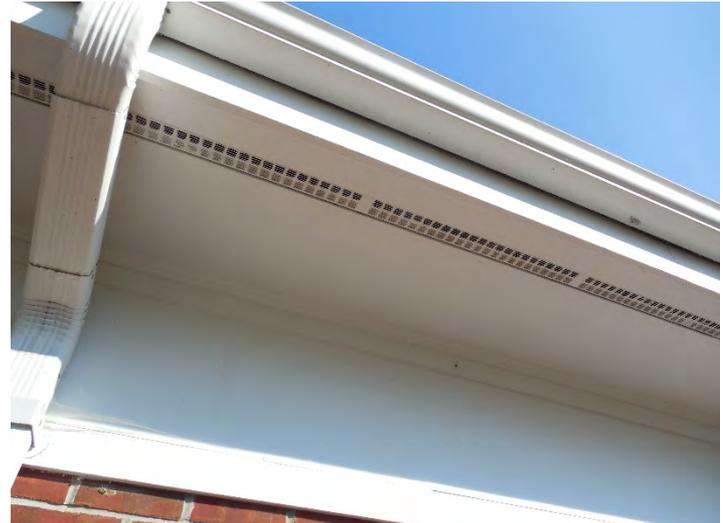
North Elevation, soffit vents

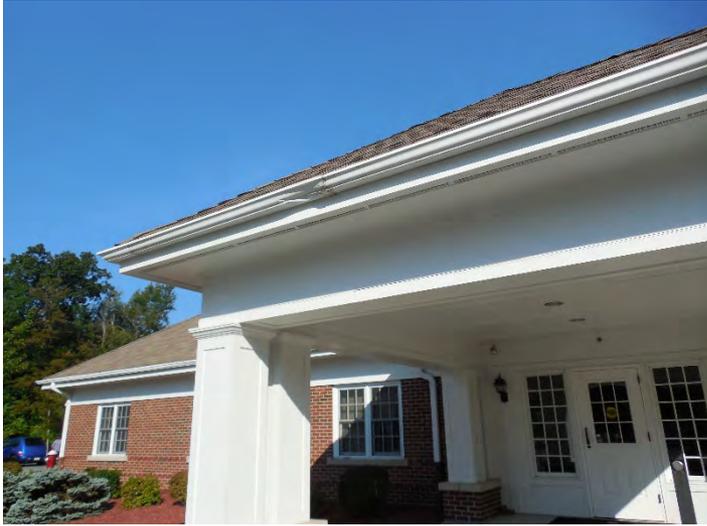
South Elevation, damaged gutter

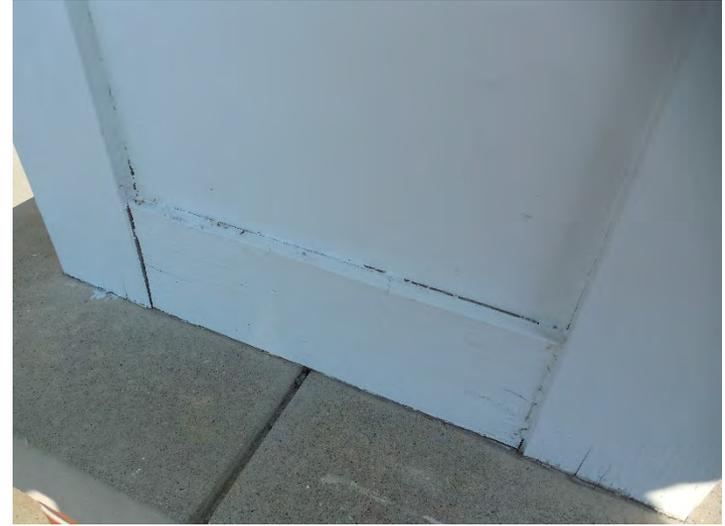
South Elevation, peeling paint and open joints at wood trim

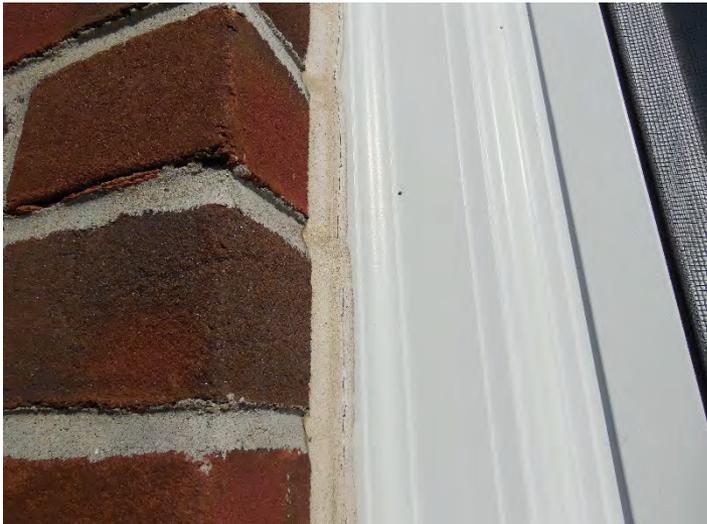
South Elevation, window jamb sealant deteriorated and failing

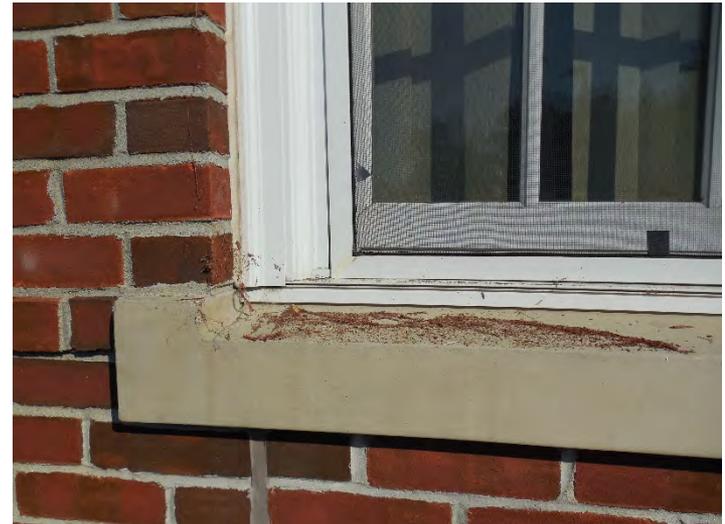
South Elevation, missing sill sealant

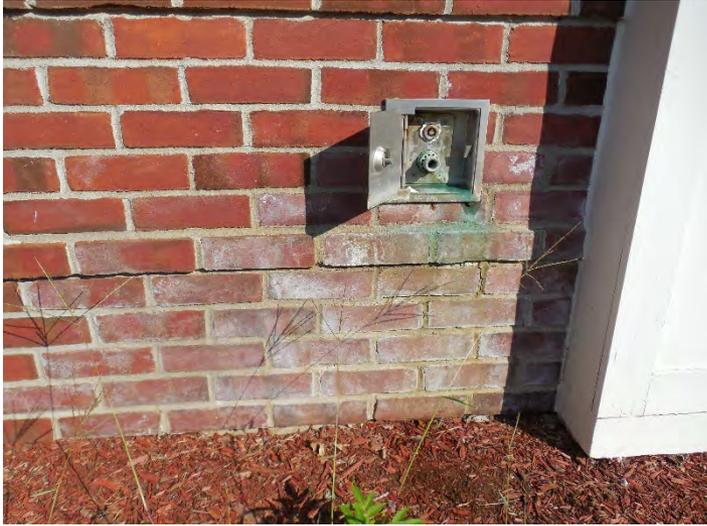
South Elevation, stained masonry and deteriorated mortar; trim paint is deteriorated

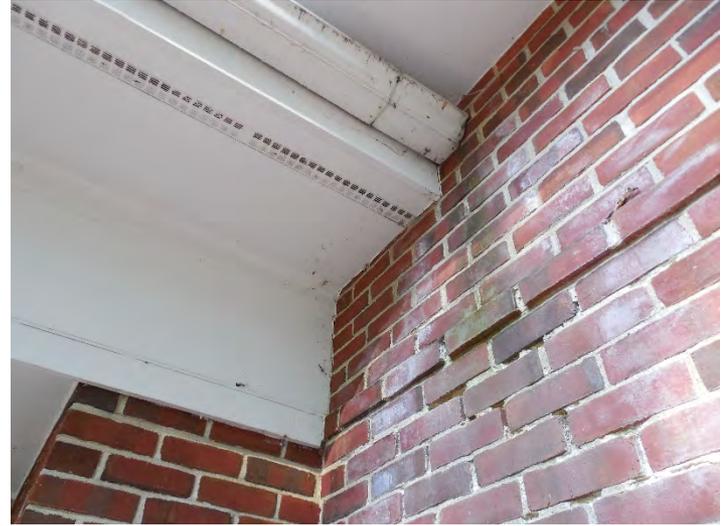
East Elevation, stained masonry and deteriorated mortar; deteriorated sealant at soffit-to-wall joint

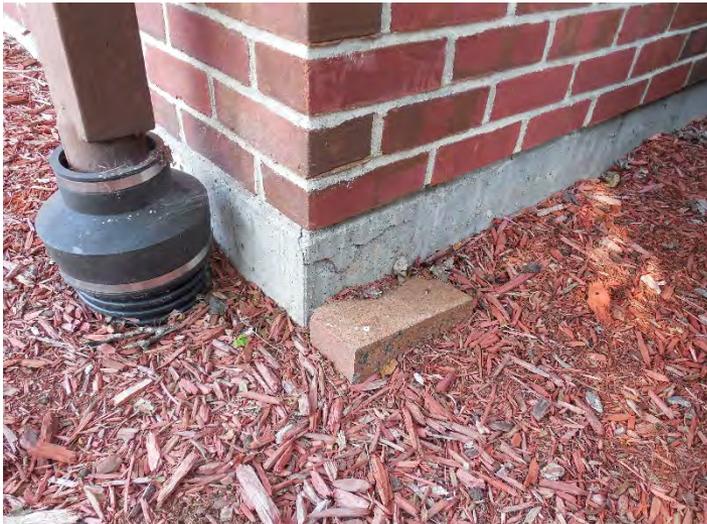
Southeast Corner, spalled concrete at foundation

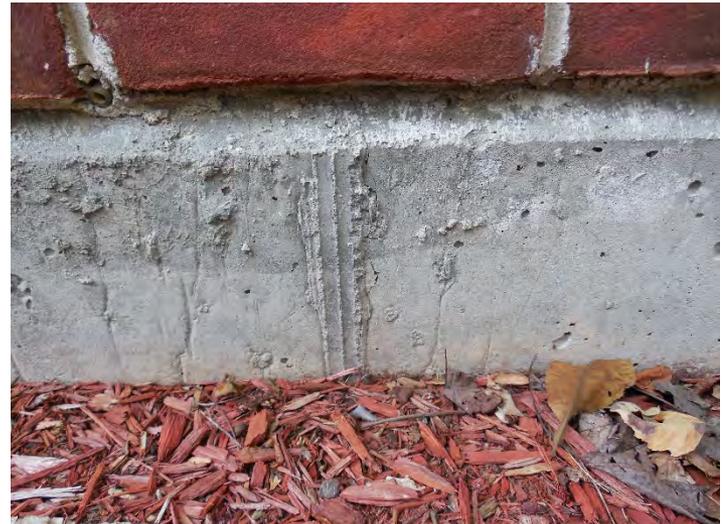
East Elevation, crack at concrete foundation wall

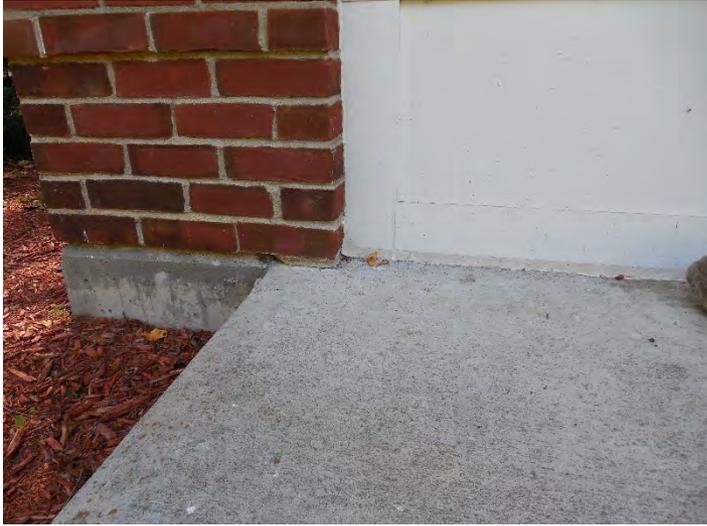
North Elevation at Northeast Corner, deteriorated mortar at base of brick

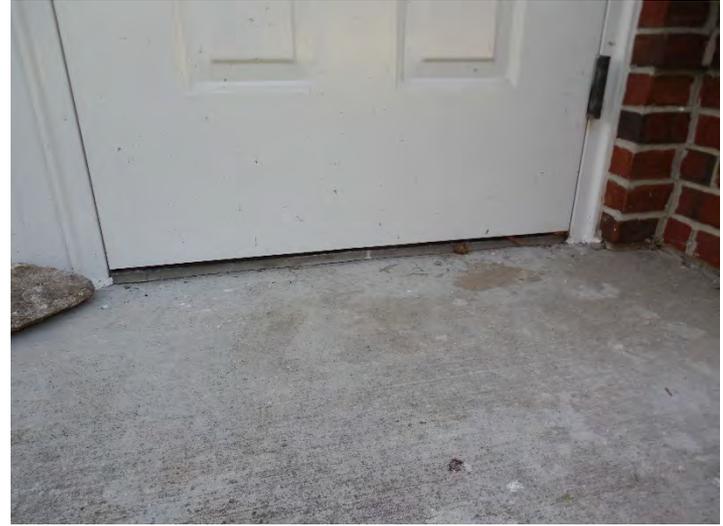
North Elevation at Northeast Corner, deteriorated and failing door perimeter sealant

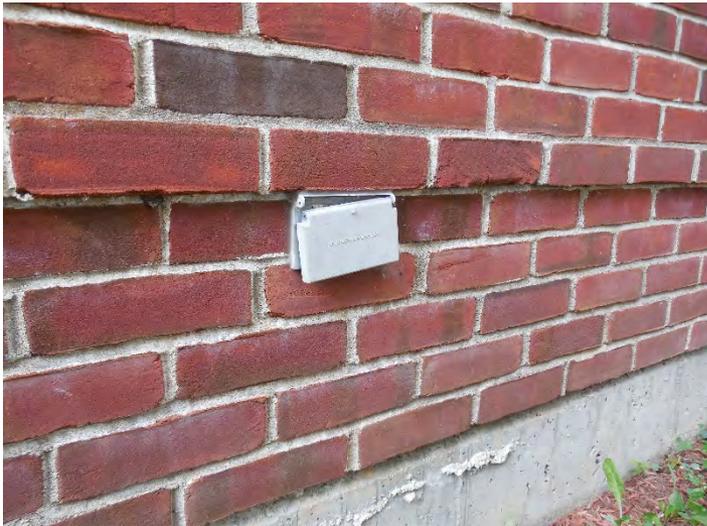
East Elevation, broken receptacle cover

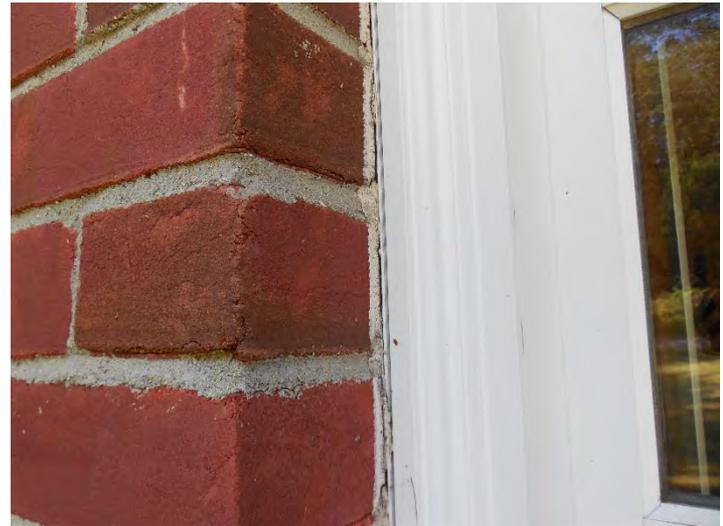
North Elevation at Northeast Corner, failed perimeter sealant at sidelight

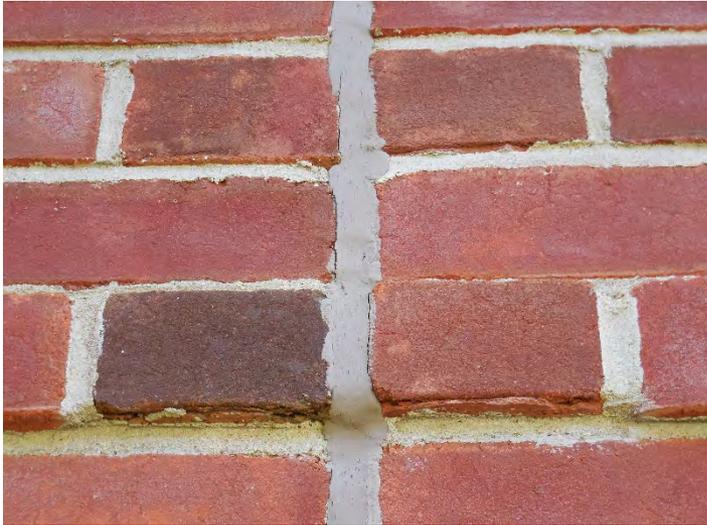
North Elevation, failing sealant at a control joint

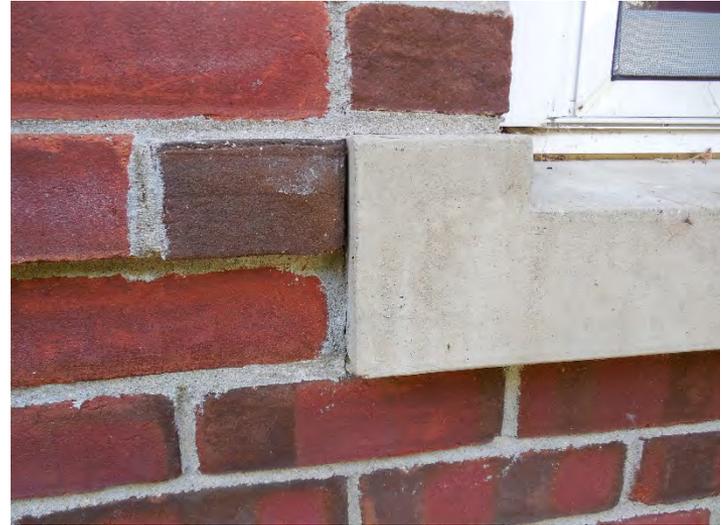
North Elevation, open joint at windowsill; crack in mortar joint

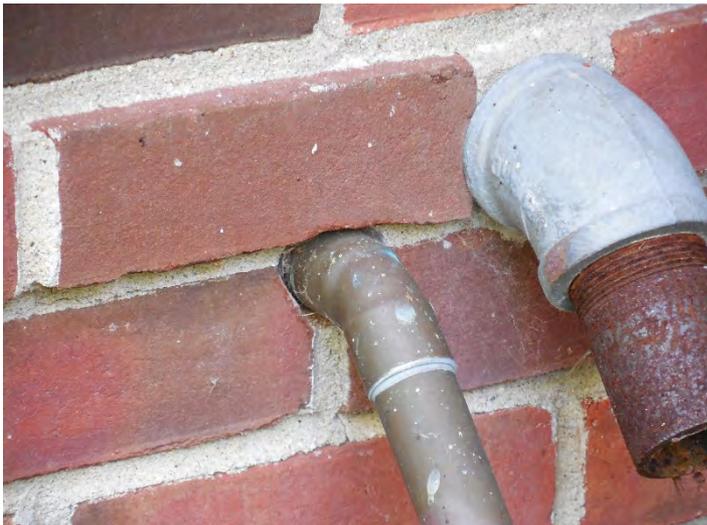
West Elevation, open pipe penetrations

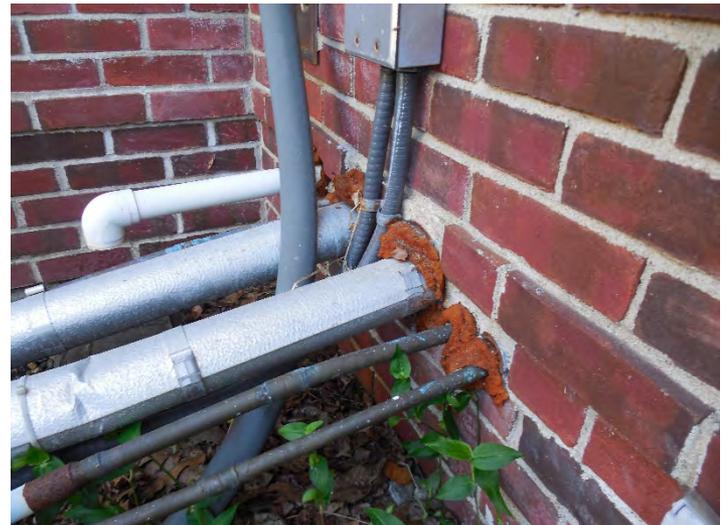
North Elevation, exposed insulation at pipe penetrations and conduit

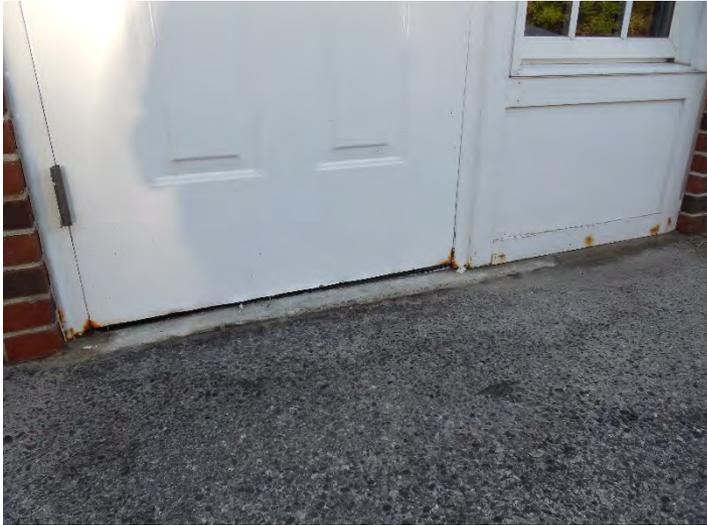
North Elevation, rust at door and frame

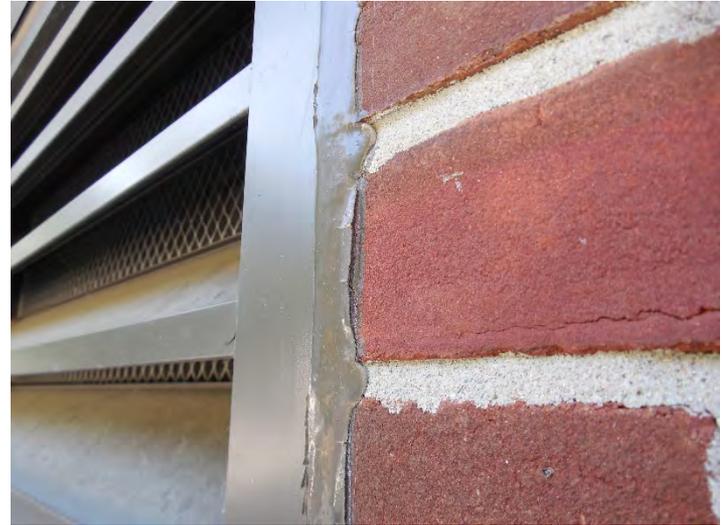
North Elevation, failed sealant at louver perimeter

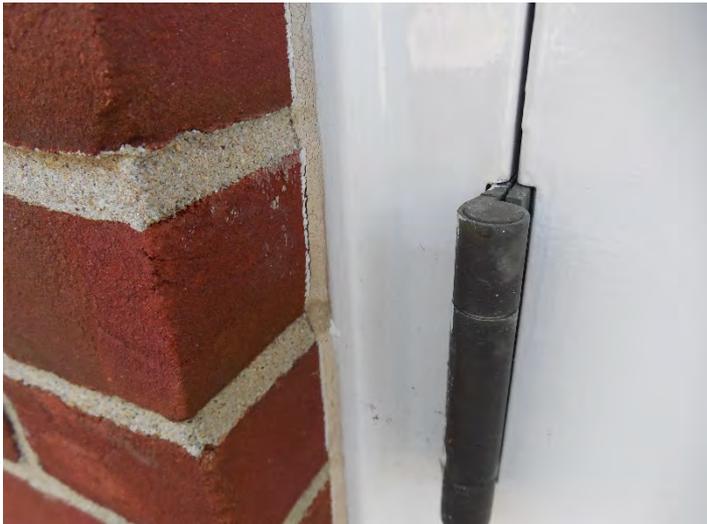
North Elevation, failed sealant at door perimeter

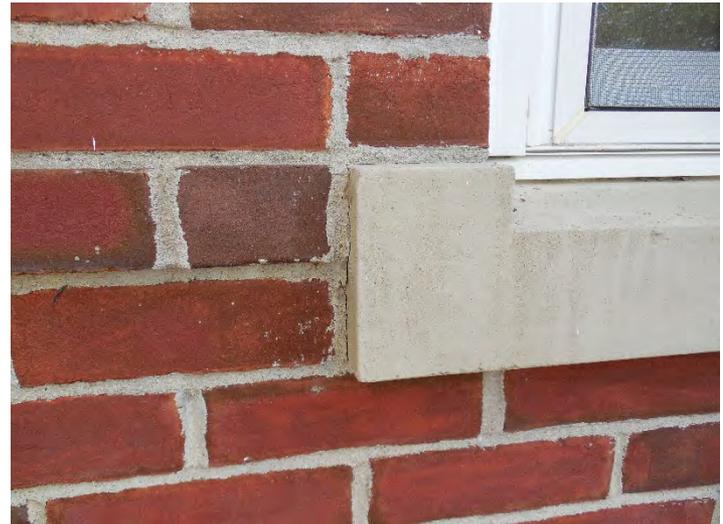
West Elevation, cracked mortar at a windowsill

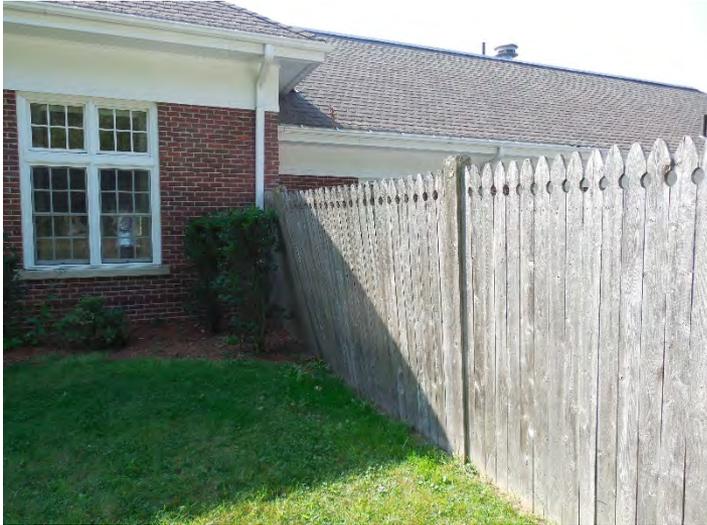
North Elevation, leaning fence

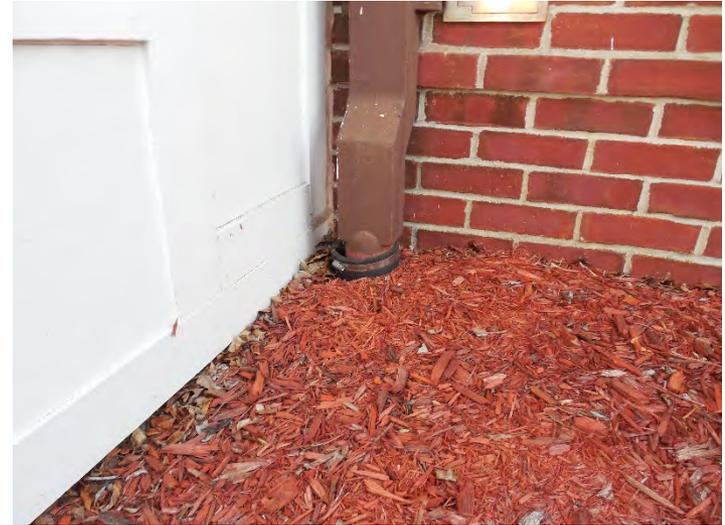
West Elevation, mulch covering portions of wood trim and weeps in brick

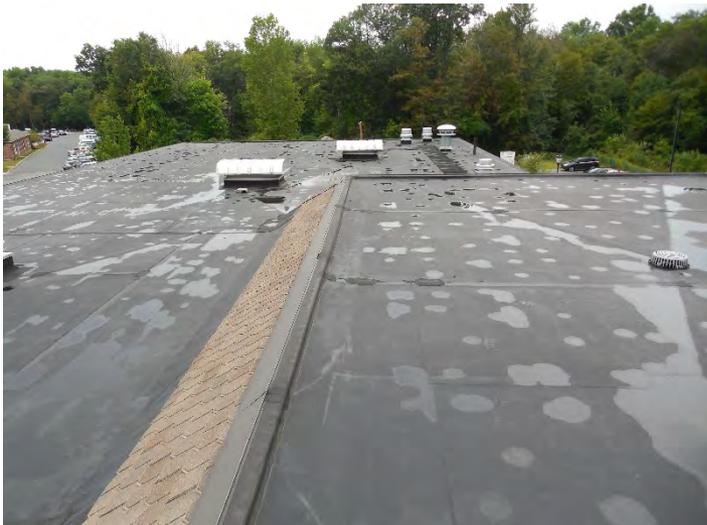
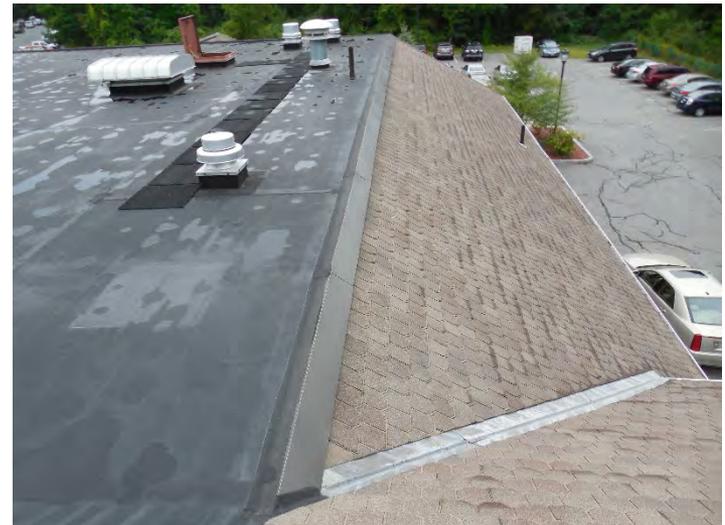
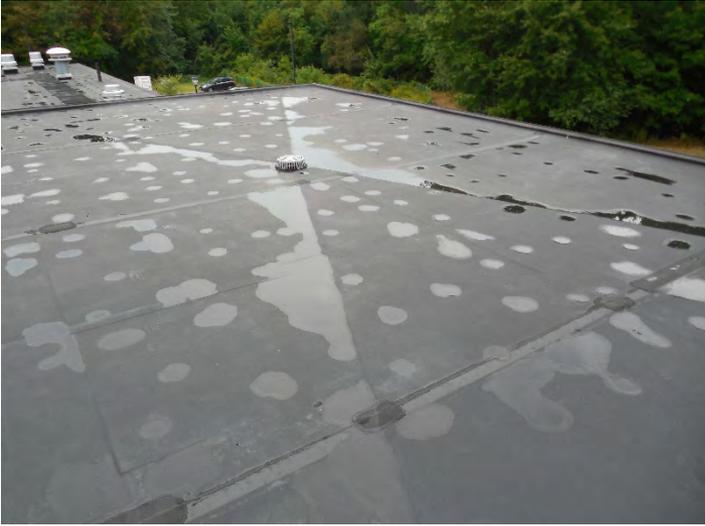
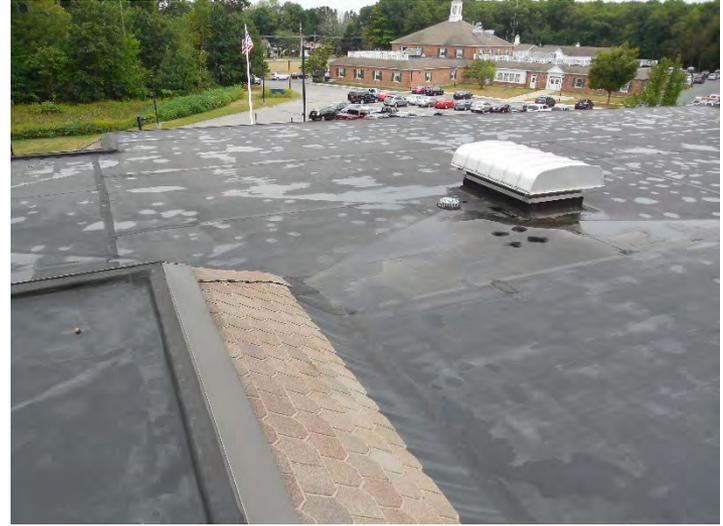
Low-slope roof, partial view of ponding water

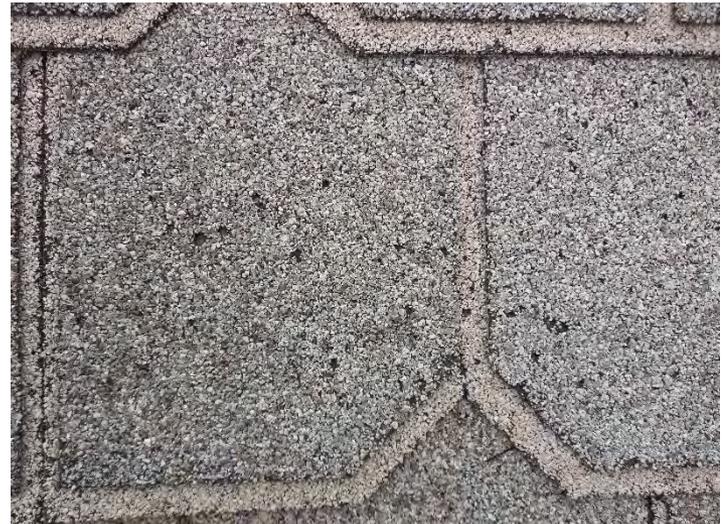
Shingled roof, blistered shingles and granule loss

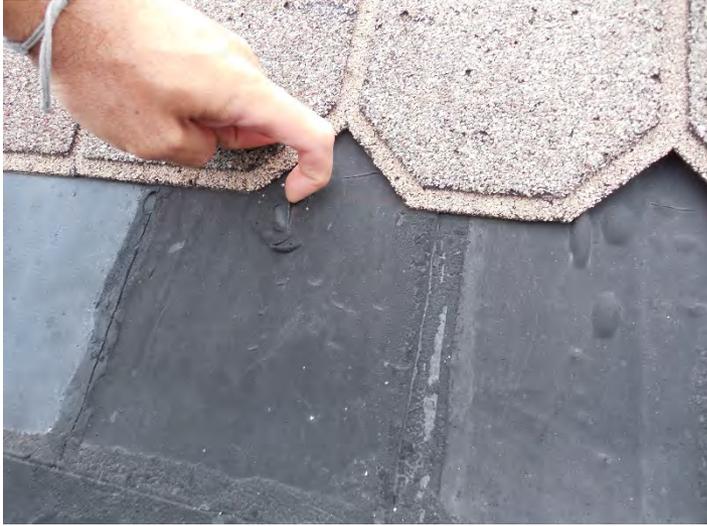
Shingle-to-EPDM transition, open EPDM seam

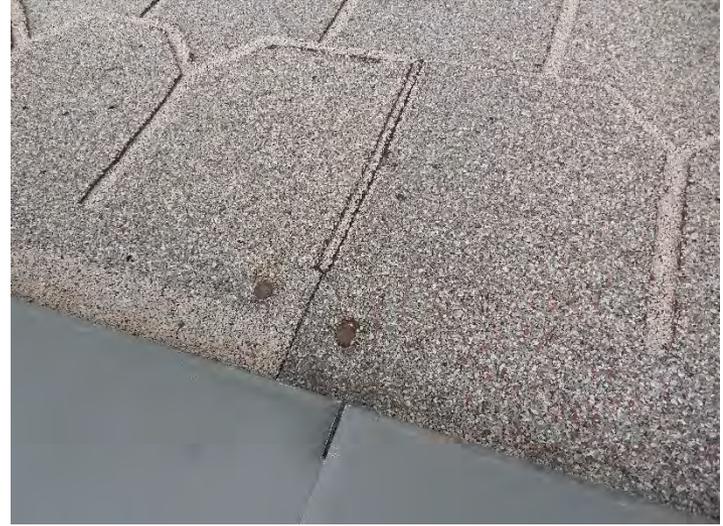
Shingled roof, exposed fasteners

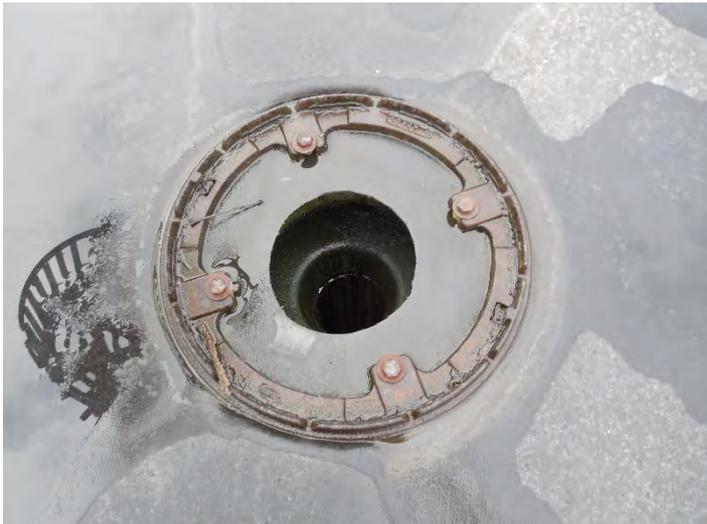
Low-slope roof drain, EPDM extends too far into the drain bowl

- i. Repair isolated damage as soon as possible. Implement a program of annual inspections.
- ii. Cut back EPDM such that it extends only slightly into drain bowl
- iii. Plan to replace 100% of roofing (EPDM and asphalt shingles) between 2022 and 2026.

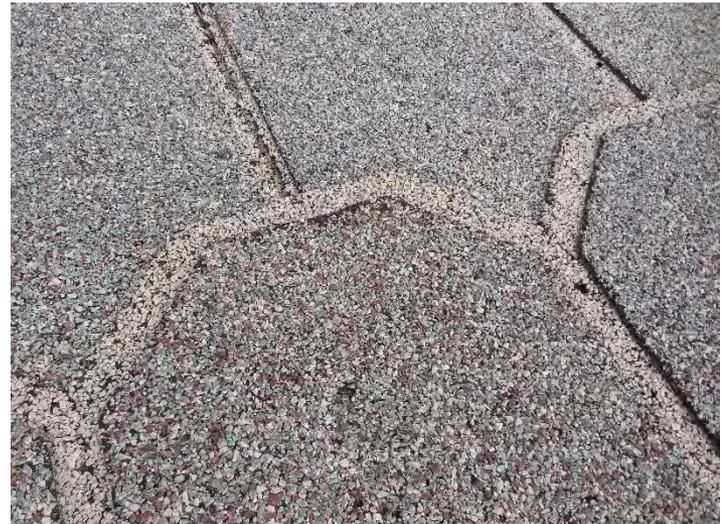
Shingled roof, granule loss at shingle edges

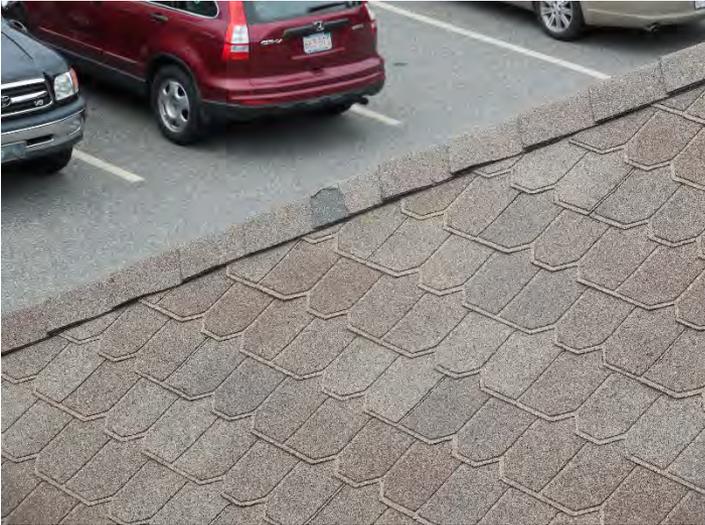
Shingled roof at entryway, broken shingle

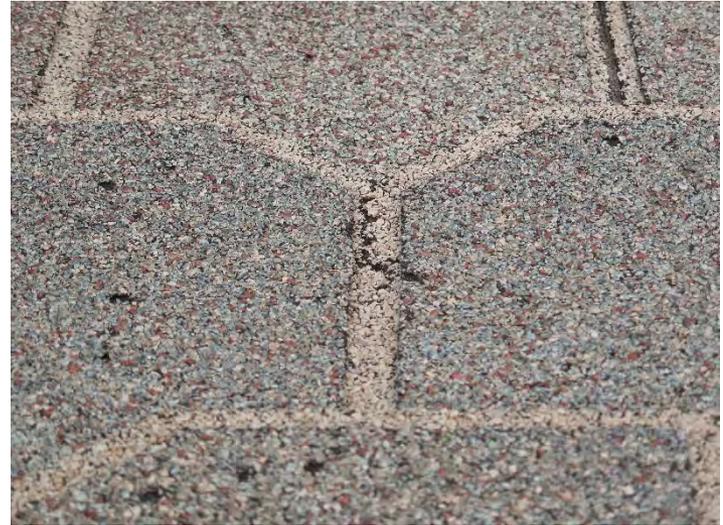
Shingled roof, granule loss and crack in shingle

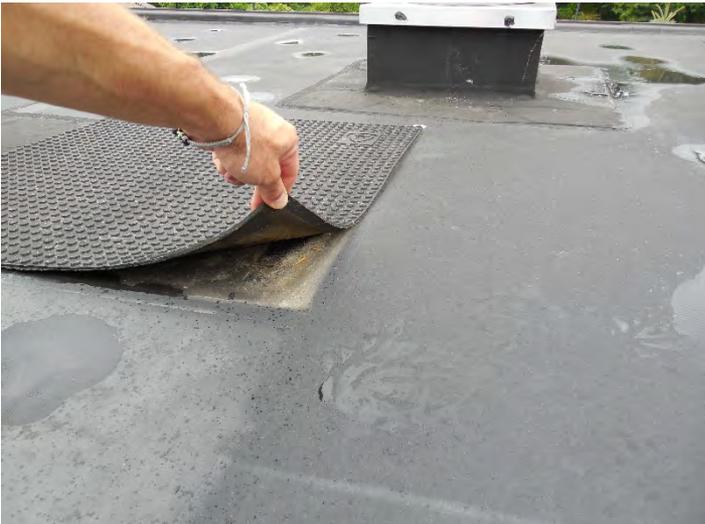
Main low-slope roof, walk pad is peeling up, and EPDM under is not adhered

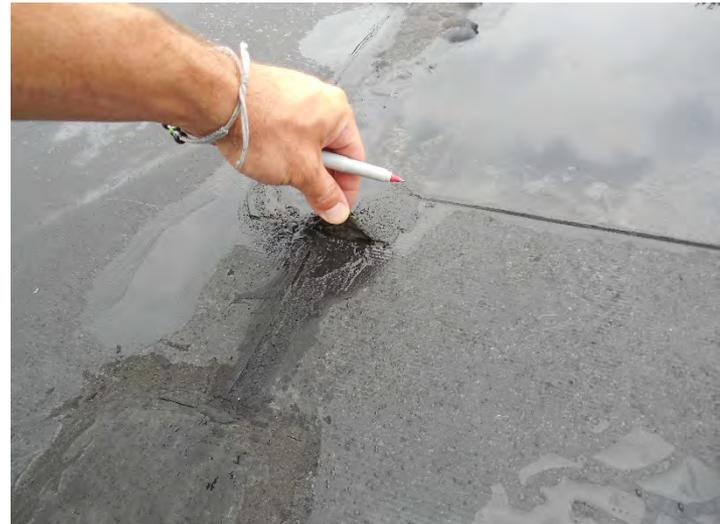
Main low-slope roof, open seam. There is also flex in the insulation for approx. 5 sf around this area

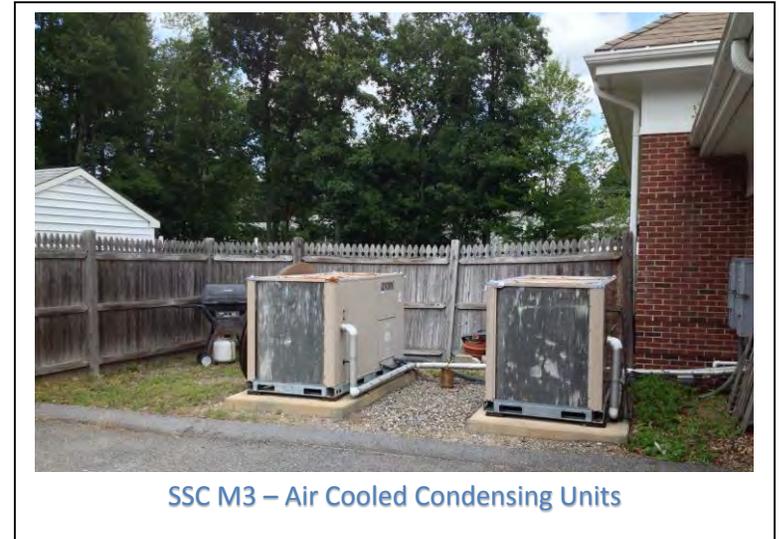
SSC M3 – Air Cooled Condensing Units

- iii. Cooling Equipment
- ACCU's: (**SSC M3**) The matching air cooled condensing units for AHU-1 and AHU-2 are both manufactured by York. ACCU-1 is a model H3CE240. It is a nominal 20 Ton unit and has R-22 as its refrigerant. ACCU-2 is a model H3CE180. It is a nominal 15 Ton unit and also has R-22 as its refrigerant. They both appear to be in fair condition but is showing signs of rust on both the casing and condenser fan guards.

- i. Check boiler for proper combustion as soon as possible.
- ii. Replace existing boiler with high efficiency condensing boiler.
- iii. Repair leaking at freeze protection pump serving AHU-1.
- iv. Replace ACCU-1 and ACCU-2.
- v. Replace existing BMS system.

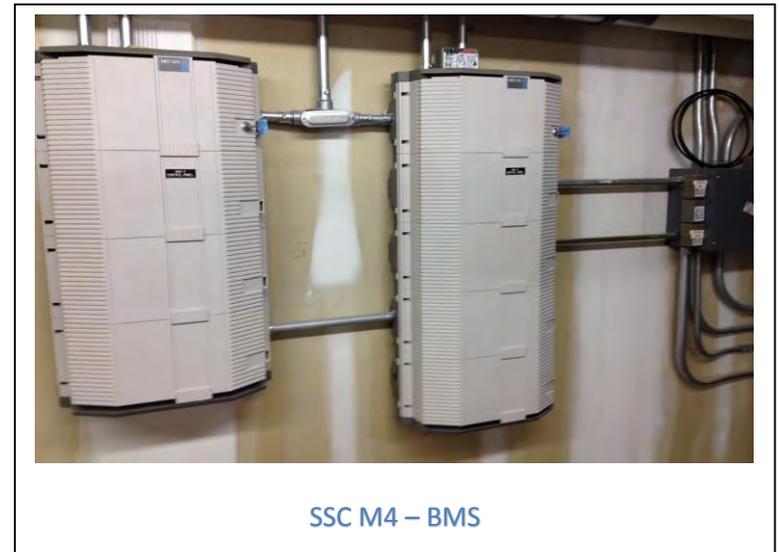
SSC M4 – BMS

- iv. Building Management System
- The existing control system is a Johnson Metasys system (DX9100). Due to the age of the BMS it is problematic and expensive to get new parts as components start to fail.
