TOWN OF SHREWSBURY

FACILITIES CONDITION ASSESSMENT OF
TOWN BUILDINGS

FINAL REPORT

SPRING
STREET
SCHOOL

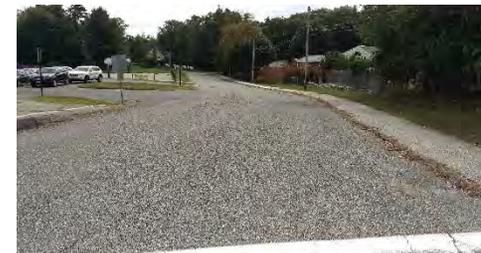
SSS E1

- i. The pavement condition of the vehicular entrances and interior circulation system ranges from fair to poor throughout the site.

- i. Implement a program of replacing damaged or worn pavement throughout the site.

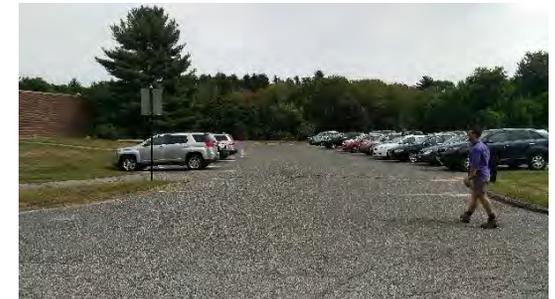
SSS E3

- i. None of the accessible parking spaces appear to comply with current MAAB standards (see “Pedestrian Accessibility and MAAB Compliance” for further detail).
- ii. The pavement condition of the parking areas mirrors that of the vehicular entrances, ranging from fair to poor throughout the site, with little evidence of recent repairs.
- iii. Confirm existing parking quantity is adequate for normal school hours, as well as after school functions.

- i. Implement a program to bring accessible parking spaces throughout the site into compliance with current MAAB standards.
- ii. Implement a program of replacing damaged or worn pavement throughout the site.

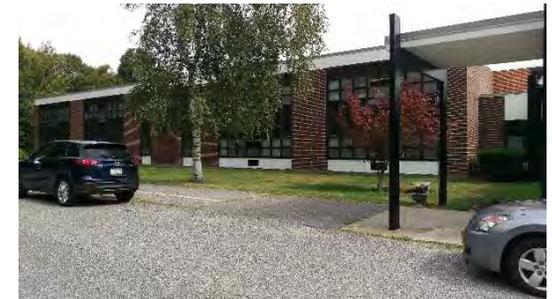
SSS E5

- i. All bituminous walkways on site should be characterized as fair to poor condition.
- ii. All Portland cement concrete walks should be characterized in fair condition.
- iii. The bituminous walkway leading from the free play area down to a natural turf field does not appear to comply with current MAAB standards

- i. Implement a program of replacing damaged or worn pavement throughout the site.
- ii. Implement a program to review accessible pedestrian routes throughout the site for compliance with current MAAB standards.

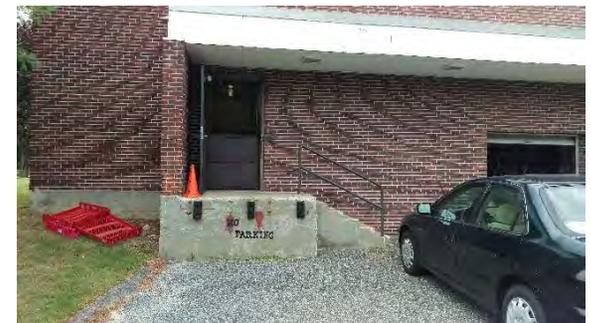
SSS E7

- i. There is one (1) loading dock located at the south side of the building. The loading dock services a bay door and is in fair condition. Its overall size appears adequate for large deliveries. There is a service bay door at grade located directly adjacent to the loading dock, and appears sufficient for the maintenance department’s needs.

- i. Maintain condition of loading area.

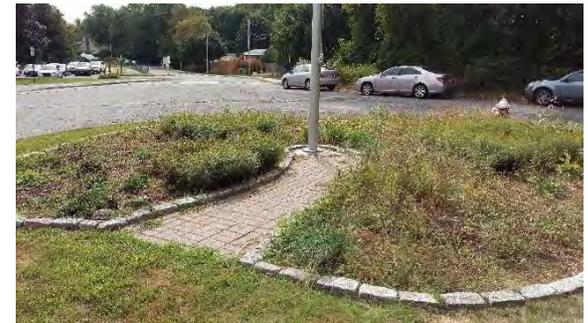
SSS E8

- i. The flagpole does not appear to have an MAAB compliant accessible route.
- ii. The bike racks appear to be accessible and are in fair condition.
- iii. The trash receptacles appear to be accessible and are in fair condition.
- iv. No benches or tables were observed around the perimeter of the building.

- i. Construct an MAAB compliant accessible route to the flagpole.
- ii. Maintain condition of the bike racks and trash receptacles.
- iii. Install site furnishing as necessary throughout the site to better develop exterior congregation areas.

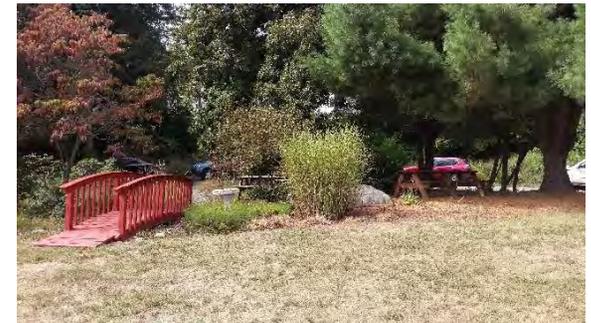
*SSS E10*

- i. The condition of the site vegetation ranges from good (deciduous and evergreen trees) to fair (shrub plantings).

- i. Implement a maintenance program for plant materials that includes regular trimming, watering, and soil testing.

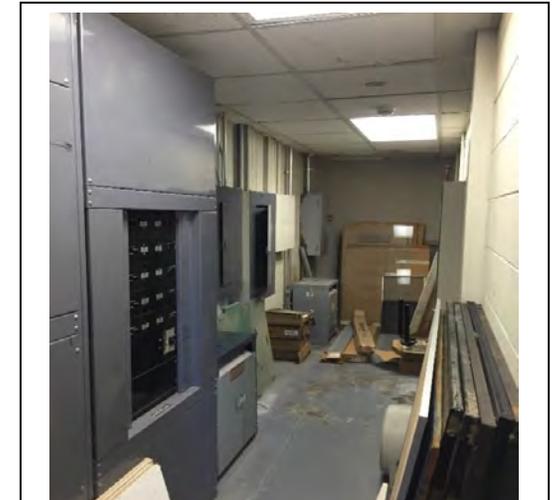
- i. Main service is 1000A at 480/277V, 3-phase, 4-wire

SSS E3 Main Electric Service Switchboard

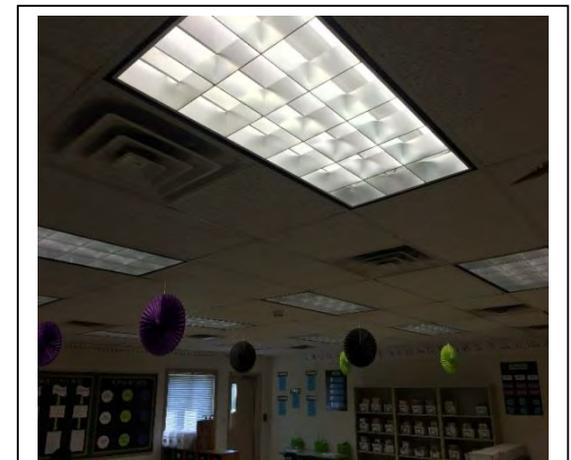
- ii. Lighting is fluorescent throughout the school

SSS E2 Recessed Parabolic Fluorescent Lighting

- i. Replace all fluorescent fixtures with new LED light fixtures for energy savings
- ii. Replace all gym HID fixtures with new T5 6-lamp pendant mounted fluorescent fixtures.
- iii. Replace all existing manual lighting controls with new automatic lighting controls to meet current energy codes
- iv. Replace all power distribution equipment including the 1000A main circuit breaker, 1000A main switchboard, 150KVA transformer, 30KVA transformer and all panelboards located throughout the school. There are approximately 8 panels located throughout the school.

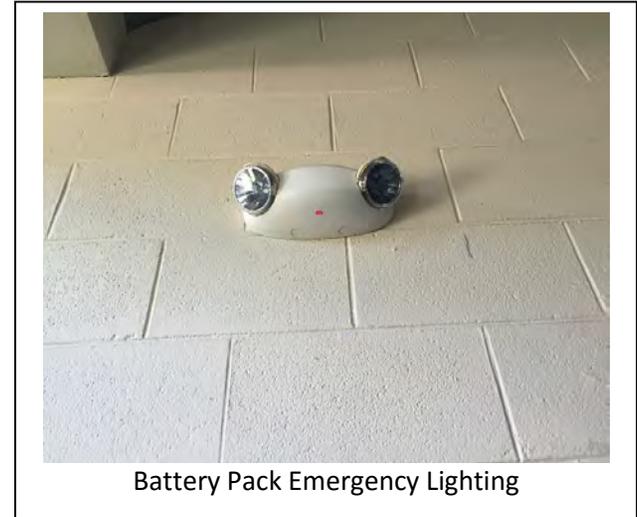
- iv. Emergency lighting is from battery pack units and remote heads.

Emergency lighting is provided via wall mounted battery pack units and remote heads. The battery pack units appear to be in good condition.

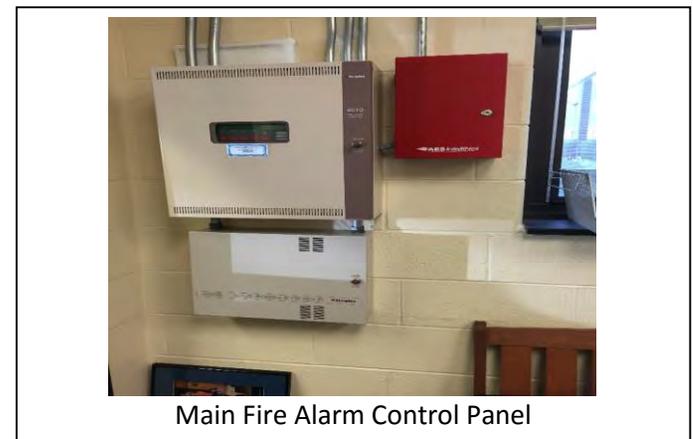
- v. Fire alarm is a 4100 Simplex addressable system

The fire alarm system is a 4100 series simplex system. There are manual fire alarm pull stations, horn strobes located throughout the building. Heat and smoke detectors are present throughout the facility. The fire alarm system horn strobes, manual pull stations, heat and smoke detectors appear appropriately located and to be in good condition.

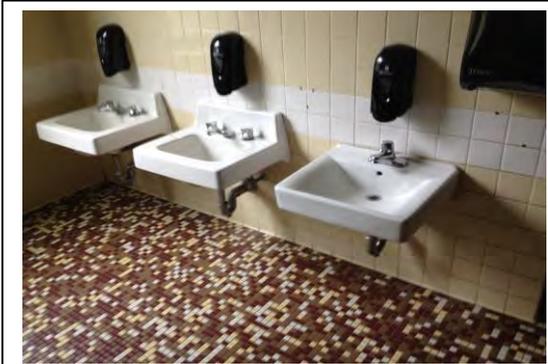
SSS P1 – Lavatory

- The majority of the plumbing fixtures are from the original 1966 and appear to be in fair condition.

- ii. Replace existing urinals flush valves with automatic flush valves.
- iii. Replace existing lavatories faucets

with automatic faucets
