## FEASIBILITY STUDY

### III. EXISTING CONDITIONS EVALUATION AND RECOMMENDATIONS B. Existing Conditions Narratives

#### 1. SITE ASSESSMENT

**Shrewsbury Public Library**  
**Shrewsbury, MA**

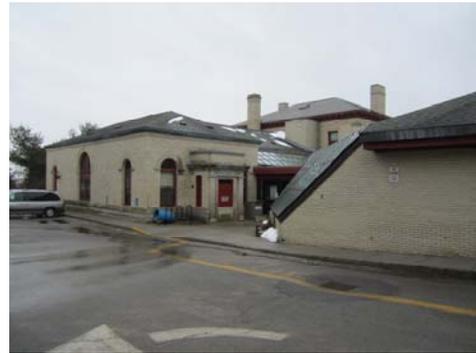
**ACCESSIBILITY:** The site includes two marked accessible parking spaces which are sufficient for the total of about 48 existing parking spaces; however they appear to exceed the allowable maximum slope of 2% and one of the two must be marked as “van-accessible”. While there is a curb cut at the main entrance drop-off (on the north side of the building adjacent to the parking area), it is located in a depression and collects pooled water and ice during inclement weather.

Non-compliant accessible parking and curb cut

**Recommendations:** Under Option 1, the two existing accessible parking spaces should be regraded so as not to exceed 2% in any direction. One should be designated “van-accessible” and have a 96” wide access aisle; both should have new signage installed. Under either Option 2 or 3, if the goal of 100 parking spaces is achieved (by utilizing the adjacent Credit Union parking lot), the total number of accessible parking spaces must be increased to four (at least one of the four being van-accessible).

The curb cut at the main entry should be regraded so as to prevent the accumulation of water and ice. All public entries and exits must be made accessible; therefore a ramp should be provided at the south (Main Street) entrance as part of its proposed reconstruction (refer to miscellaneous exterior envelope item recommendations below). If the historic 1903 Main Street entrance is opened to the public, it too would be required to be

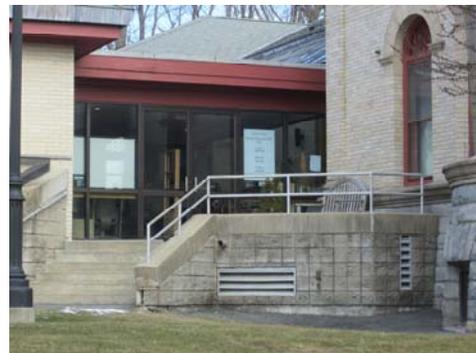
The other public building entrance, on the Main Street (south) side of the building, is non-accessible as it requires patrons to negotiate stairs. The original 1903 building entrance is no longer utilized as a public entrance and has alarmed exit hardware on the interior. Similar to the other Main Street entrance, it includes stairs as well as a raised step at the door, and would require substantial modifications to achieve accessibility.

Non-accessible south (Main Street) entrance

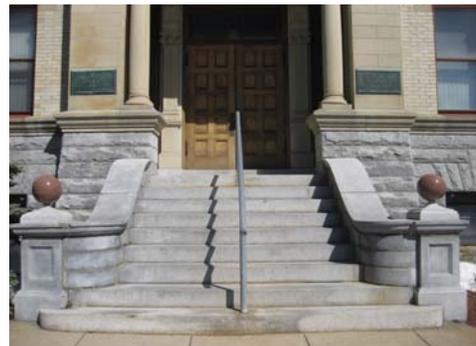
Historic 1903 main entrance

accessible. Given the cost and difficulty in connecting to the ornate masonry stairs at this location, LPA’s recommendation is to maintain this as an exit-only and request a variance based on the building’s historic status.

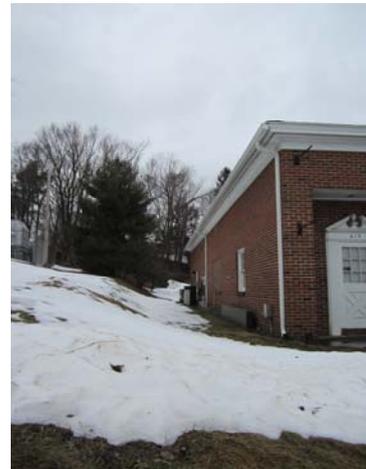
**Topography:** The site has a total elevation change of about 23 feet, from west to east, and 11 feet from north to south. The slopes are generally in the range of 4-10%; however the area between the Library and former Credit Union has slopes in excess of 40% (or 1 in 2.5).

40% slope next to Credit Union

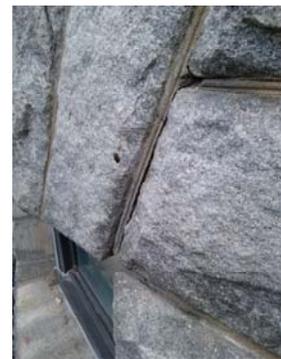
Dislodged stone and open joint

**Recommendations:** Exterior masonry walls at the 1903 and 1923 buildings should be cleaned and selectively repaired/repointed. At the 1979 Addition, LPA recommends that the split-face CMU, brick and precast concrete masonry veneer exterior walls be removed in their entirety. This would at the same time allow replacement of the existing back-up wall assembly with new metal stud, fiberglass-faced exterior gypsum board, air/vapor barrier membrane, rigid board insulation, and through-wall flashing systems.

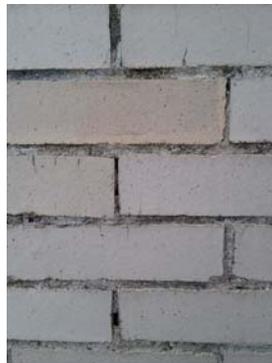
- Masonry at the 1923 Ward Annex is similar to the 1903 building except for the cast stone (instead of natural sandstone) trim elements. This building, compared to the 1903 library, has a greater percentage of brick masonry requiring repointing. Nails and other fasteners were observed in a number of mortar joints.

Open joints at 1923 brick masonry

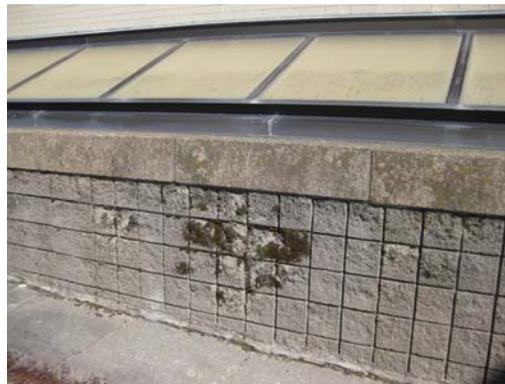
- The exterior walls at the 1979 Addition are constructed of yellow-gray brick and split-face CMU veneer over metal stud backup walls. Split-face CMU is inherently very porous and has suffered from water infiltration, exhibiting many cracked/dislodged units as well as chronic moss and algae growth.

Deteriorated split-face CMU masonry and lower level skylights at 1979 Addition

These problems are most notable at the skylights, the south entrance deck (which is built partially over conditioned interior mechanical space), and locations where the CMU extends below grade; the above conditions are poorly detailed and allow water to splash, accumulate, and find its way behind the masonry veneer.

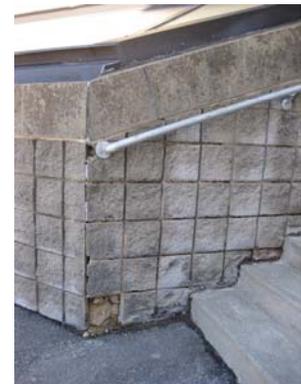
Water damage to 1979 split-face CMU

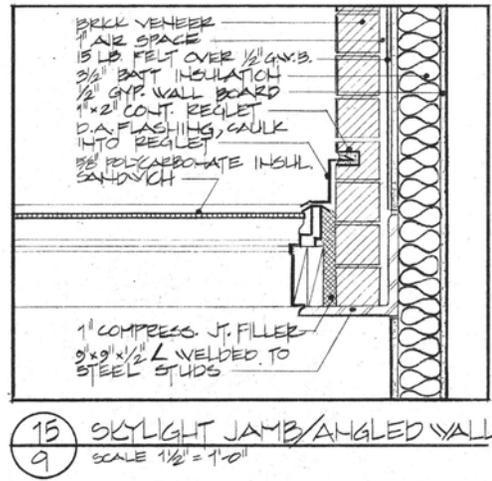
One condition in particular, at the lower level skylight rake flashing, is illustrative of why water infiltration has been a chronic problem for so many years. The 1979 construction drawings detail the jamb/angled wall condition at this location as indicated below. The skylight flashing is simply terminated into a saw-cut reglet in the brick masonry; there is no through-wall flashing tied into the 15# felt cavity wall air/moisture barrier or weep holes to allow moisture to exit the cavity. Any water entering the masonry cavity above the rake flashing travels down the face of the 15# felt and eventually drips off the

Rake flashing detail from 1979 construction drawings indicating no through-wall flashing

steel lintel into the conditioned lower level space. No amount of re-caulking will alleviate this condition. In addition to the water infiltration issues described above, the recessed brick masonry walls adjacent to the lower level skylights are cracked in several places. This brick masonry is shown, on the 1979 construction drawings, as being supported by steel angles welded to the metal wall studs, which in turn are carried by wood glue-laminated beams. The condition of wood structure being supported by masonry is not an ideal condition due to potential for movement, especially if water infiltration is introduced, and this factor has no doubt contributed to the cracking. Refer also to Bolton & DiMartino Structural Existing Conditions Report, attached as Appendix E, for more information.

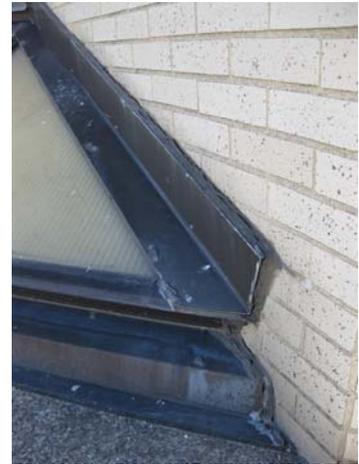
Rake wall flashing exhibiting lack of weep holes

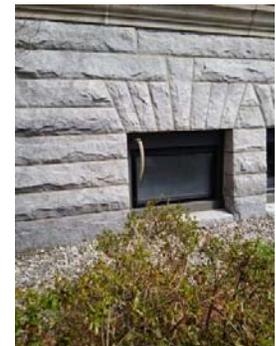
- The original lower level windows have been replaced with bronze finish anodized aluminum windows with insulated glass units. The window pictured has been penetrated to allow a condensate drain to exit the building.

Lower level window

Bronze aluminum lower level windows at the 1903 Library should be replaced with new wood or aluminum windows that more accurately represent the original features, including divided lites and muntins.

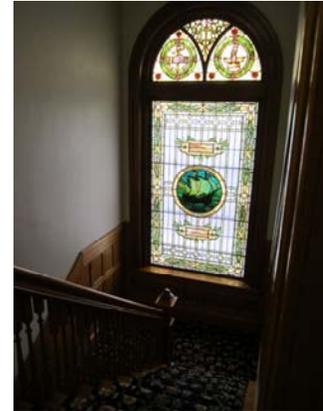
- At the stair landing between the 1<sup>st</sup> and 2<sup>nd</sup> floor levels, there is a beautiful stained glass window panel depicting a sailing ship with the phrase “LET YOUR QUEST BE FOR KNOWLEDGE”; also the Latin phrases “CONCORDIA” (HARMONY), and “LABORE ET CONSTANTIA” (WORK AND PERSEVERANCE). Some bowing of the support structure was observed, presumably due to heat build-up between the exterior window and stained glass panel.

Stained glass window at 1903 main stair landing

The original 1903 stained glass window should be restored to prevent further bowing and provisions made to adequately vent the space between the stained glass and exterior storm panel.

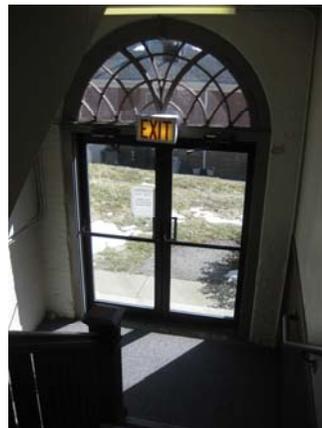
- A bronze finish aluminum single-glazed storefront/entry system was installed, at some unknown point in time, to replace the original exit doors from the main stairway at the mid-level landing between the 1<sup>st</sup> and lower floor levels. The original wood transom was retained, therefore the aluminum doors are only about 74” high and the closer arm extends below that.

Anodized 74” high bronze finish aluminum doors at 1903 stair lower level landing

All existing aluminum storefront and entry door systems, as well as associated finish hardware, should be replaced. Electronic access control and intrusion detection capabilities should be provided at all exterior doors.

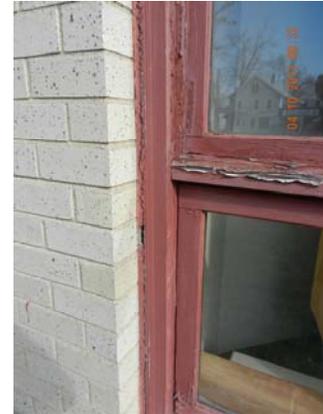
- Anodized bronze aluminum fixed storefronts were installed as part of the 1979 Addition & Alterations
- 1979 Addition:
  - The 1979 windows are painted wood fixed residential-grade windows with insulating glass units. The finger-jointed wood exteriors, particularly on the south elevation, are in very poor condition; paint has peeled, cracks have developed and gaps have opened up between the window and adjacent masonry.
  - Storefront systems at the Lobby are anodized bronze aluminum, medium stile with insulating glass units. The north entry from the parking area has a vestibule with automatic sliding doors; while the south entry from Main Street has no vestibule and a pair of hinged doors. It was reported that the automatic sliding doors malfunction frequently and must be slid open or closed manually.

Deteriorated wood window at 1979 Addition

Wood windows at the 1979 Addition should be replaced in their entirety with new aluminum or clad wood units with fluoropolymer exterior coating. These new windows

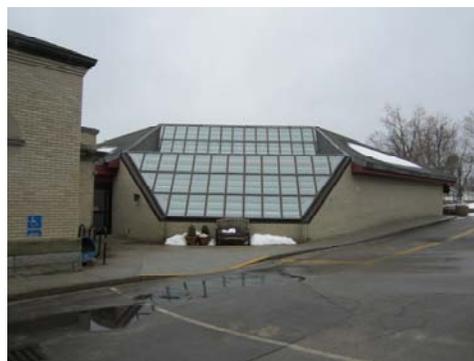
- Aluminum-framed self-supporting skylights were installed, at several locations, as part of the 1979 Addition & Alteration project. It was reported that water infiltration has been a chronic problem with all of the skylights; this has no doubt contributed to mold-related air quality issues. Three of these skylights are above the Stair, Adult Services and Lobby area (connecting to the 1923 Ward Annex); these are glazed with insulating glass units and have painted wood sun control grilles. During LPA's visits, water was observed leaking onto the floor of the Lobby and the intermediate landing of the 1979 Stair.

Aluminum-framed skylights at 1979 Addition

The 1979 Addition skylights leak badly, have exceeded their useful life, and should be replaced, along with new flashings properly tied into walls and roofs. Consideration should be given to an insulated translucent fiberglass sandwich panel skylight system that will achieve greater thermal efficiency than the present type systems. New gutters and downspouts should also be installed at the roof edge above lower level skylights to prevent roof runoff from dripping directly onto the skylights.

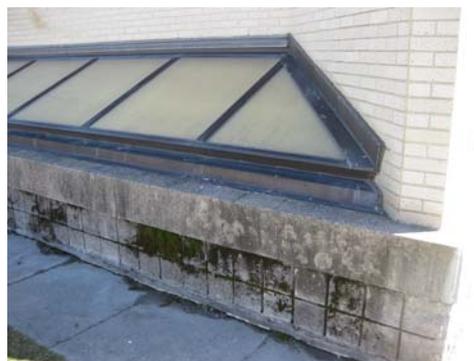
Two other skylights, providing daylighting to the Lower Level, are glazed with translucent plastic panels. These locations are especially susceptible to water infiltration due to their placement directly under the drip line of the higher roof. Accordingly, they are subjected to a much greater volume of water which falls and splashes on the skylights, flashings and surrounding masonry walls. It was reported that efforts have been made to re-seal all of the skylights over the years without success; the lack of through-wall flashing (described in the Exterior Wall narrative above) undoubtedly contributes to this ongoing problem.

Lower level skylights at 1979 Addition

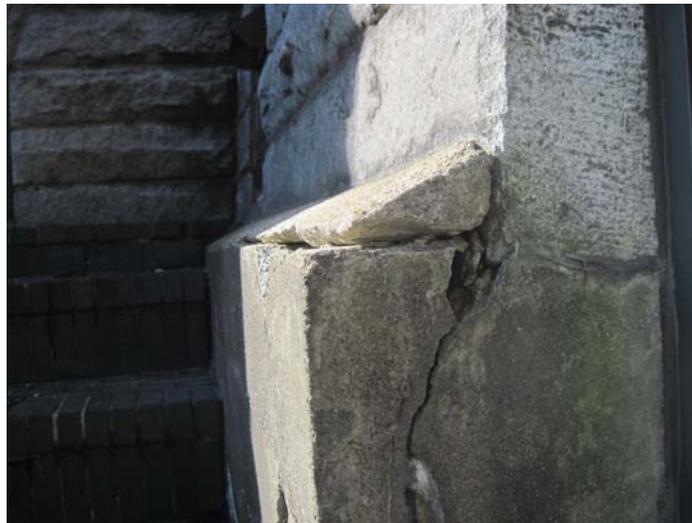
**Figure 4-1923 Courtyard Masonry Requiring Repair**

The exterior walls are granite/brick veneer backed up by brick masonry bearing walls, similar to the original 1903 building. The walls appear to be in good condition with minimal cracking or movement. There was some noticeable water damage to the mortar and concrete parge near the courtyard area that should be repaired as part of the maintenance program.

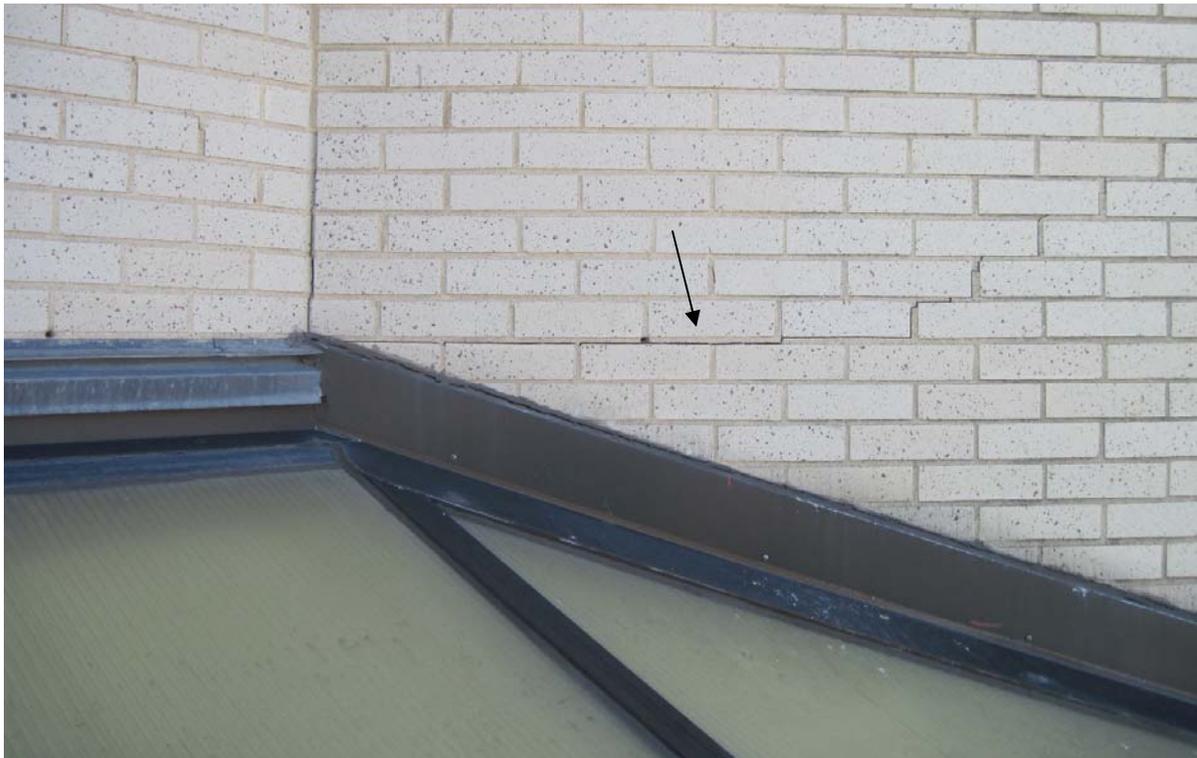
**Figure 6-1979 Masonry Cracks at Skylight Area**

There are horizontal cracks in the brick veneer at a few locations, mainly corners and near the light well locations. We did not notice any signs of settlement at the foundation walls. The masonry veneer is typically supported on the exterior concrete foundation walls, but at the light wells the veneer appears to be supported by steel angles attached to metal studs on wood floor members, or directly on the wood floor system. Either way, the brick load is supported on the wood glu-lam members below, which would be more likely to move over time and could be causing the horizontal cracks as the wood creeps and the exterior walls remain unchanged on the concrete foundation walls.

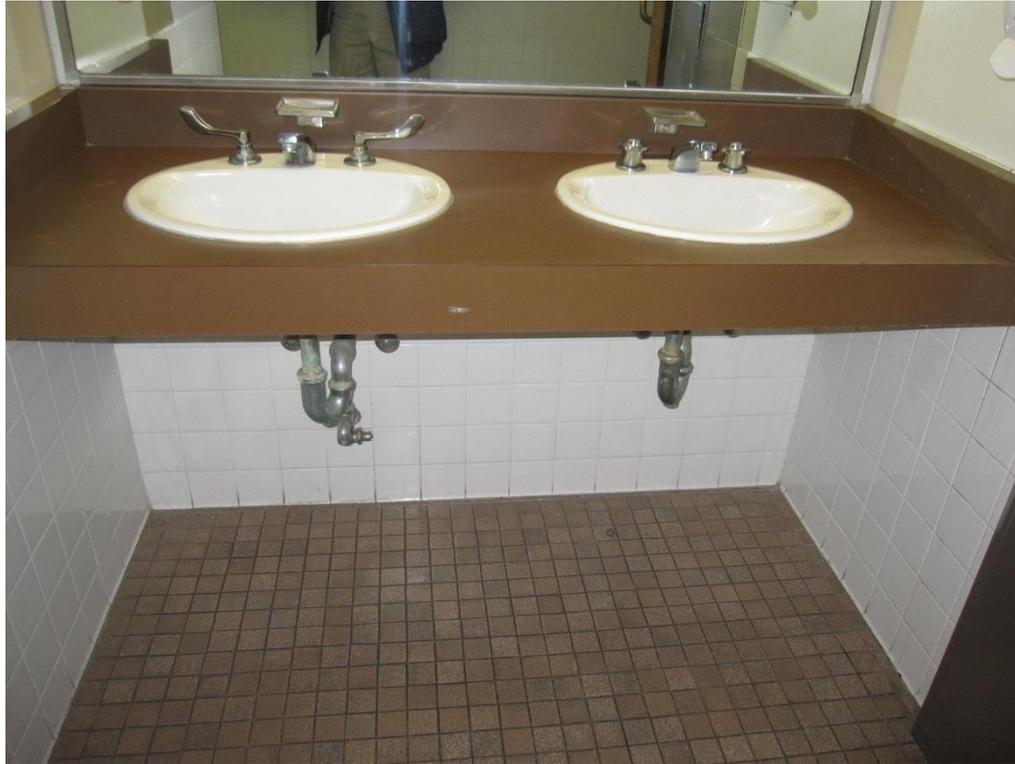
Most existing water closets are of the wall mount flush valve type all of which were not of the water conserving 1.6 gallon per flush type as required by current code. The lavatory sinks are of the counter mount wall hung style, but are not metered as required by the current code for public fixtures. Protective insulation on the piping below the counter is absent which is required by current code. Urinals appear adequate in number and configuration to accommodate current code requirements.

*Public Lavatories – Note, no metered faucets or pipe protection.*

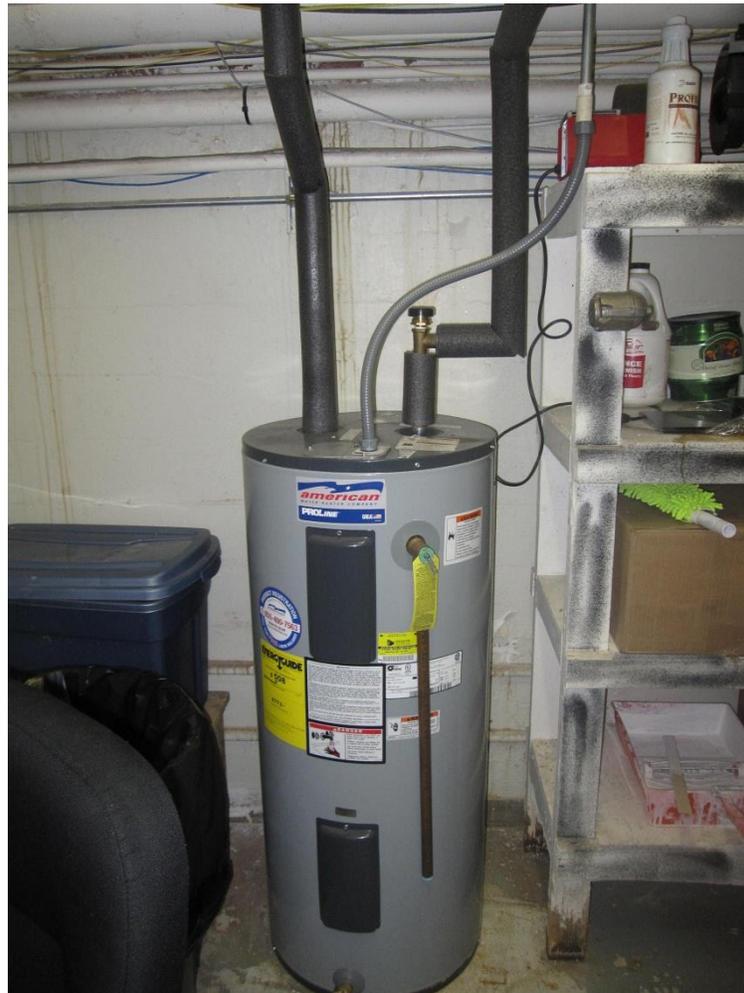
There is no recirculation pump at the water heater. The code requires a hot water temperature maintenance system (recirculation or equal) be provided if fixtures are more than 100 feet from the hot water source. Although this does not appear to be the case in this building, the future use of additional low water flow conservation fixtures may necessitate the need to avoid long delay times for hot water at the remote fixtures.

*Water Heater – Note, no mixing valve*

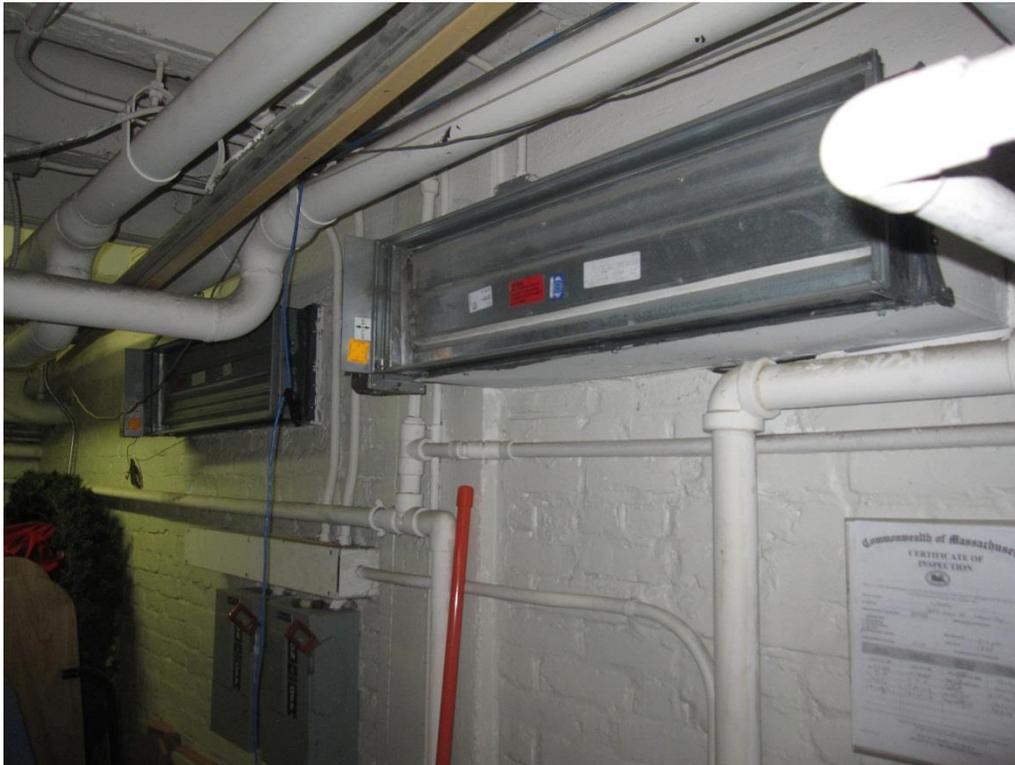
4. The systems have limited capacity to introduce 100% outdoor air for economizer (free cooling) when outdoor conditions allow as there is no provisions for relief air. Although automatic dampers are provided on outdoor air and return air ducts/grilles it is unclear if they still operate. The current energy code required economizer control for systems of this size.

*Mechanical Room Dampers – Note plenum return with storage*
