TOWN OF SHREWSBURY
FACILITIES CONDITION ASSESSMENT OF
TOWN BUILDINGS

FINAL REPORT

June 01, 2016

**Shrewsbury
Fire Station**

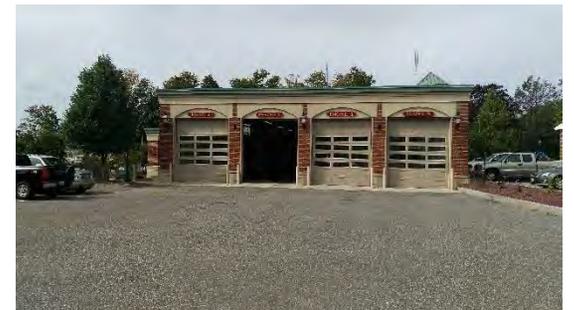
SFS E5

- i. There are three (3) garage bay doors located on the east side of the building, and one (1) on the north to allow emergency vehicles to be stored in the building. There are 6' Portland cement concrete aprons at all vehicular entrances to the building.

- i. The bituminous concrete and Portland cement concrete in this area all appear to be in good condition.

- i. Maintain condition of vehicular and service areas.

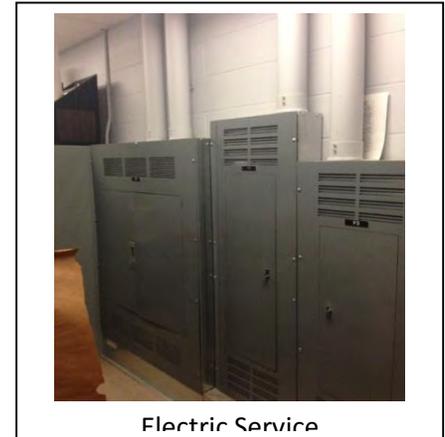
Electric Service

- i. Main service is 400A at 120/208V, 3-phase, 4-wire

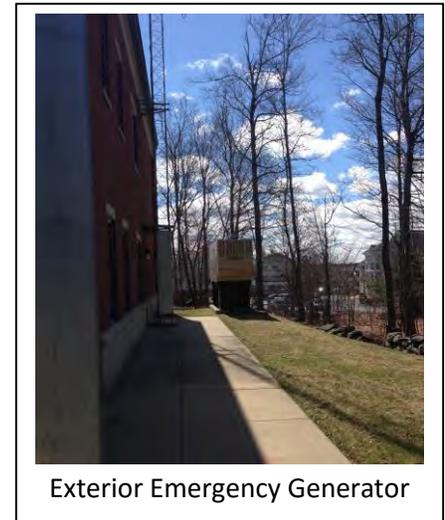
Exterior Emergency Generator

- ii. Emergency power is by a 225KW Diesel Generator

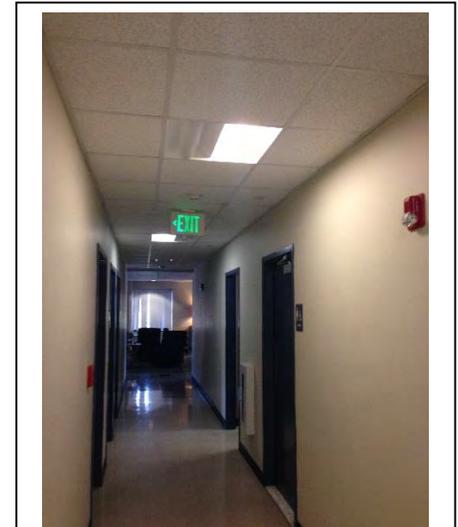
Fluorescent Lighting

- iii. Lighting is predominantly fluorescent throughout the building
- iv. Lighting controls is via wall mounted switches and occupancy sensors.

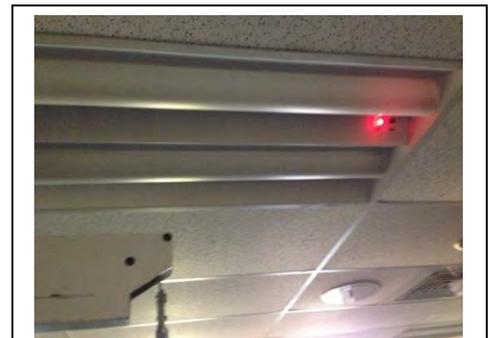
Fluorescent Emergency Lighting

- v. Emergency lighting is by emergency ballasts installed in select fixtures throughout the facility.

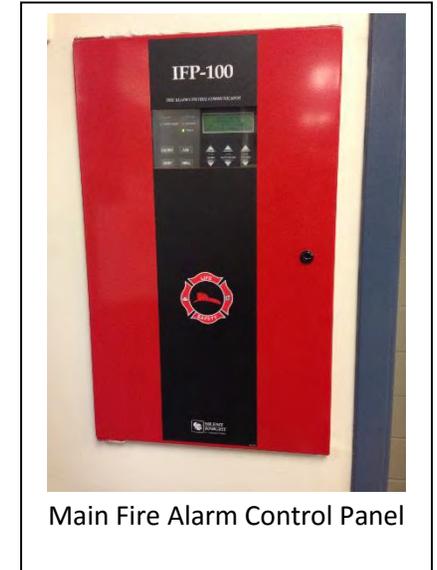
Main Fire Alarm Control Panel

- vi. Fire alarm is a Silent Knight IFP-100 addressable system

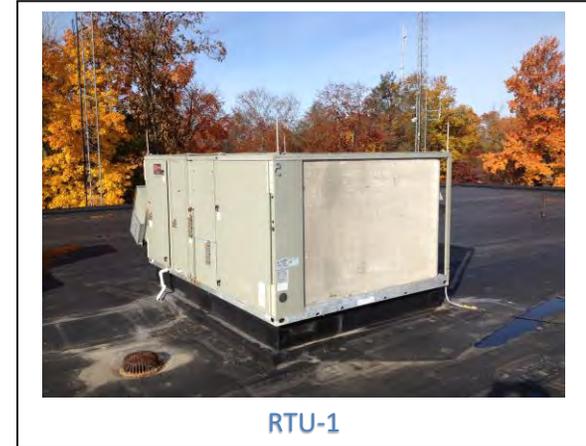
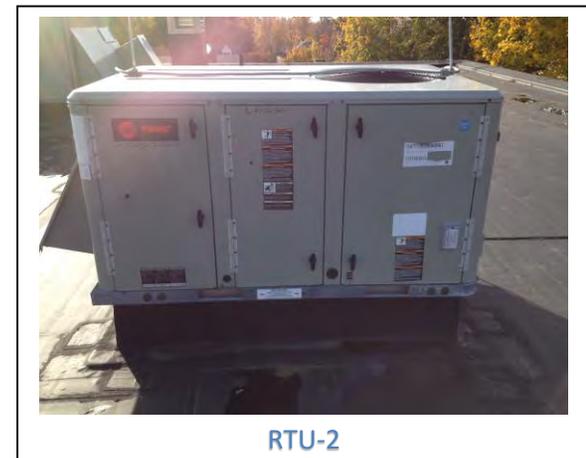
- i. The Fire headquarters was constructed in 2007.
- ii. The Fire Headquarters' heating and cooling systems consist of one (1) gas condensing boiler (B-1), two (2) constant volume cooling only packaged rooftop units (RTU-1 & 2), VAV boxes with hot water reheat coils, unit heaters, duct mounted reheat coils, finned tube radiation, and electric unit heaters.
- iii. Heating Hot water is circulated by two (2) hot water inline pumps (w/VFD's) to VAV reheat coils, finned tube radiation, duct mounted reheat coils and unit heaters.
- iv. Heating for the Garage is by gas fired Infrared heaters.
- v. There are exhaust fans located throughout the building and are all are located on the roof. The majority of these fans are constant volume fans serving general exhaust and toilet exhaust.
- vi. There is a vehicle exhaust system located in the garage area.
