TOWN OF SHREWSBURY

FACILITIES CONDITION ASSESSMENT OF
TOWN BUILDINGS

FINAL REPORT

SPRING
STREET
SCHOOL

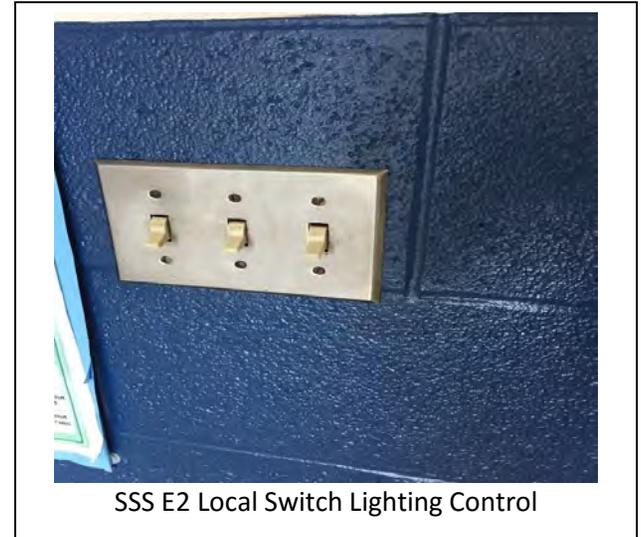
SSS E2 Recessed Parabolic Fluorescent Lighting

- iii. Lighting controls is via wall mounted switches.

- iv. Emergency lighting is from battery pack units and remote heads.
