## FEASIBILITY STUDY

### III. EXISTING CONDITIONS EVALUATION AND RECOMMENDATIONS B. Existing Conditions Narratives

#### 1. SITE ASSESSMENT

**Shrewsbury Public Library**  
**Shrewsbury, MA**

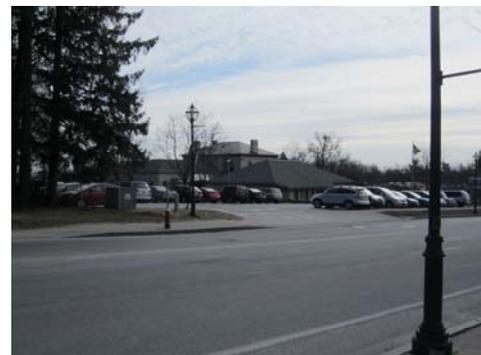
**Parking/Loading and Vehicular Circulation:** Currently, parking areas for the Library and Credit Union are separate and accessed independently. Library parking is accessed from Boylston Street/Route 140 via an approximately 32.5 foot wide curb cut adjacent to the northern-most property line. The curb cut has one entrance lane and two exit lanes for left or right turns. The Library parking exit lanes sometimes become congested due to stopped southbound traffic on Boylston Street/Route 140 backing up beyond the curb cut; this generally occurs during peak hours of morning and afternoon commutes. The former Credit Union parking is accessed from Main Street via a 24 foot wide curb cut adjacent to the eastern-most property line, with one lane each for entrance and exit. Similarly to the Library, exit from this curb cut can be difficult due to stopped west-bound traffic on Main Street.

Boylston Street/Route 140 vehicular entrance

**Recommendations:** Under Options 2 and 3, the Credit Union parking area should be connected to the Library lot by a driveway not exceeding 8% in slope, with appropriate guardrails and/or retaining walls as required. Revised parking areas should comply with the Town’s Zoning Ordinance relative to dimensions, buffer zones and landscaping requirements; however some relief may be requested based on current usage.

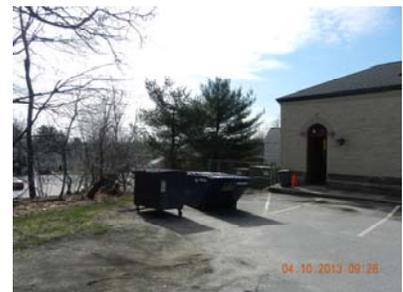
Trash/recycling containers at east end of parking area

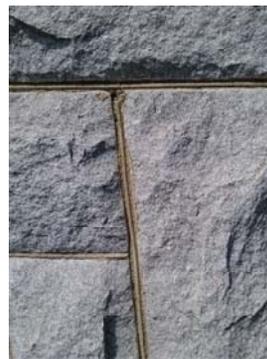
- The exterior walls of the 1903 Howe Library consist of gray granite base, water-struck yellow/beige brick and sandstone trim (water table, window sills, columns, lintels, cornice, pediment, etc.) over masonry bearing walls. In 1995, the exterior masonry was cleaned, repaired and some portions were repointed. The granite base, with its grapevine mortar joints, is typically in excellent condition; exceptions being a dislodged lintel stone and a few open joints. The yellow/beige brick, distinguished by very narrow vertical and horizontal mortar joints, is in good condition despite some areas in need of repointing. The sandstone trim is generally in good condition although some open vertical joints were observed. Some embedded sheet metal

Granite with grapevine mortar joint

**Recommendations:** Exterior masonry walls at the 1903 and 1923 buildings should be cleaned and selectively repaired/repointed. At the 1979 Addition, LPA recommends that the split-face CMU, brick and precast concrete masonry veneer exterior walls be removed in their entirety. This would at the same time allow replacement of the existing back-up wall assembly with new metal stud, fiberglass-faced exterior gypsum board, air/vapor barrier membrane, rigid board insulation, and through-wall flashing systems.

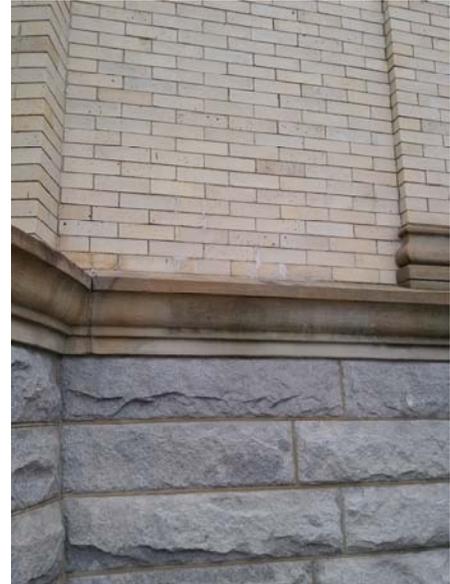
Granite base, sandstone trim and brick masonry at 1903 Library

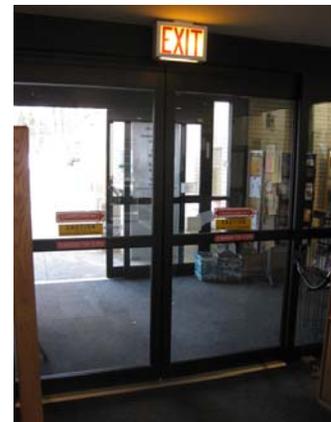
- Anodized bronze aluminum fixed storefronts were installed as part of the 1979 Addition & Alterations
- 1979 Addition:
  - The 1979 windows are painted wood fixed residential-grade windows with insulating glass units. The finger-jointed wood exteriors, particularly on the south elevation, are in very poor condition; paint has peeled, cracks have developed and gaps have opened up between the window and adjacent masonry.
  - Storefront systems at the Lobby are anodized bronze aluminum, medium stile with insulating glass units. The north entry from the parking area has a vestibule with automatic sliding doors; while the south entry from Main Street has no vestibule and a pair of hinged doors. It was reported that the automatic sliding doors malfunction frequently and must be slid open or closed manually.

Anodized bronze finish aluminum sliding glass main entry doors at 1979 Addition

All existing aluminum storefront and entry door systems, as well as associated finish hardware, should be replaced. Electronic access control and intrusion detection capabilities should be provided at all exterior doors.

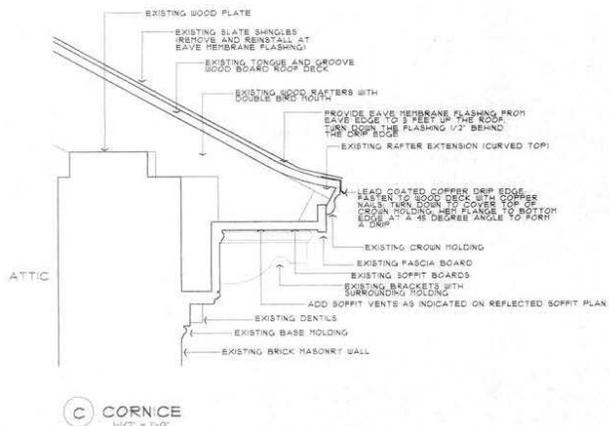
Metal vents were shown, at the underside of the soffits and near the ridge, as part of the 1998 Cornice Repairs project scope of work. These vents, however, were not visible and it is questionable as to whether or not this work was done. The 1998 documents also indicate that a 3' wide strip of eave membrane flashing was provided by removing and reinstalling the bottom 3-4 courses of slate at the eaves; this also could not be verified.

Roof edge detail from 1998 construction drawings

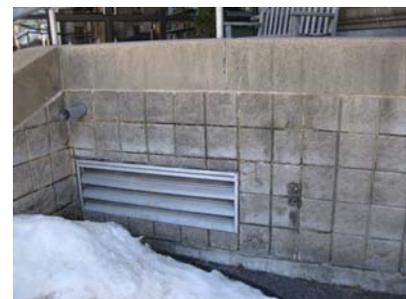
- There are several mill finish extruded aluminum louvers at various locations around the building. Most of these are associated with the 1979 addition and alterations and are built into split-faced CMU masonry walls. Without further testing it cannot be concluded that these louvers are the cause of leaks in the mechanical rooms below; however it is clear that they are too close to grade level and frequently subjected to splashing water, built-up snow and other debris.

Louver at 1979 Addition south entrance

**Recommendations:** The 1979 south entry deck (above the lower level mechanical space on the Main Street side of the building) should be rebuilt utilizing a more effective plaza deck waterproofing/insulation system. New extruded aluminum drainable blade exhaust and fresh air intake louvers should be incorporated at a higher elevation above grade; or, another means of exhausting and taking in air should be studied.

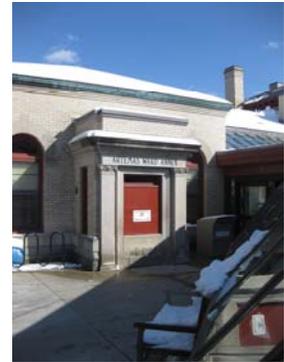
- The former entrance to the 1923 Ward Annex was modified, as part of the 1979 scope of work, to serve as a book return drop. A second freestanding drop box, for video and DVD media, was added to the right side of the book return. Both must be manually emptied; the book return from the interior of Technical Services and the freestanding drop box from the exterior (this requires library staff to exit and re-enter the building). It was also reported that some library patrons have been observed using the book return as a drive-up, backing their vehicles onto the sidewalk directly in front of the main entrance doors.

Book/media returns at 1979 north entrance from parking lot

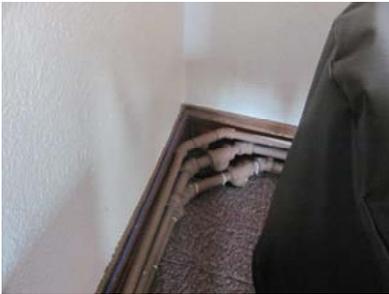
- The large upper level meeting room has a 15' high coved plaster ceiling with pendant-mounted fluorescent light fixtures. Minor water stains and peeling paint were observed in several places on this ceiling. Unfortunately, exposed piping was installed at some point over the wood base in this space.

Exposed piping

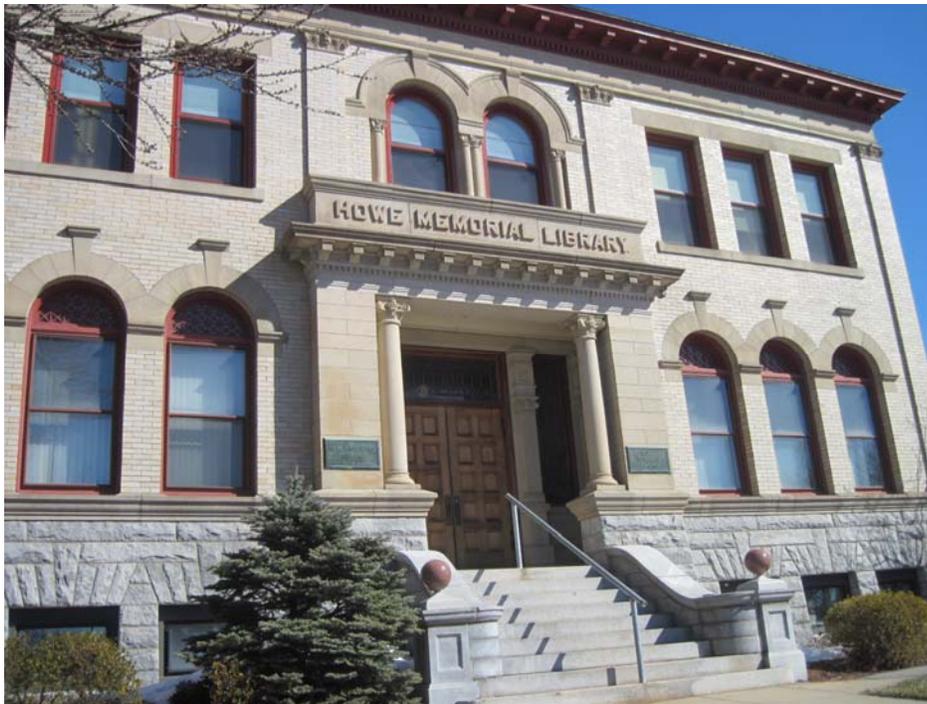
**Figure 2-1903 Building**

The 1903 structure has remained relatively unchanged from its original construction. A few masonry bearing walls in the basement have been modified with steel lintels to create doors and openings to the 1923 addition, but otherwise the framing appears to be unchanged. The structural framing for the building was not visible due to plaster walls and ceilings throughout the building, and original construction drawings were not available. Based on renovation notes on the 1979 Addition drawings, the floors and roof are framed with traditional wood framing and brick masonry bearing walls.

The exterior walls are granite/brick veneer backed up by brick masonry bearing walls, and they appear to be in good condition with minimal cracking or movement. The interior of the building appears to have remained untouched other than typical plaster repairs. There are a few water stains and plaster cracks at the second floor ceiling, but otherwise the walls and finishes appear to be in good condition. We did not access to the attic space during the walkthrough, but if the project continues, we would recommend at least a visual inspection of the roof framing to verify the integrity of the framing. Based on the condition of the ceiling, we would expect that the roof framing is in good condition. The hip roof is clad with slate shingles, and it is our understanding that the slate will remain.

- Parapets: There were no parapets, but there are two chimneys that extend 8-10 feet above the roof and do not appear to be used. If the chimneys are not part of the Architectural features of the building, we would recommend removing the masonry above

- the roof and roofing over the opening. Otherwise, we would recommend inspecting the masonry during the roof inspection to verify the integrity of the masonry.
- Unsupported partitions: Interior and exterior masonry walls appear to be bearing walls and do not appear to be free standing. We were unable to determine actual attachment details due to finishes and lack of structural drawings, but the wood framing appears to be bearing directly onto the walls.
  - Roof diaphragm attachment to masonry walls: We were unable to determine the connection of the roof diaphragm (likely wood boards) to the masonry bearing walls.

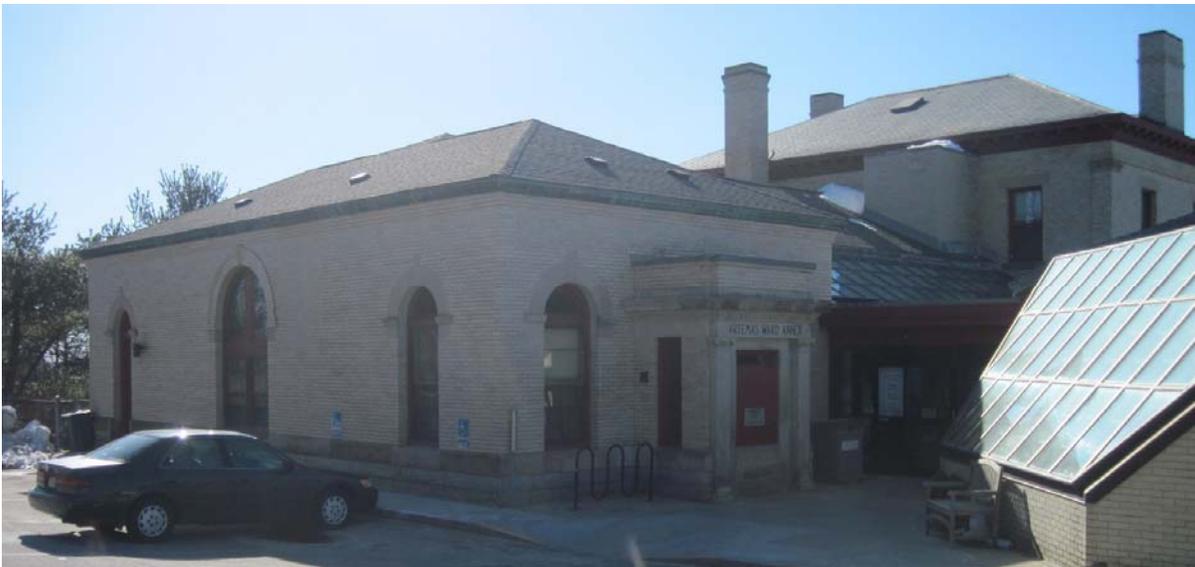
**Figure 3-1923 Addition**

Similar to the 1903 structure, the building has remained relatively unchanged from its original construction. A few masonry bearing walls in the basement have been modified to provide access to the 1979 addition and exterior courtyard. The structural framing for the first floor was partially visible in the basement area, but we could not determine member sizes and concrete slab reinforcing. The first floor structure appears to consist of unreinforced masonry bearing walls, structural concrete rib slabs in the mechanical area, and structural concrete slabs built

over steel beams in the central area. The second floor is a mix of original 1923 construction, masonry walls and unknown framing, and steel joist and concrete slab that was added in 1979 to replace a glass and steel framed floor assembly. The floors appear to be in good condition. The steel and concrete infill at the second floor was fairly light construction and heel drops could produce noticeable vibrations. The vibrations do not affect the structure, but may be problematic if the space was used for office use, or other vibration sensitive use.

The exterior walls are granite/brick veneer backed up by brick masonry bearing walls, similar to the original 1903 building. The walls appear to be in good condition with minimal cracking or movement. There was some noticeable water damage to the mortar and concrete parge near the courtyard area that should be repaired as part of the maintenance program.

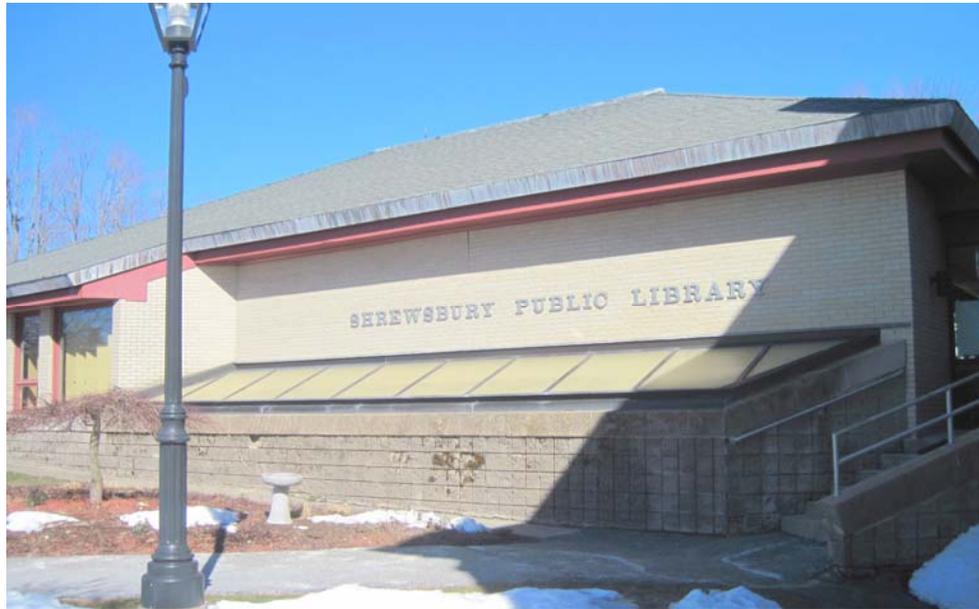
**Figure 5-1979 Building**

The 1979 addition is a mix of exposed glu-lam wood framing and traditional steel and concrete framing. The glu-lam framing includes heavy timber members at the floor level and exposed trusses at the hip roof. The wood members appear to be in good condition, except some local water damage at skylights.

The roof trusses are exposed in the main 1979 addition area and appear to be in good condition. The wood decking also appears to be in good condition. There are several skylights which appear to be a constant source of leaks and water infiltration. Water damage was noticed at each skylight and also at the basement mechanical room. Any possible renovation option should address the water infiltration.

The exterior walls of the 1979 addition are split face block and brick veneer backed up by 3 ½” steel studs, and the walls do not appear to be in good overall condition. The split face blocks are located at the base of the exterior walls, and have suffered water damage at several locations, including holes through the exterior face at a few locations. The damage appears to be more prevalent near walkways where rain can splash against the blocks, and ice melting chemicals are likely used on the walkways during the winter, exacerbate the freeze/thaw problems.

There are horizontal cracks in the brick veneer at a few locations, mainly corners and near the light well locations. We did not notice any signs of settlement at the foundation walls. The masonry veneer is typically supported on the exterior concrete foundation walls, but at the light wells the veneer appears to be supported by steel angles attached to metal studs on wood floor members, or directly on the wood floor system. Either way, the brick load is supported on the wood glu-lam members below, which would be more likely to move over time and could be causing the horizontal cracks as the wood creeps and the exterior walls remain unchanged on the concrete foundation walls.

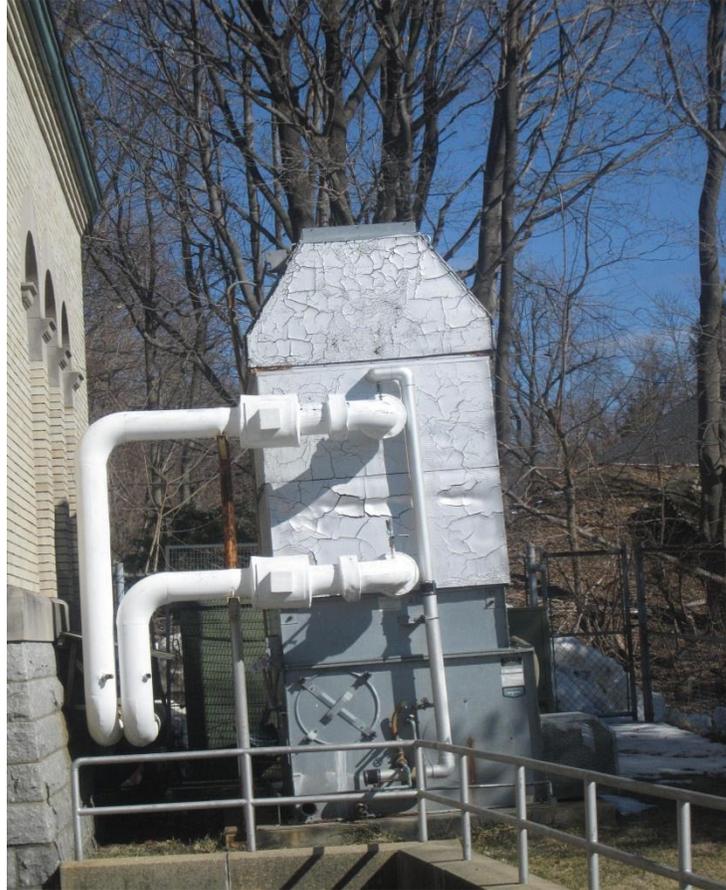
*Cooling Tower*

An evaporative type cooling tower is located adjacent to the building. This tower has a water coil in it in which building condenser water flows through in order to reject heat. The tower utilizes a blower, spray pump and outlet dampers to control the amount of heat rejection from the tower. The system also incorporates a bypass valve to bypass water around the tower during very low heat rejections periods such as in the winter months. The tower is manufactured by Evapco, Inc. and appears to have been replaced in 1996 making it 17 year old.

Condenser water system chemical treatment is accommodated through the use of a shot feeder whereas the cooling tower water has automatic chemical feed pumps and a corrosion testing coupon rack. Both of these types of chemical treatment systems are typical of systems of this nature.

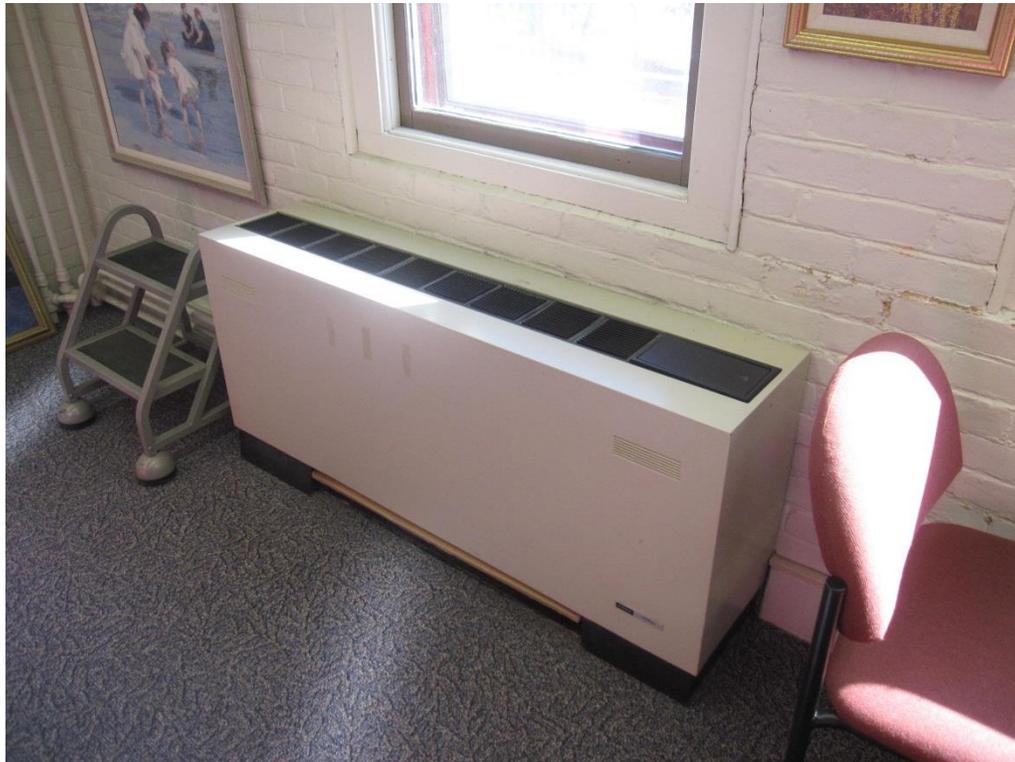
*Console Style Water Source Heat Pump*

The rest of the buildings (1903 & 1923) heating and cooling needs are primarily supported via console style water source heat pumps. These units sit on the floor of the respective area they serve and incorporate integral thermostats and fan switches. According to Mr. Cox, not all the units operate and one or more is currently being used to support parts replacements for the others.
