TOWN OF SHREWSBURY
FACILITIES CONDITION ASSESSMENT OF
TOWN BUILDINGS

FINAL REPORT

June 01, 2016

**Shrewsbury
High School**

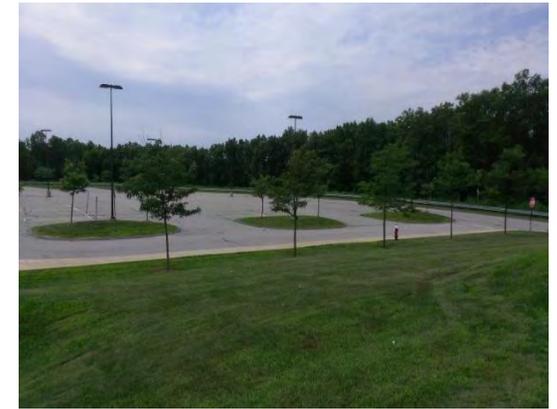
SHS E3

- i. The accessible parking spaces in the parking area north of the drop off drive do not appear to comply with current MAAB standards (see “Pedestrian Accessibility and MAAB Compliance” for further detail).
- ii. The accessible parking spaces in the student parking area do not appear to comply with current MAAB standards.

- i. Implement a program to bring accessible parking spaces throughout the site into compliance with current MAAB standards.
- ii. Implement a program of replacing damaged or worn pavement throughout the site.

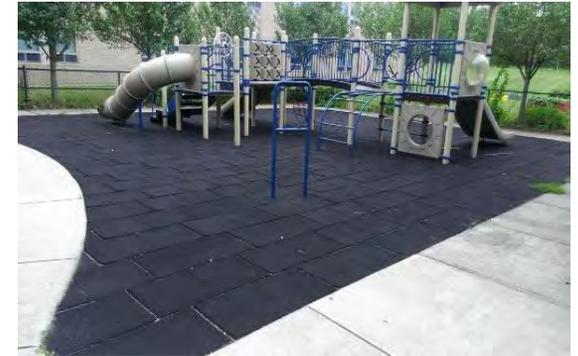
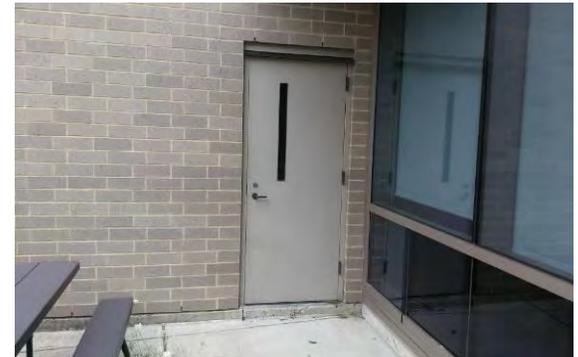
- i. The concrete pavement and furnishings in the large courtyard are in good to fair condition.
- ii. The rubber tile surfacing of the play area in the smaller courtyard does not appear to meet fall zone drop height requirements.

- i. Implement a program of replacing damaged or worn pavement throughout the site.
- ii. Replace the existing rubber tile surfacing at the play area with a compliant surface that meets current fall zone height requirements.

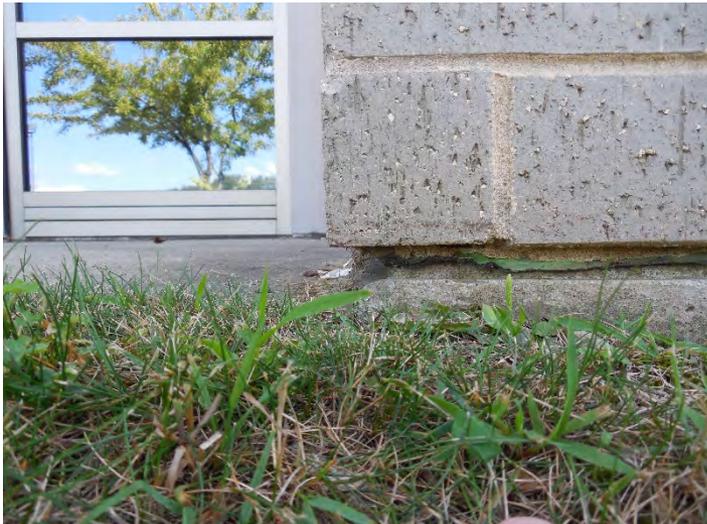
North Elevation, brick overhang at concrete foundation

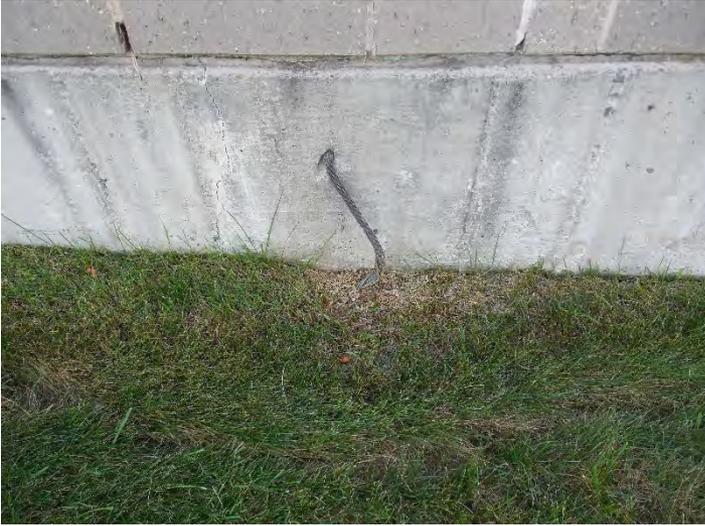
North Elevation, unsealed wire penetration and crack in concrete foundation

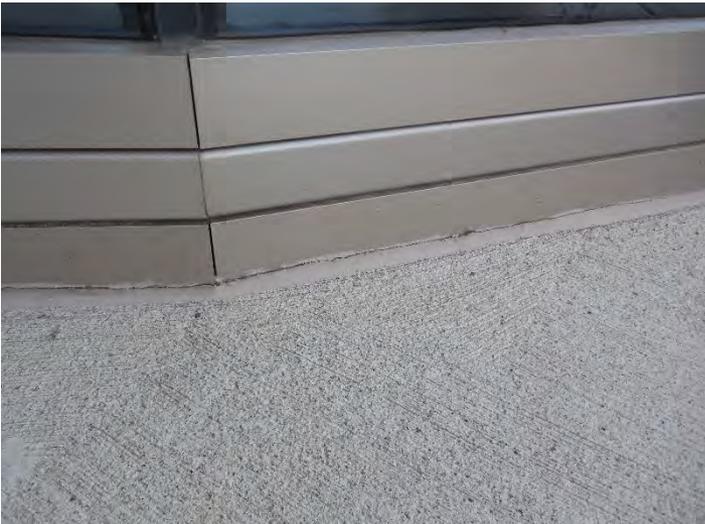
North Elevation, failed sealant at base of wall-to-walkway juncture

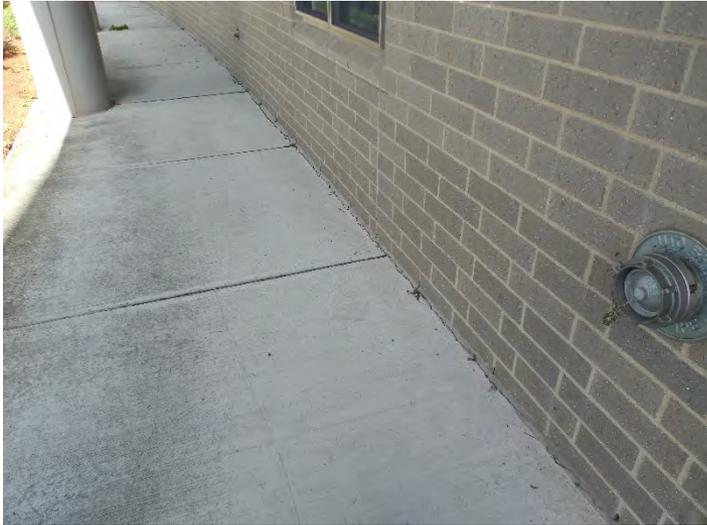
North Elevation, failed sealant along base of wall-to-walkway juncture

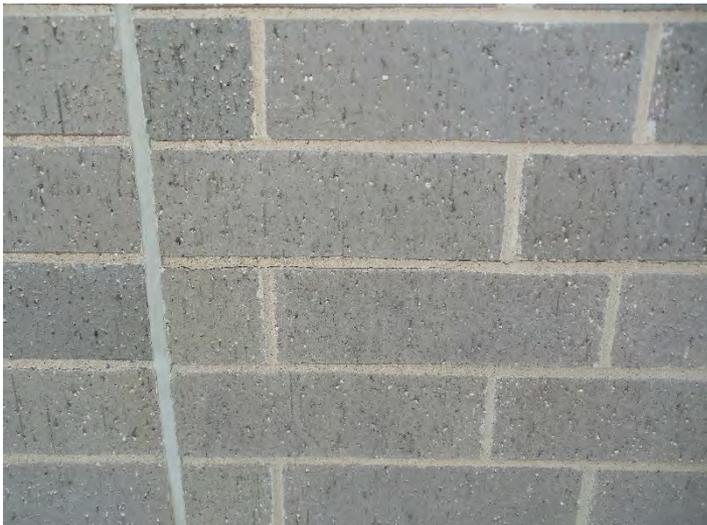
North Elevation, crack at mortar joint

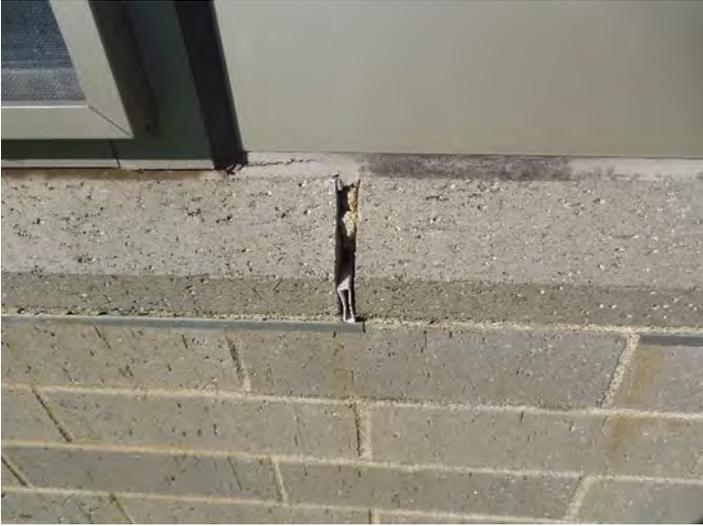
'A' Wing, East Elevation, deteriorated and cracked mortar joints;
failed metal panel-to-masonry-sealant joint

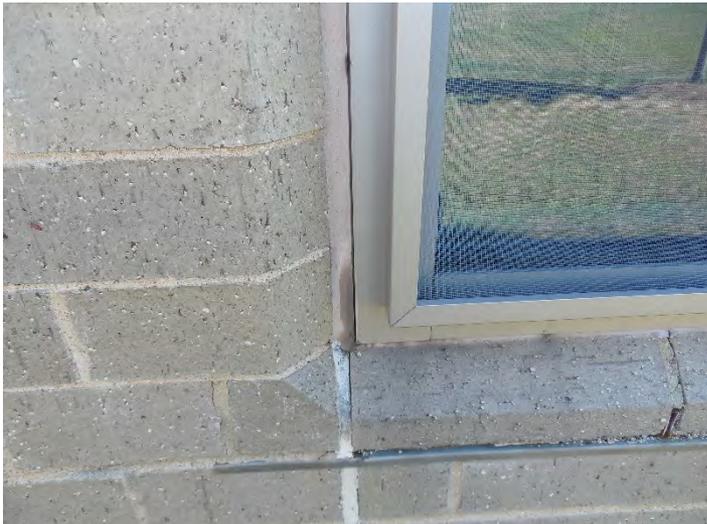
'A' Wing, West Elevation, mortar deterioration below windowsill; sealant failure at window perimeter

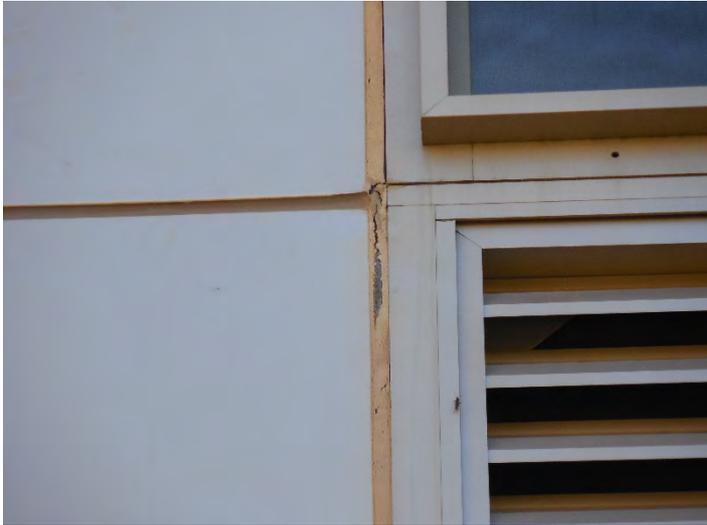
'A' Wing, West Elevation, failed sealant at a louver jamb

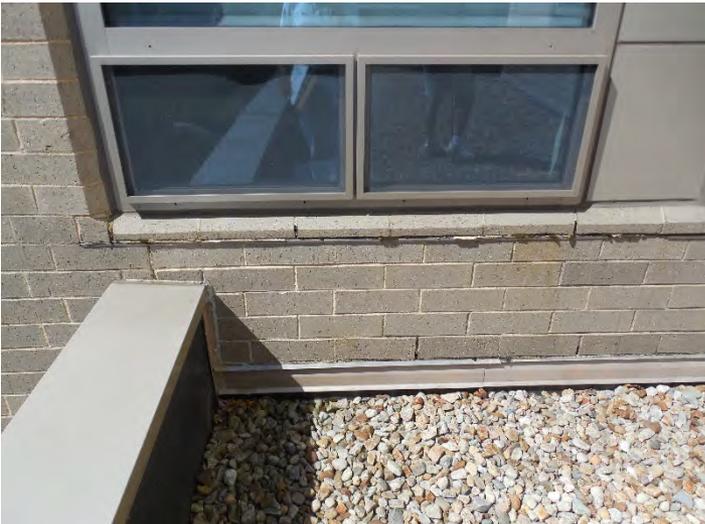
'B' Wing, East Elevation, mortar deterioration below a window

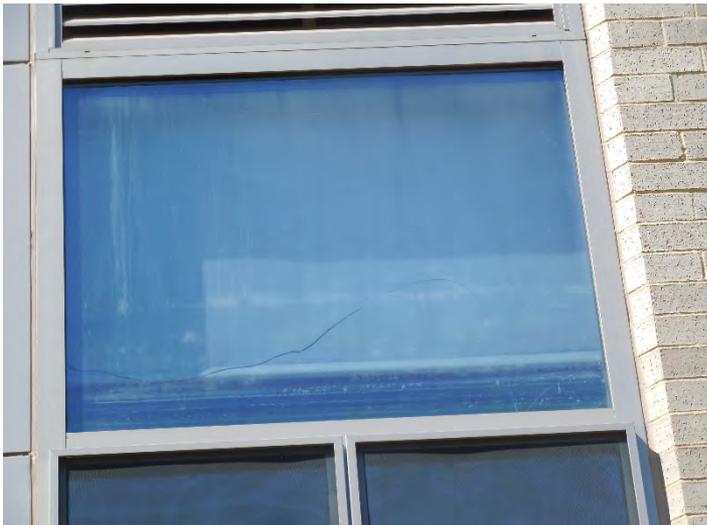
'B' Wing, East Elevation, broken glass at a second floor window

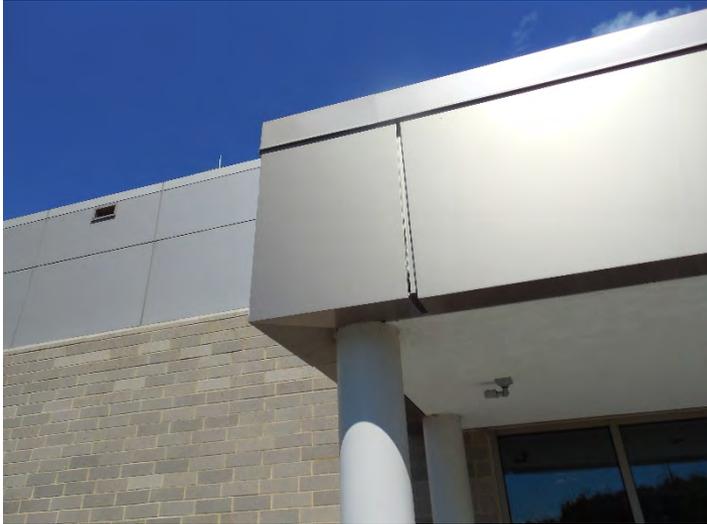
'B' Wing, South Elevation, displaced metal panel; missing sealant in metal panel joints

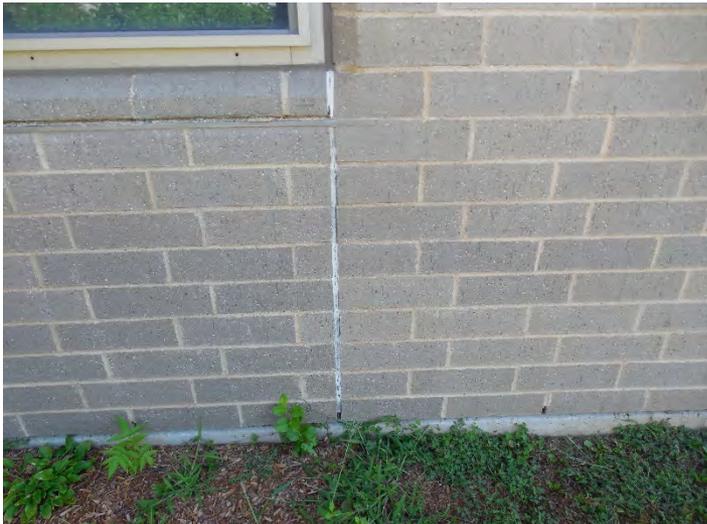
'B' Wing, West Elevation, sealant failure at an expansion joint

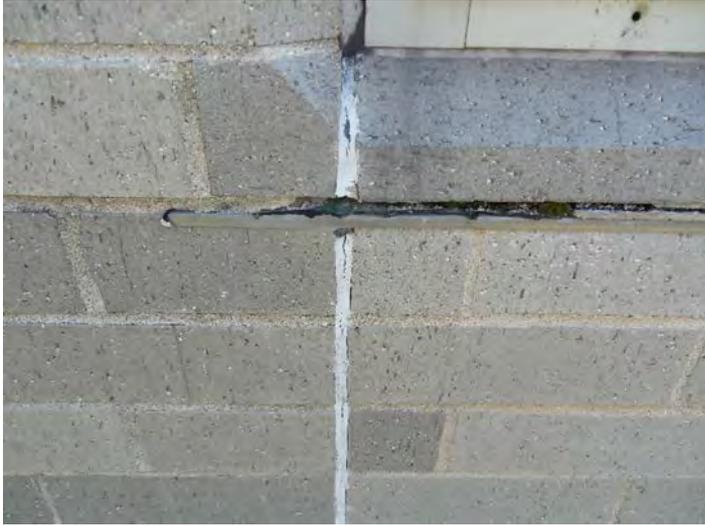
'B' Wing, West Elevation, cracked and deteriorated mortar and sealant joints below a window

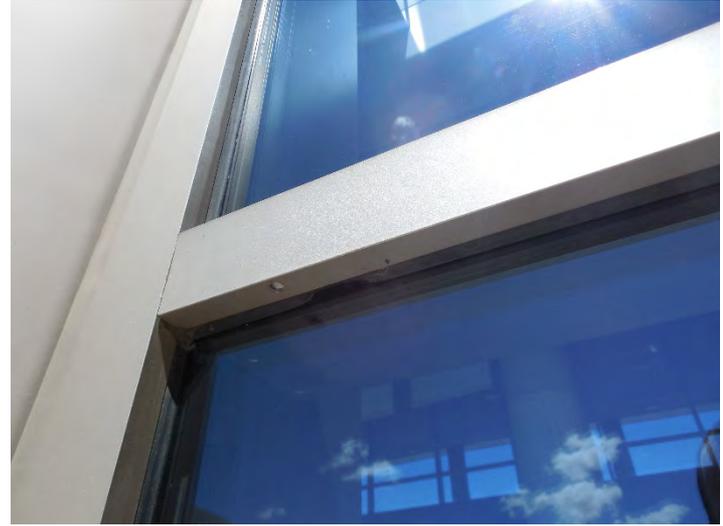
South Elevation at Lobby, displaced glazing gasket

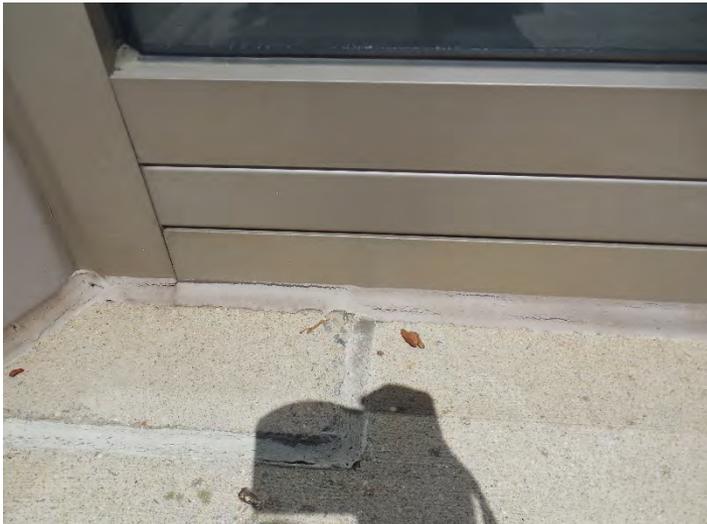
South Elevation at Lobby, failed sealant joint at metal panel-to-walkway juncture

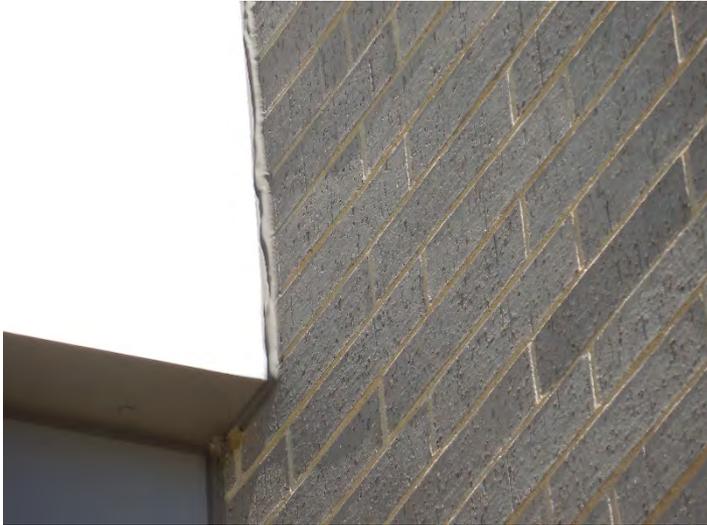
South Elevation at Lobby, wrinkled and displaced sealant at metal panel-to-brick juncture

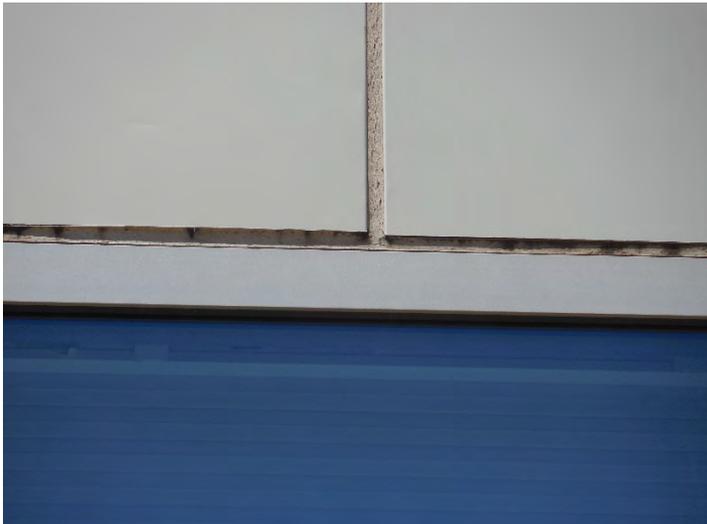
Auditorium Wing, East Elevation, failed sealant joints at curved portion of wall

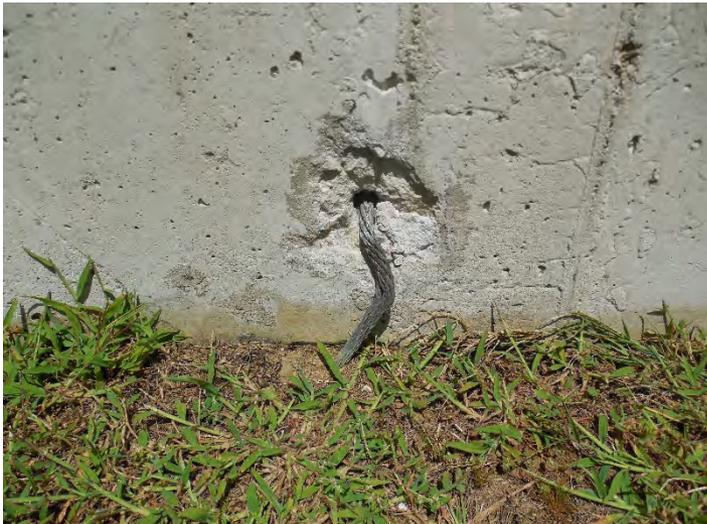
Auditorium Wing, South Elevation, unsealed cable penetration

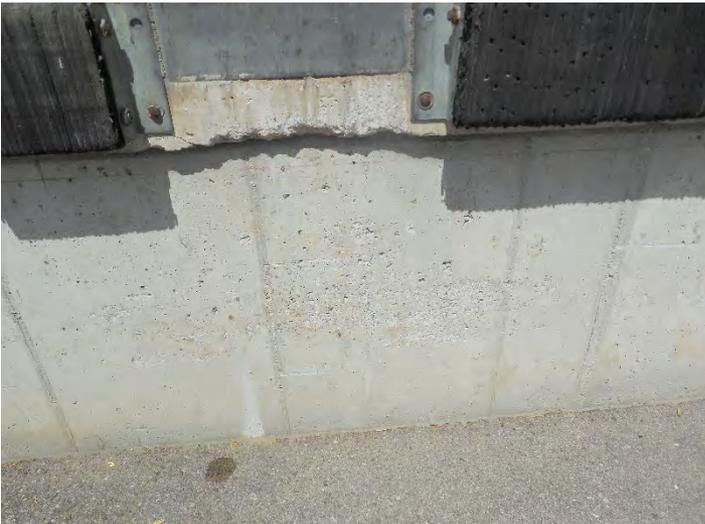
Loading Dock, South Elevation, cracks and spalled concrete

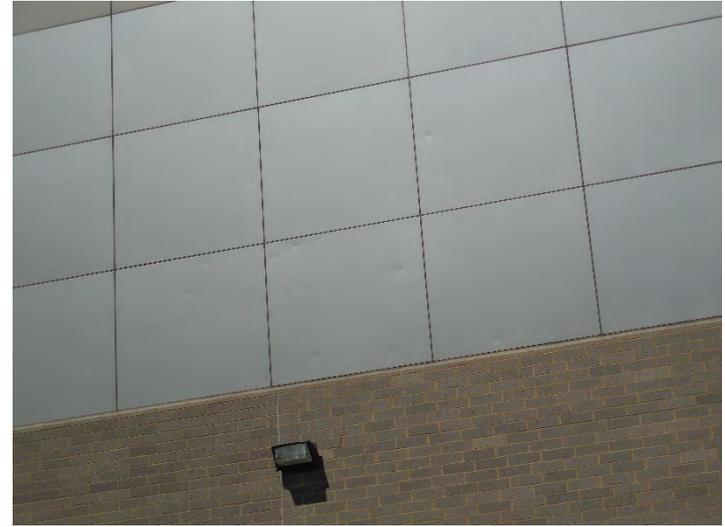
Gymnasium Wing, South Elevation, dented metal panels

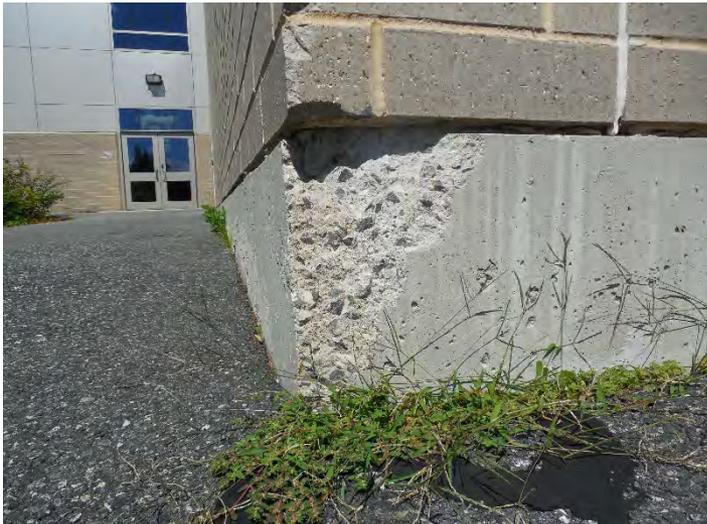
Gymnasium Wing, South Elevation, spalled brick and concrete

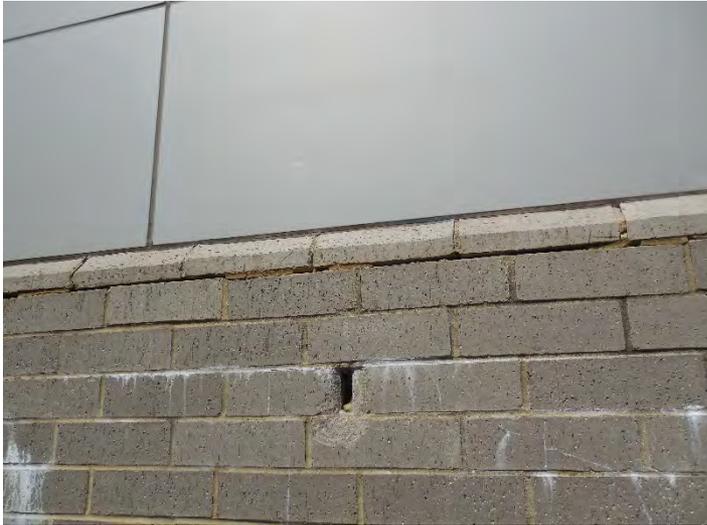
Gymnasium Wing, West Elevation, efflorescence on brick masonry, mortar deterioration, and spalled bricks

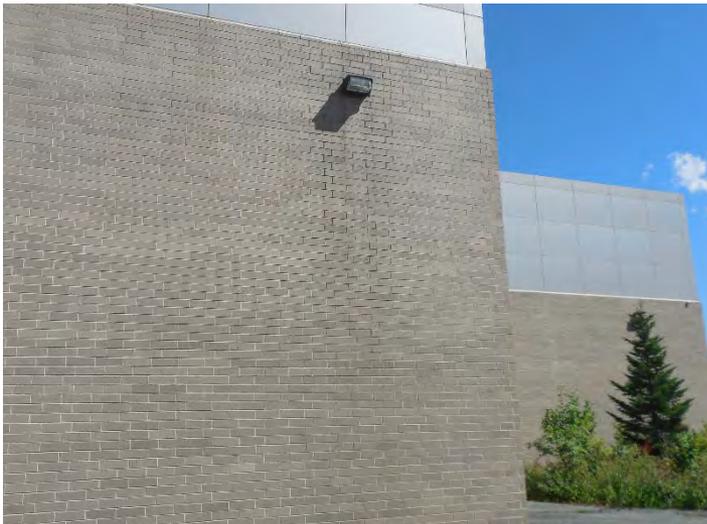
Gymnasium Wing, West Elevation, staining on brick masonry

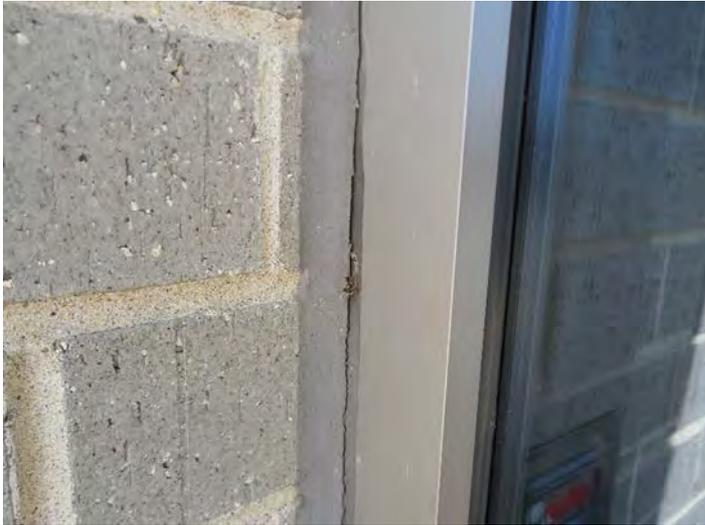
Gymnasium Wing, West Elevation, failed door perimeter sealant

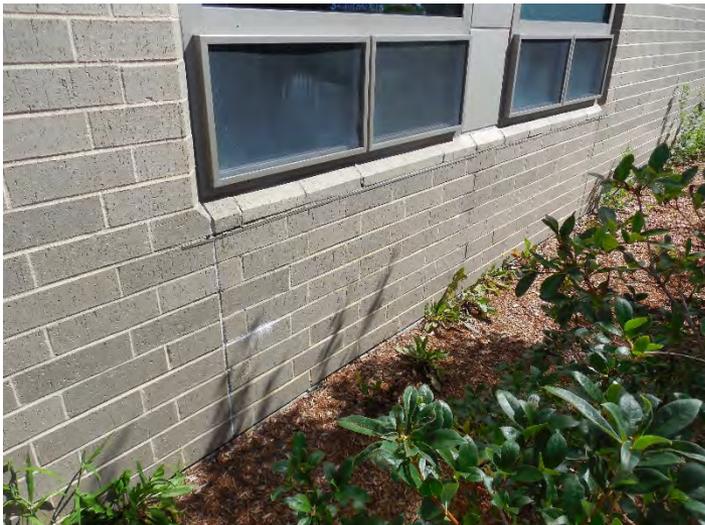
Gymnasium Wing, West Elevation, efflorescence and mortar and sealant deterioration

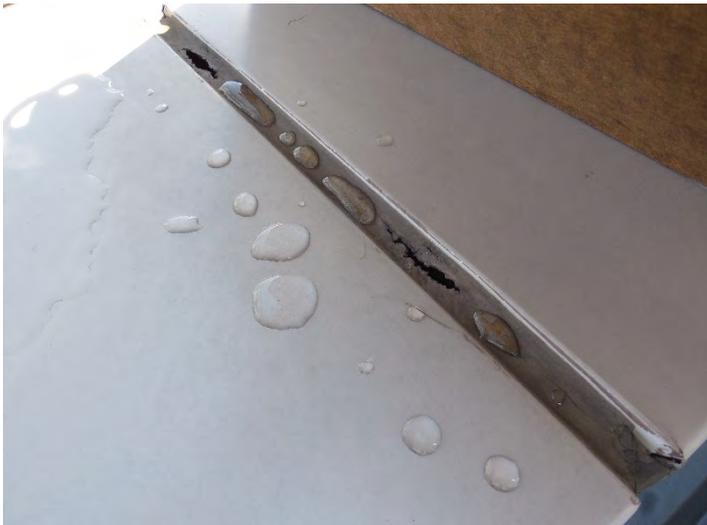
'A' Wing roof, sealant failure at a coping joint

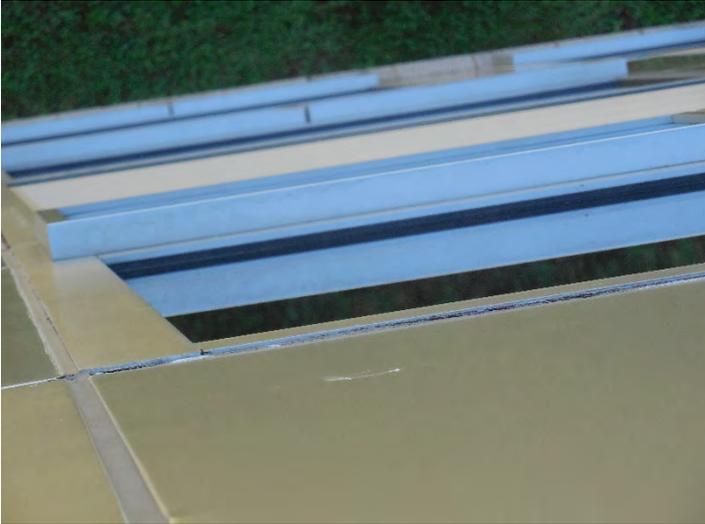
'A' Wing roof, view looking down at third floor window head with sealant failure

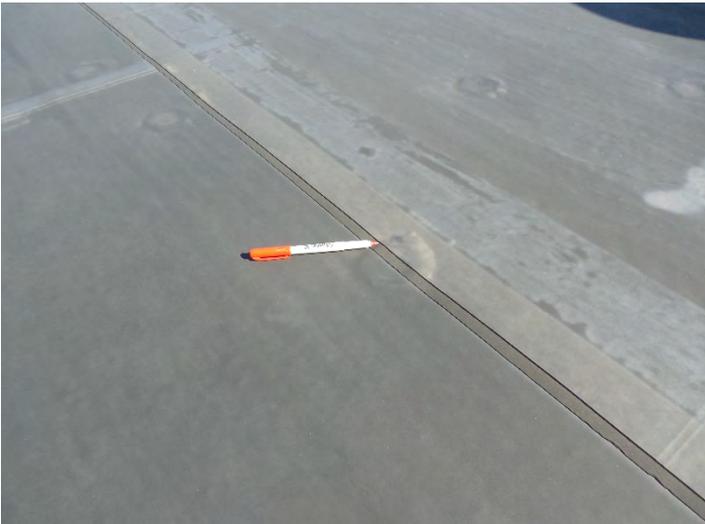
'A' Wing roof, bubble in EPDM membrane at a seam

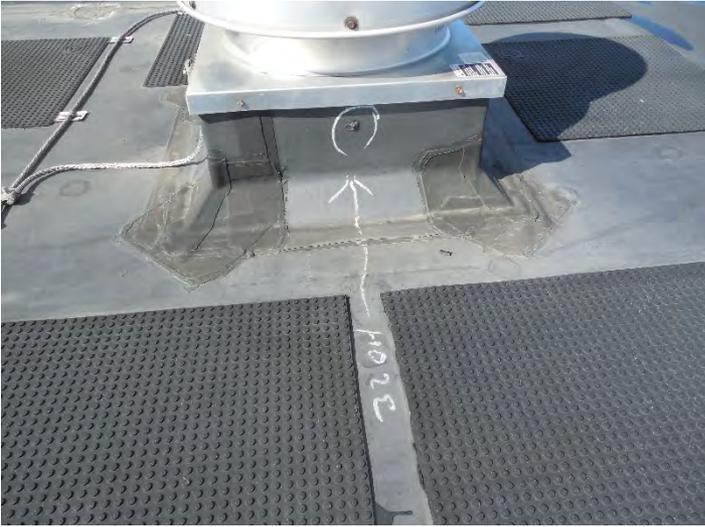
'A' Wing roof, hole repaired with a bead of sealant

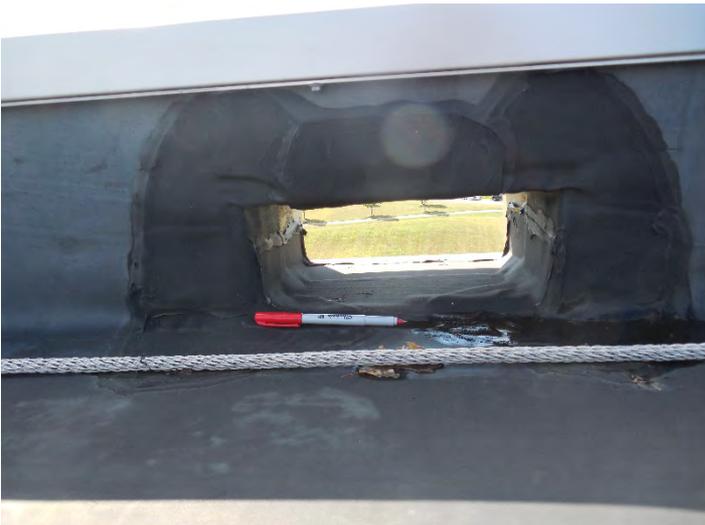
'A' Wing roof, height of scupper prevents water from draining

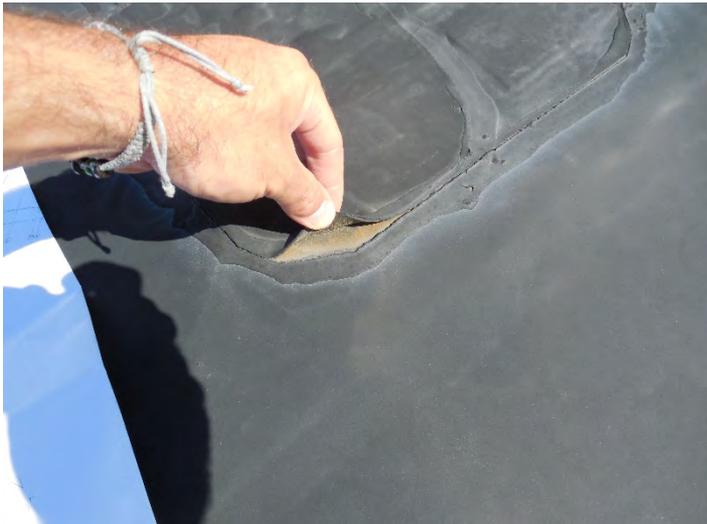
'A' Wing roof, unadhered flashing at a mechanical penetration

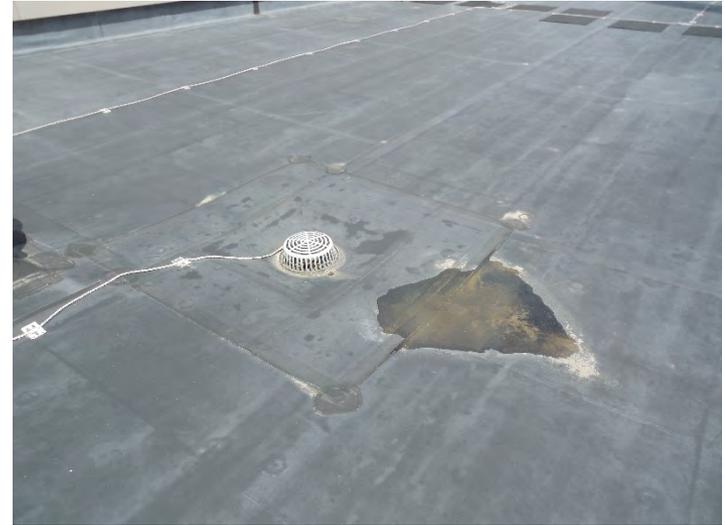
Auditorium wing roof, ponded water

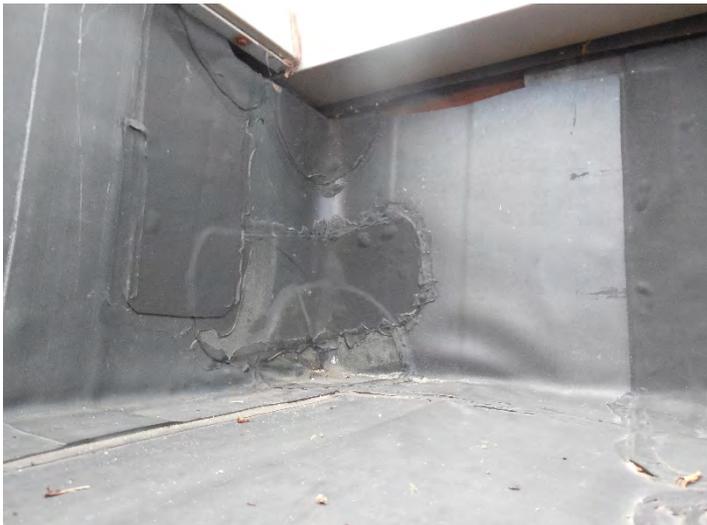
Auditorium wing parapet, incomplete flashing with exposed plywood sheathing

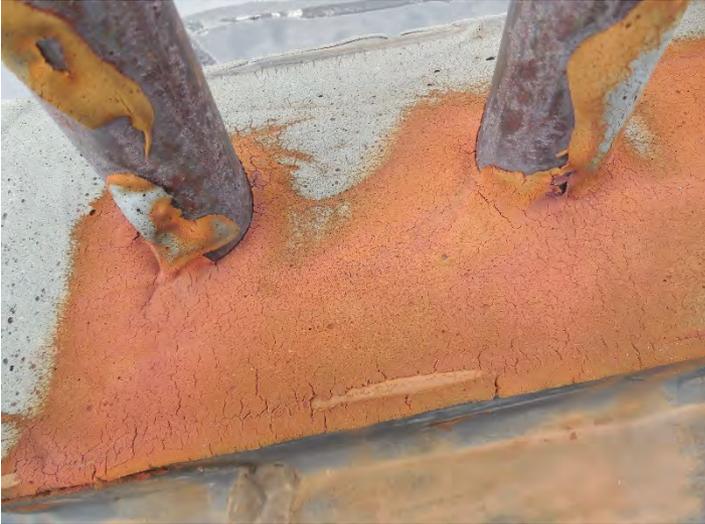
Auditorium wing roof, pitch pocket sealant is hardened and cracked

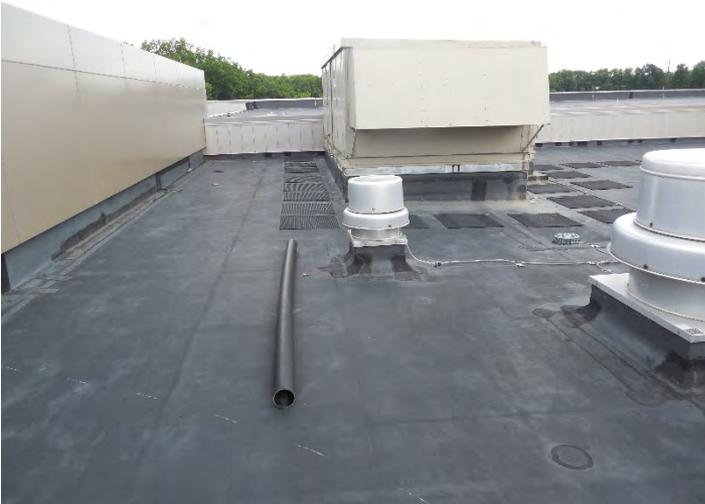
Auditorium wing roof, loose pipe on roof

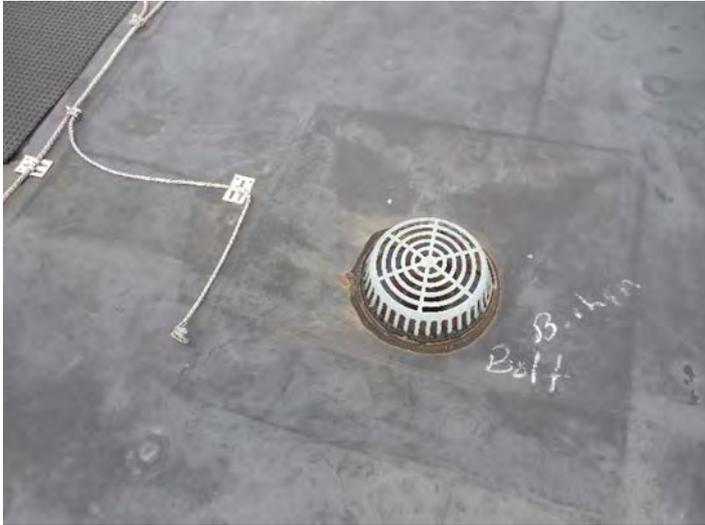
Auditorium wing roof, lightning protection cable not attached at drain

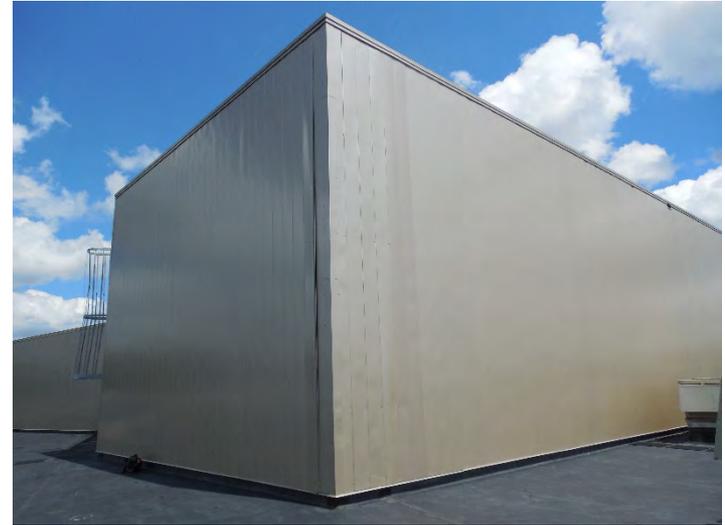
Auditorium wall, metal panels are buckled/bowed

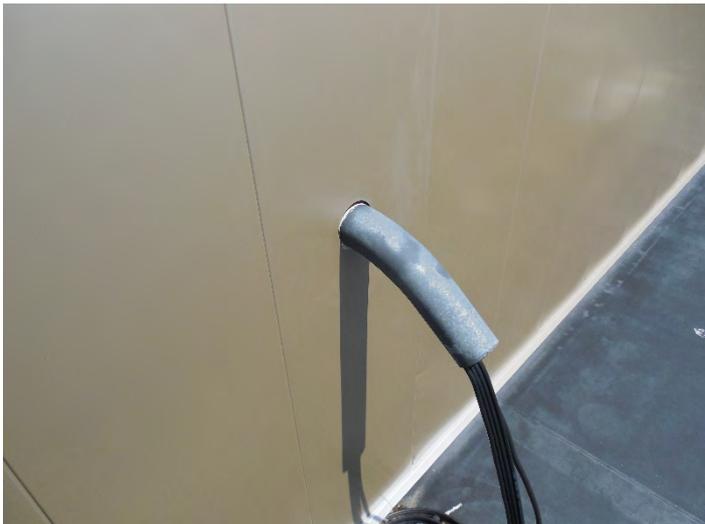
Auditorium wall, open pipe penetration

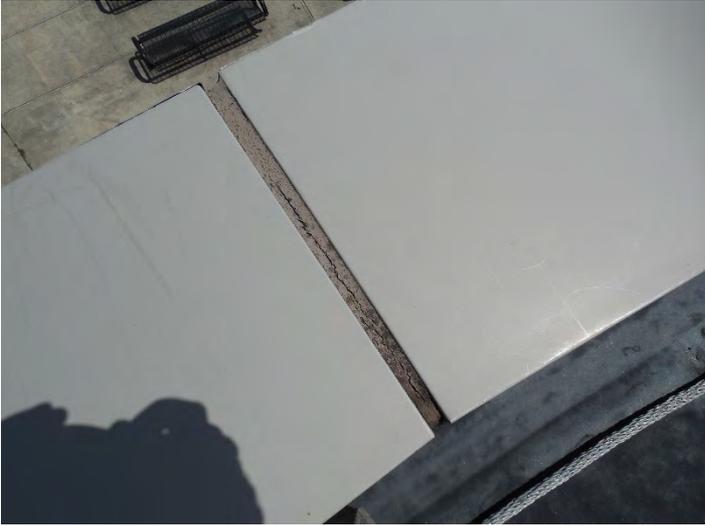
Auditorium wing curved parapet, failed sealant at coping joints

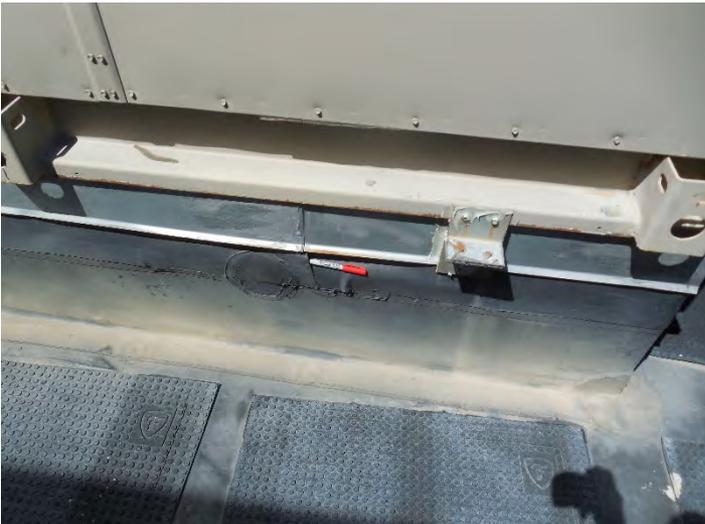
Auditorium wing roof, mechanical unit flashing has open seams

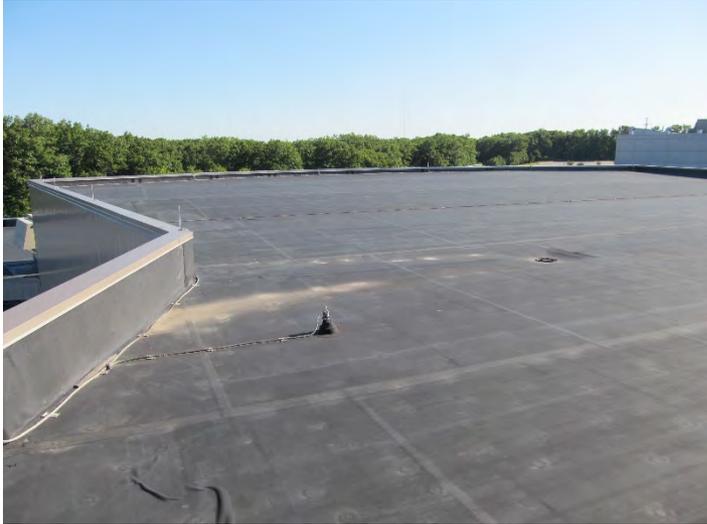
Auditorium roof, evidence of ponding, and wrinkles in the EPDM

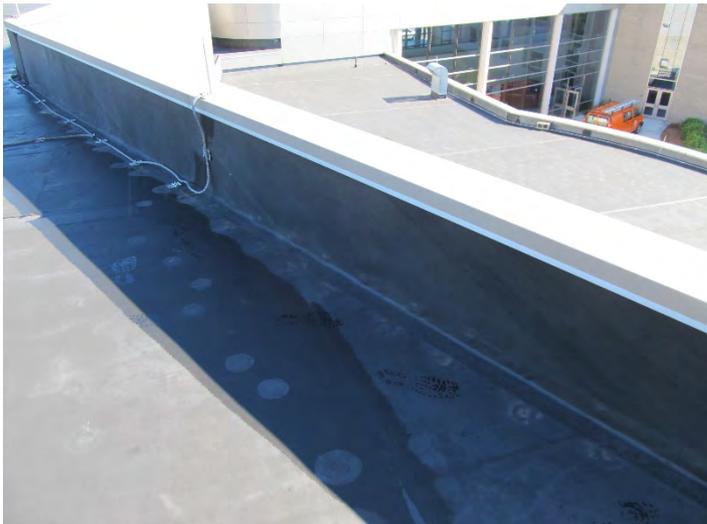
Auditorium parapet, debonded base flashing

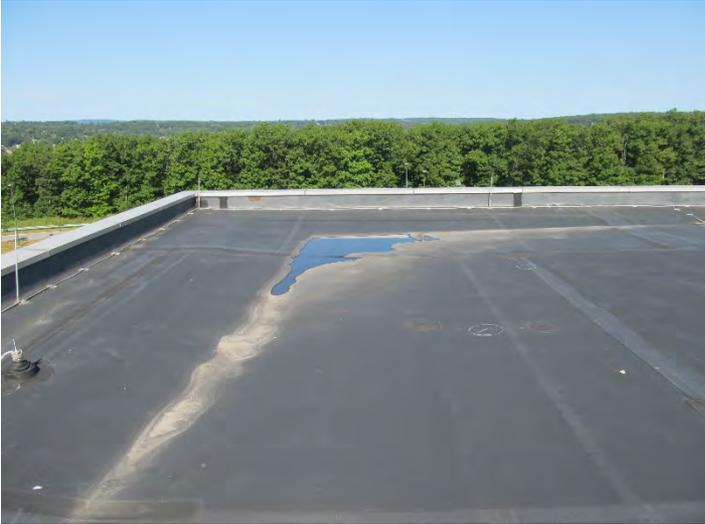
Gymnasium roof, ponded water and evidence of ponding around perimeter

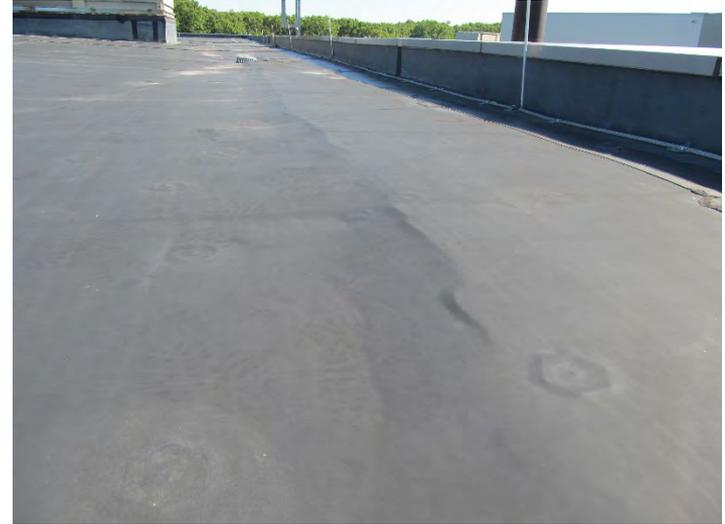
Gymnasium roof, unsupported EPDM over uneven insulation

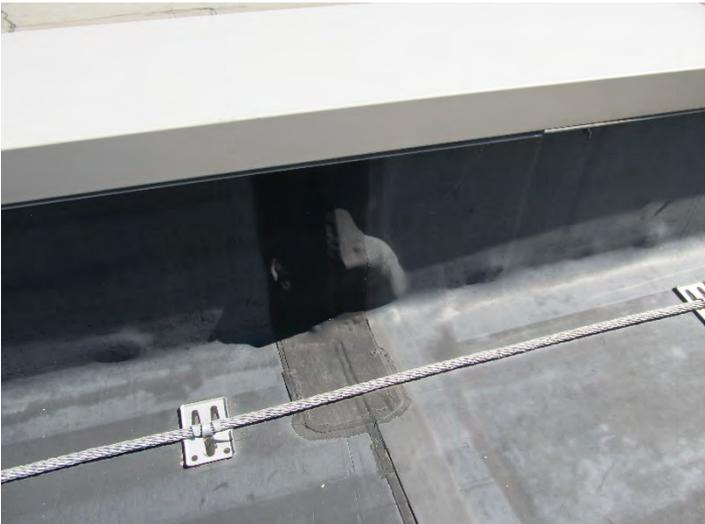
Gymnasium parapet, debonded EPDM base flashing

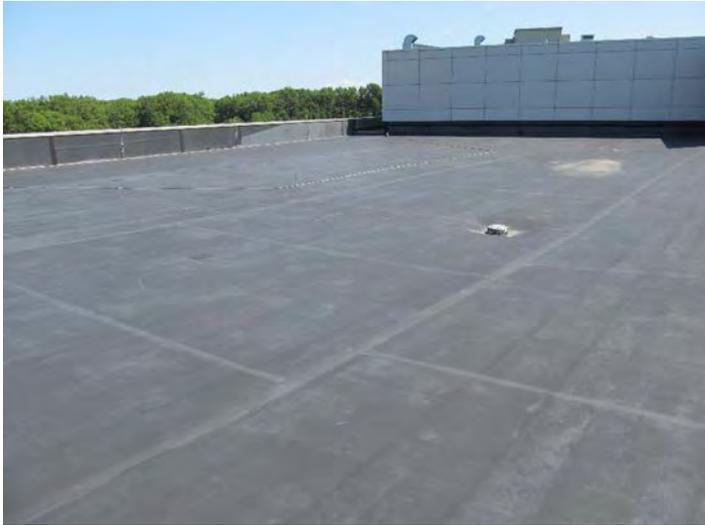
Main Entrance roof, partial view facing Northeast

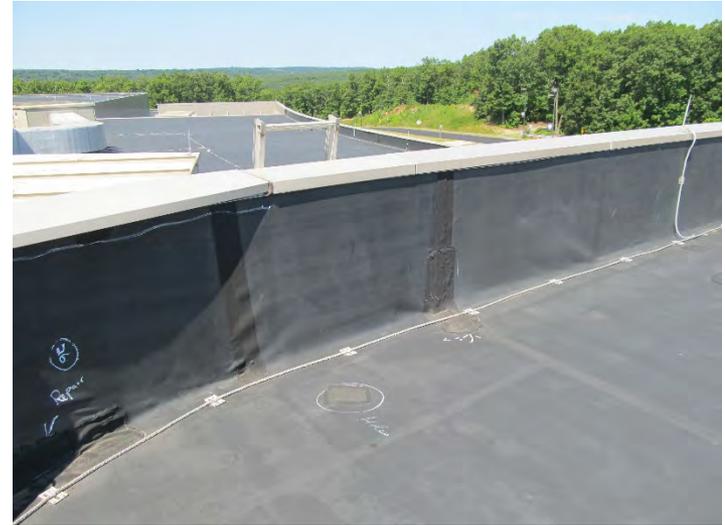
Main Entrance roof, unadhered EPDM base flashing

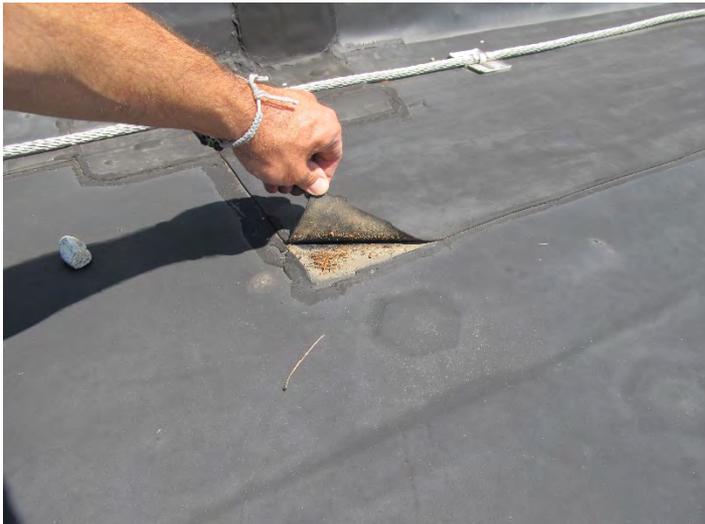
Main Entrance roof, unadhered EPDM patch

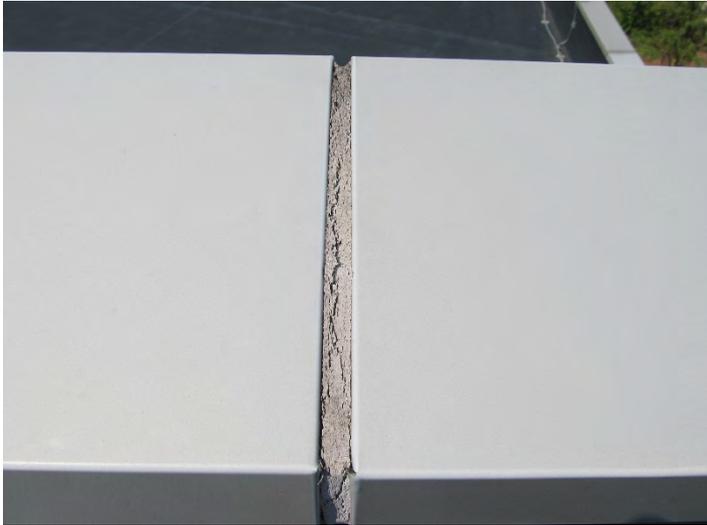
Main Entrance parapet, failed sealant at coping joint

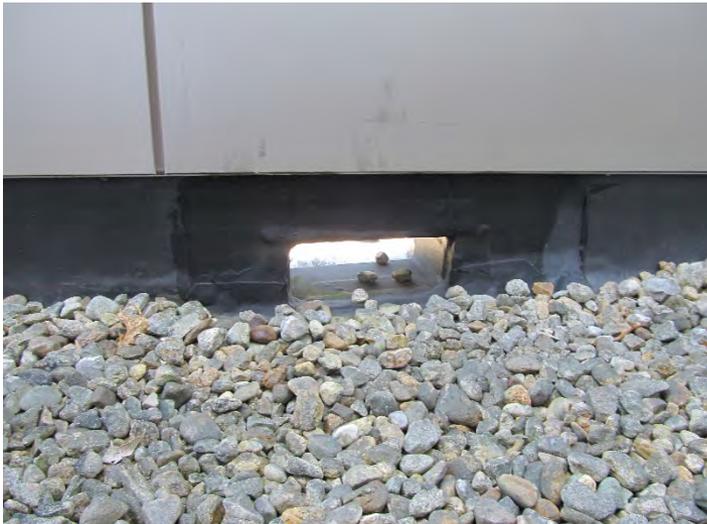
Ballasted roof at North 'B' Wing, ballast stones in a scupper adhered to roofing

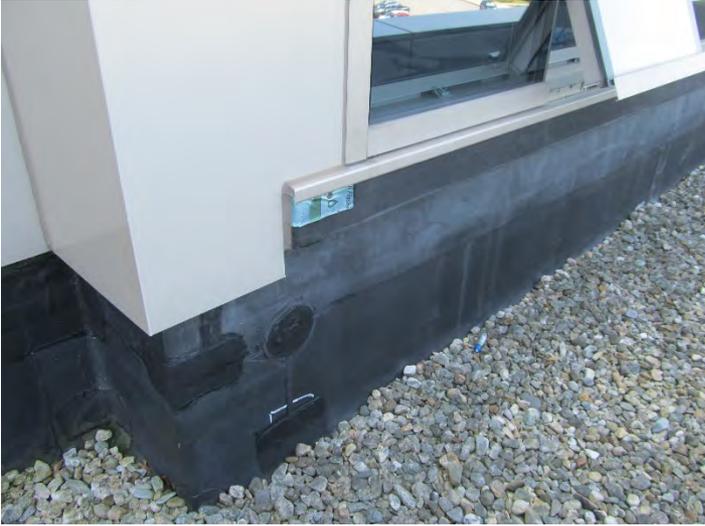
Ballasted roof at North 'B' Wing, exposed self-adhering membrane

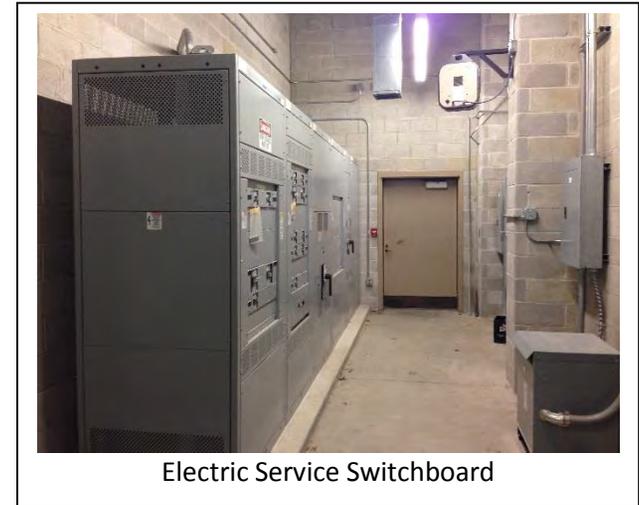
Electric Service Switchboard

The building is served by a single electrical service rated 5000 amperes, 480Y/277volts, 3-phase, 4-wire and is located in the main electrical room. The service equipment consists of an exterior utility company pad mounted transformer and an underground feed to utility metering equipment and a 5000amp main disconnect switch within the main switchboard. All electrical distribution equipment is manufactured by G.E. The predominance of the main distribution equipment is in good condition. The main switchboard feeds additional distribution switchboards located throughout the facility.

There are a number of electrical panels located throughout the facility that are fed from the distribution switchboards. The panel boards appear to have spare circuit breakers available for new circuits to be added, or include the space to add new circuit breakers. The panelboards are in good condition.

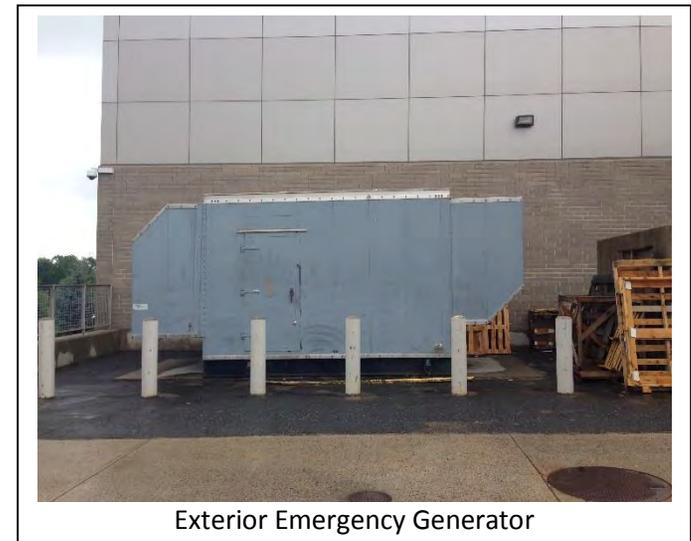
Exterior Emergency Generator

There is an onsite 300kw diesel emergency/standby generator manufactured by Caterpillar. The generator feeds four automatic transfer switches, for emergency life safety and for stand-by equipment that back-up a portion of the facility. The generator, transfer switches and emergency/standby panelboards all appear to be in good condition.

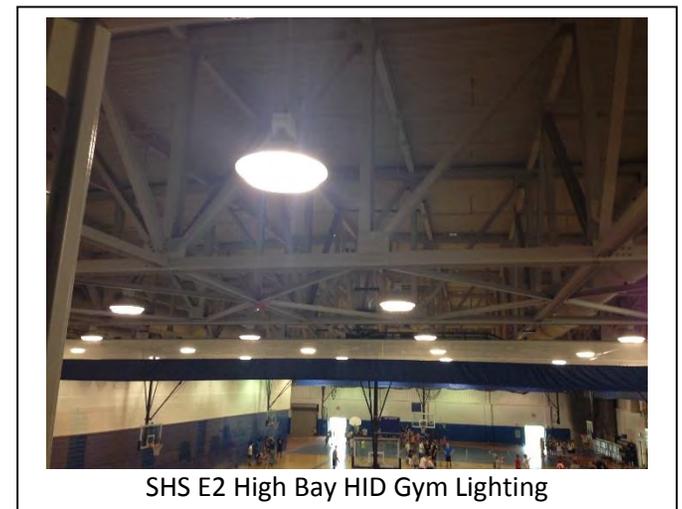
- v. Lighting in the Gym is pendant mounted HID fixtures.

- i. Replace all existing GYM lighting with new Fluorescent T5 6-lamp high bay fixtures.
- ii. Replace all fluorescent fixtures with new LED fixtures for energy savings.

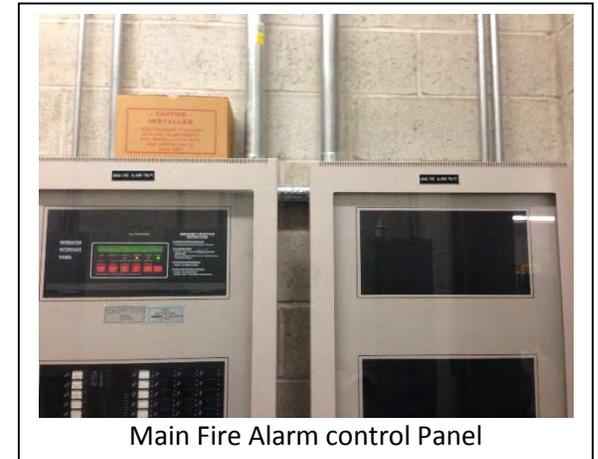
Main Fire Alarm control Panel

The fire alarm system is a Simplex 4100 addressable voice evacuation system. There are manual fire alarm pull stations and speaker strobes located throughout the building. Heat and smoke detectors are present throughout the facility. The fire alarm system appears to be in good condition.

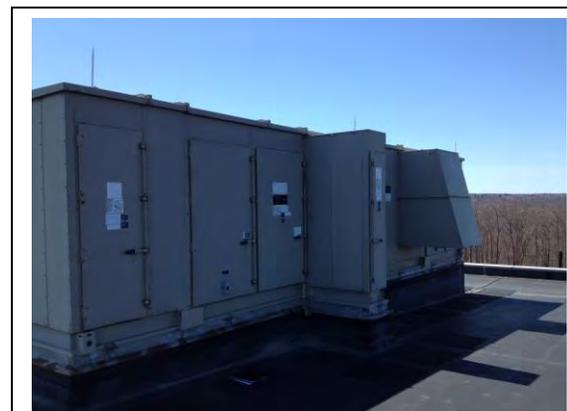
Typical Rooftop Air Handling Unit

- Rooftop Units: There are twenty RTU', all are Trane Modular Climate Changers at various size. Overall the majority of the units are in good condition but generally the units had the following issues:
 - Coils were dirty
 - Outer casing showing signs of rust
 - Interior of the units were dirty
 - It was also noticed that on some of the units (AHU-6 for example) even though the fans was not running and the temperature outside was in the 50's the unit's hot water coil was hot indicating hot water was running thru the coil.
- Exhaust fans: There are approximately sixty roof mounted exhaust fans. Upon visual most appear to be in good condition although most were off at the time.
- Fuel Oil Pump: Fuel Oil pumps appear to be in poor condition and are longer used.
