TOWN OF SHREWSBURY
FACILITIES CONDITION ASSESSMENT OF
TOWN BUILDINGS

FINAL REPORT

June 01, 2016

**Shrewsbury
High School**

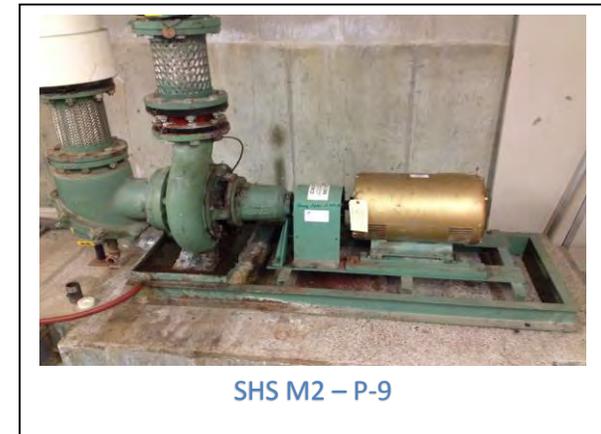
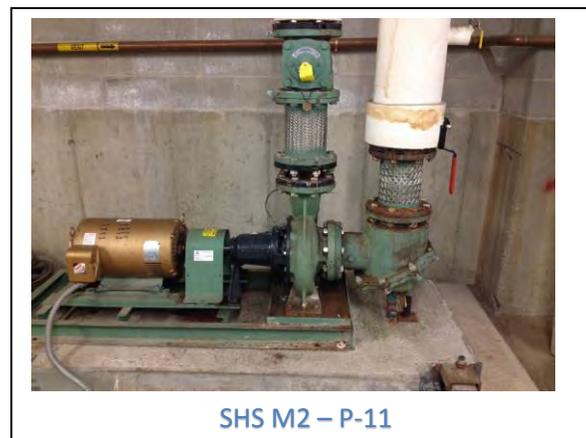
- P-3 & P-4 are both Taco model FE600. Upon visual inspection of both P-3 & P-4 both are in good condition.
- P-9, P-10 & P-11 are Taco model FE500. Upon visual inspection of the pumps the following was observed:
 - P-9 was leaking water and had significant corrosion overall it is in poor condition it was noticed that the pump seal was replaced in May of 2011
 - P-10 had significant corrosion and overall it is in poor condition. There is also signs of possible past leaking as indicating by the rust in the drip pan. Also while running the pump was vibrating.
 - P-11 had corrosion and overall it is in fair condition. There is also signs of possible

past leaking as indicating by the rust in the

drip pan. Also while running the pump was vibrating. It appears that the shaft seal was also replaced.

- iv. Install chilled water coils and connect to chilled water system the AHU's serving the Auditorium.
- v. Replace Hot water pumps P-9, P-10 & P-11.

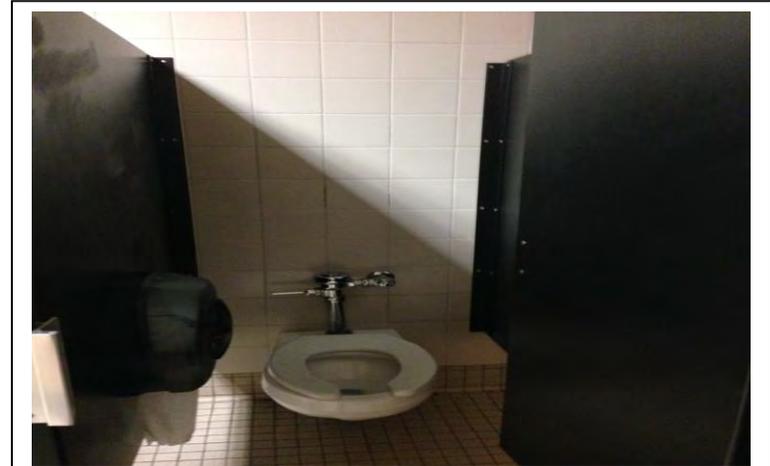
SHS P1 – Water Closets

- i. The plumbing fixtures are original to the 2002 construction and appear to be in good condition.

- i. Replace existing water closets flush valves with automatic flush valves.
- ii. Replace existing urinals flush valves with automatic flush valves.
