TOWN OF SHREWSBURY
FACILITIES CONDITION ASSESSMENT
OF
TOWN BUILDINGS

FINAL REPORT

June 01, 2016

**Shrewsbury
Oak Middle School**

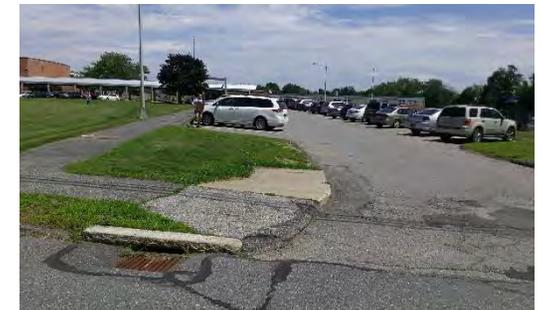
OMS E1

- i. The pavement condition of the vehicular entrances and interior circulation system ranges from good to fair to poor throughout the site.
- ii. There is some evidence of recent repairs and improvements to the vehicular circulation immediately in front of the main entrance of the school.

- i. Implement a program of replacing damaged or worn pavement throughout the site.

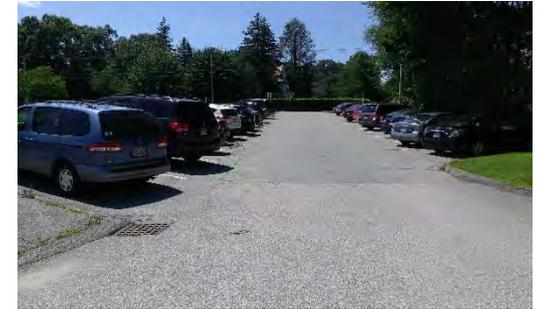
OMS E2

- i. Some of the accessible parking spaces in the parking areas do not appear to comply with current MAAB standards (see “Pedestrian Accessibility and MAAB Compliance” for further detail).
- ii. The pavement condition of the parking areas mirrors that of the vehicular entrances, ranging from good to fair to poor throughout the site, with little evidence of recent repairs.

- i. Implement a program to bring accessible parking spaces throughout the site into compliance with current MAAB standards.
- ii. Implement a program of replacing damaged or worn pavement throughout the site.

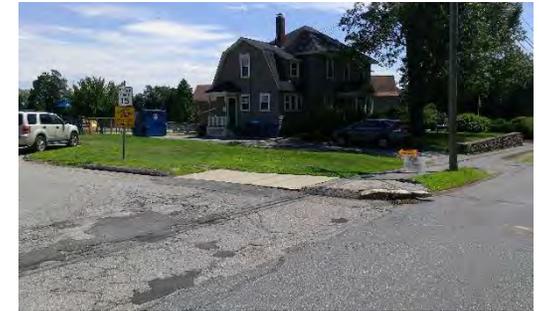
OMS E4

- i. The condition of the pavement on the site ranges from fair to poor throughout.

- i. Implement a program of replacing damaged or worn pavement throughout the site.
- ii. Implement a program to review accessible pedestrian routes throughout the site for compliance with current MAAB standards.

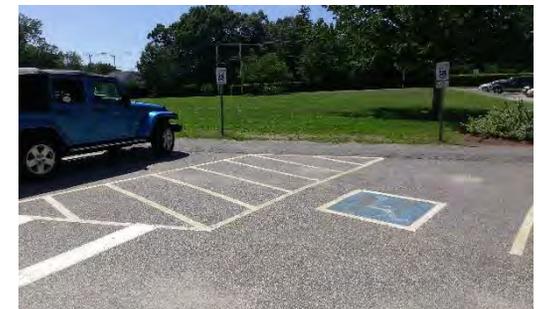
OMS E5

- i. Four (4) accessible parking spaces are located at the visitor parking area directly across from the main building entrance. These accessible spaces lead to the building by a combination of bituminous concrete and Portland cement concrete walkways. The parking spaces, signage, access aisle and accessible route do not appear to comply with current MAAB standards.
- ii. Three (3) accessible spaces are located along the faculty access drive. These parking spaces and access aisles do not appear to comply with current MAAB standards.

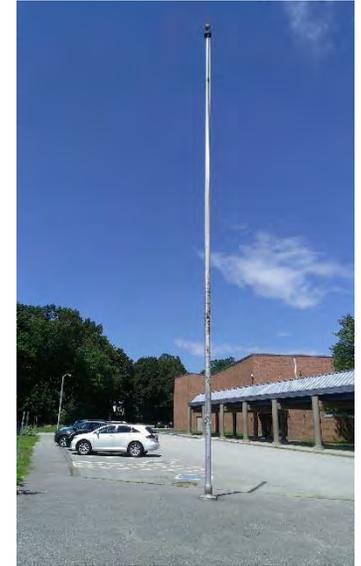
OMS E8

- i. The flagpole does not appear to have an MAAB compliant accessible route.
- ii. The bike racks do not appear to have an MAAB compliant accessible route.
- iii. The benches adjacent to the tennis courts are in poor condition and do not appear to have an MAAB compliant accessible route.

- i. Construct an MAAB compliant accessible route to the flagpole.
- ii. Install site furnishing as necessary throughout the site to better develop exterior congregation areas, and to allow students safe and convenient access to bicycle facilities.
- iii. Construct an MAAB compliant accessible route from an accessible building entrance to all site furnishings.

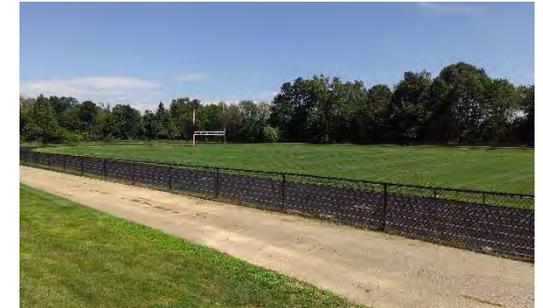
OMS E10

- i. The Football field appears to be in good condition. The field appears to continue to be in useable working order, and it is our understanding that flooding on the field has not been a major or consistent problem.

- ii. The synthetic rubber surface for the track is in fair condition-it is showing typical signs of age and wear, especially along the edges, which is typical of this type of construction.

- iii. There is no designated area for the bleachers, so when they are out and in use they obstruct a pedestrian circulation path.
- iv. The tennis courts are in good condition; however, there is no accessible route to the courts.

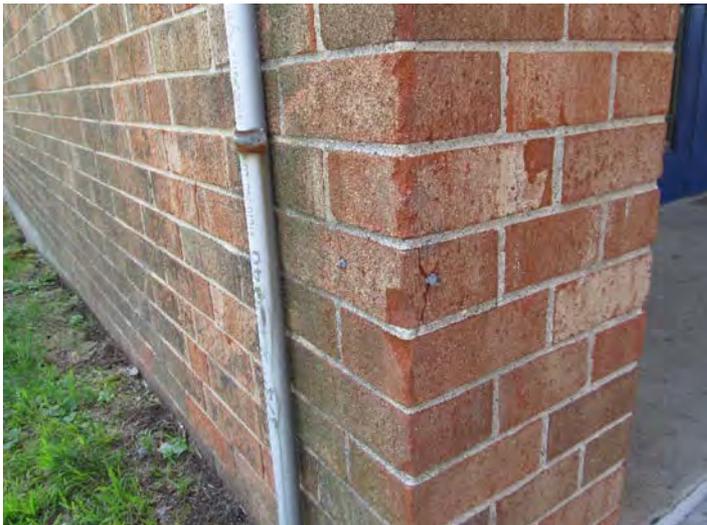
West Elevation, spalled brick

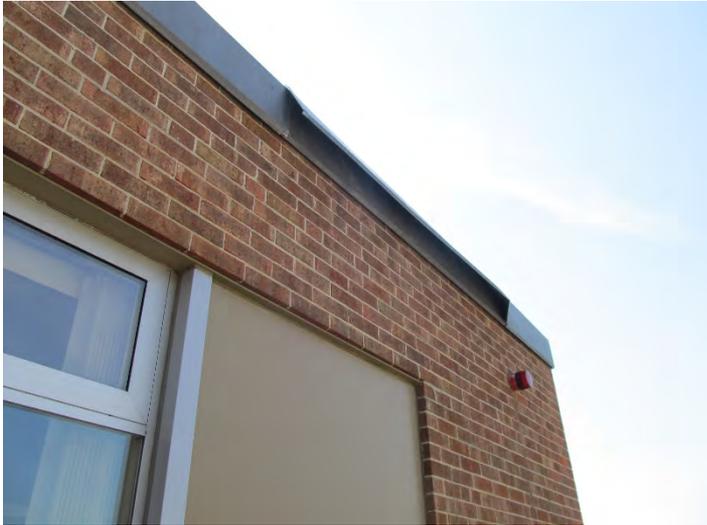
West Elevation, damaged/lifted roof coping

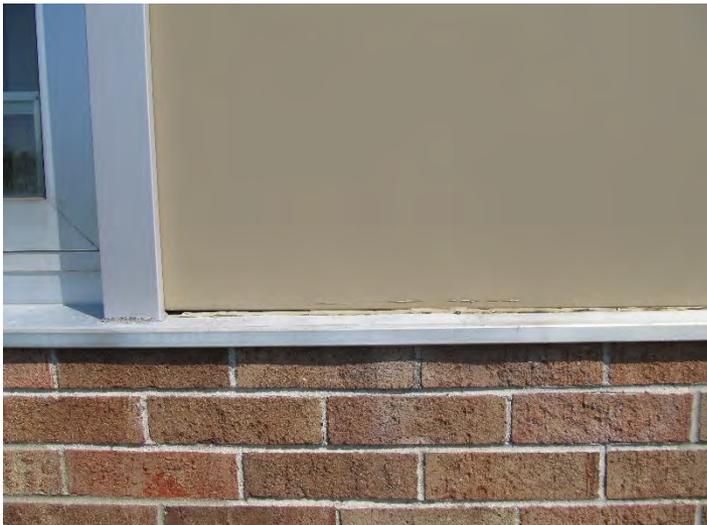
South Elevation at front entry, failed sealant

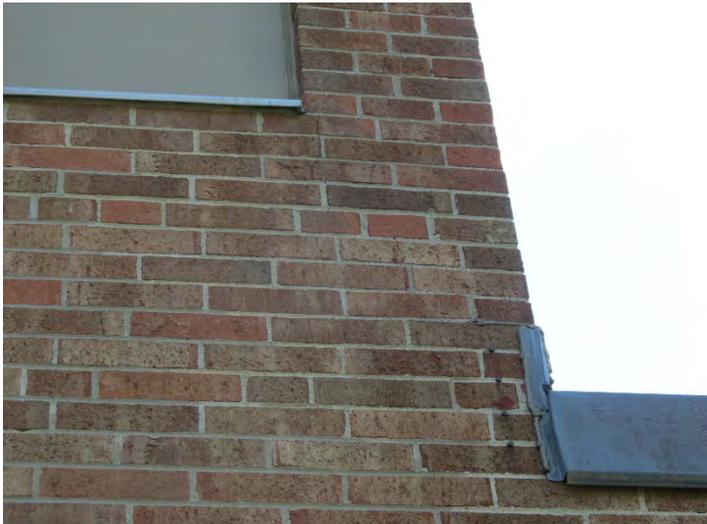
West Elevation, crack through bricks and mortar joints

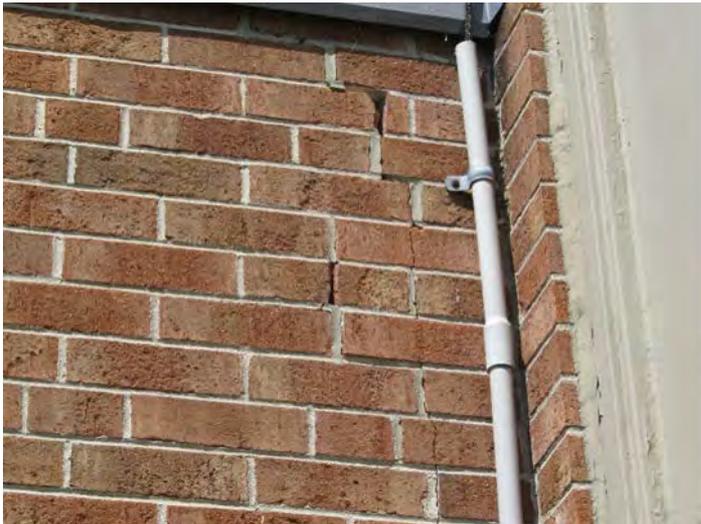
South Elevation, crack through brick and mortar joints

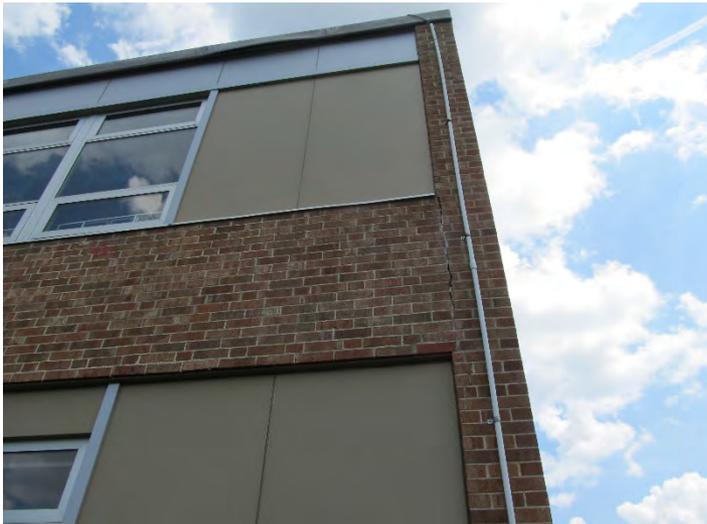
West Elevation, crack through brick and mortar; bulged brick

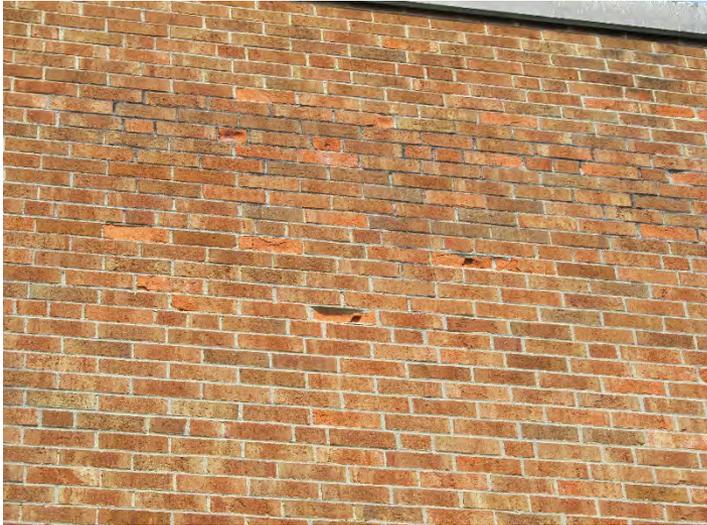
South Elevation, spalled brick masonry

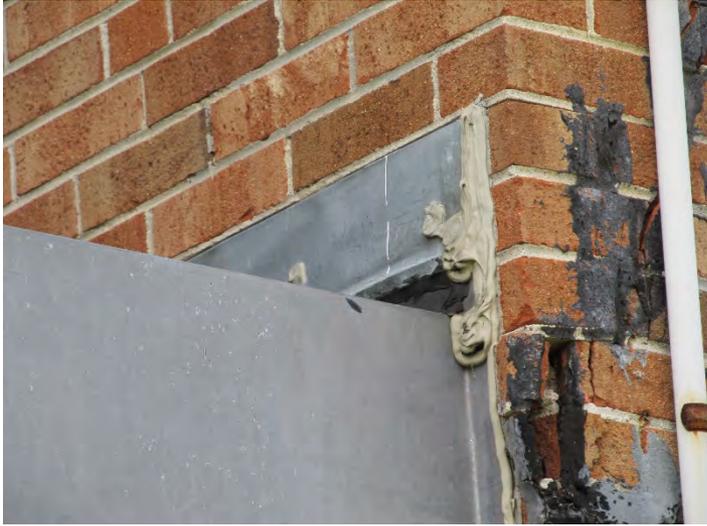
East Elevation, open mortar joint at a reglet; spalled and cracked brick

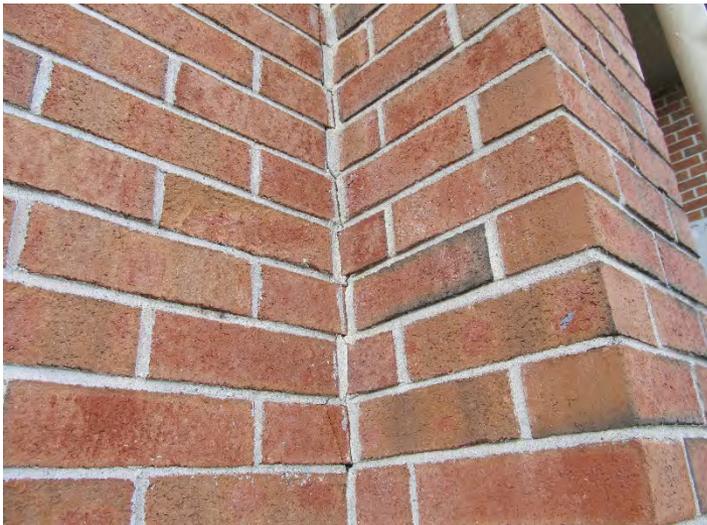
East Elevation, crack through brick and mortar joints

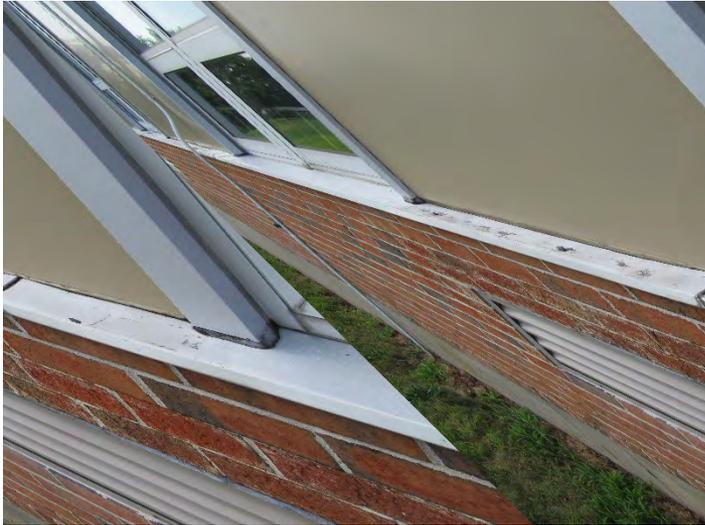
East Elevation, deteriorated windowsill flashing

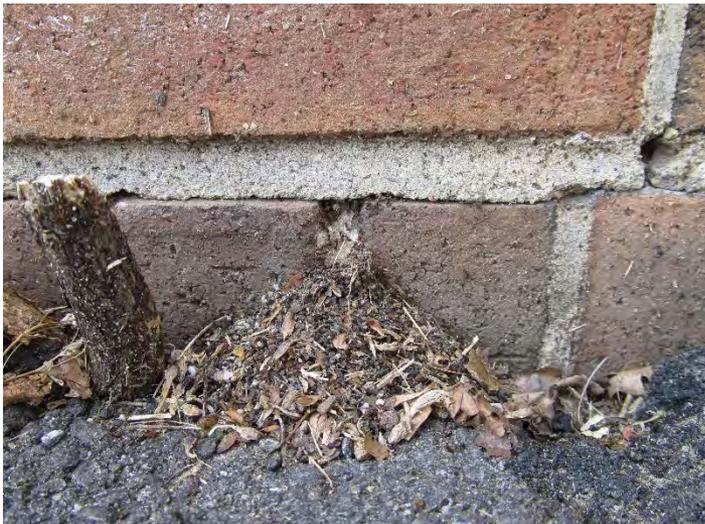
East Elevation, crack in brick with insect activity

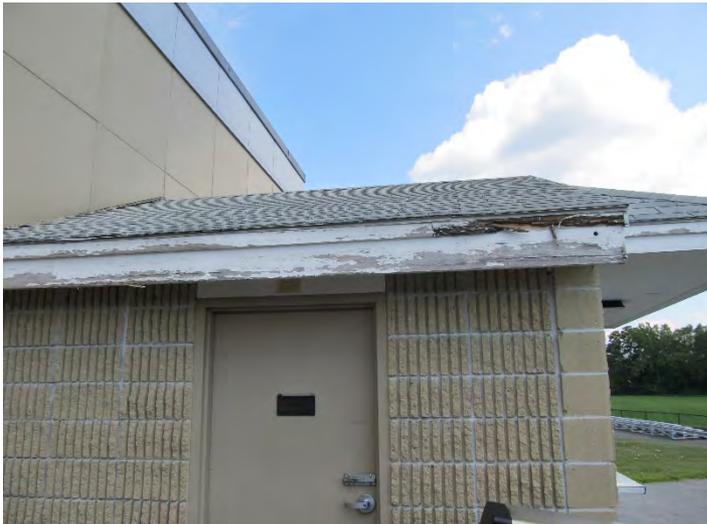
South Elevation, deteriorated wood trim

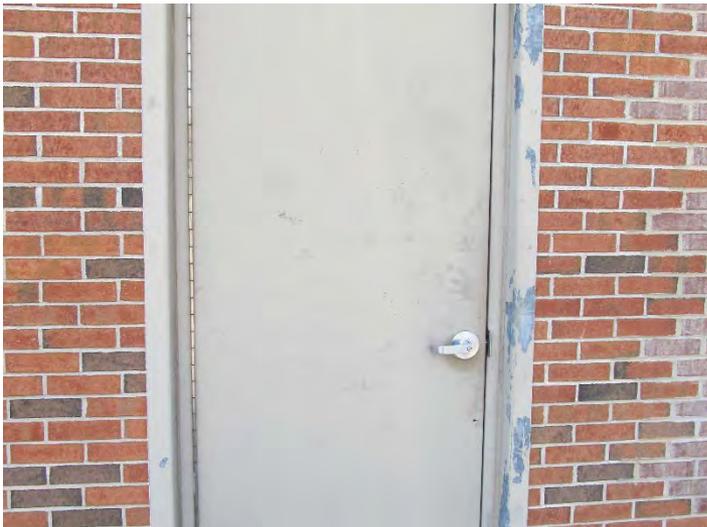
East Elevation, peeling paint at a door frame

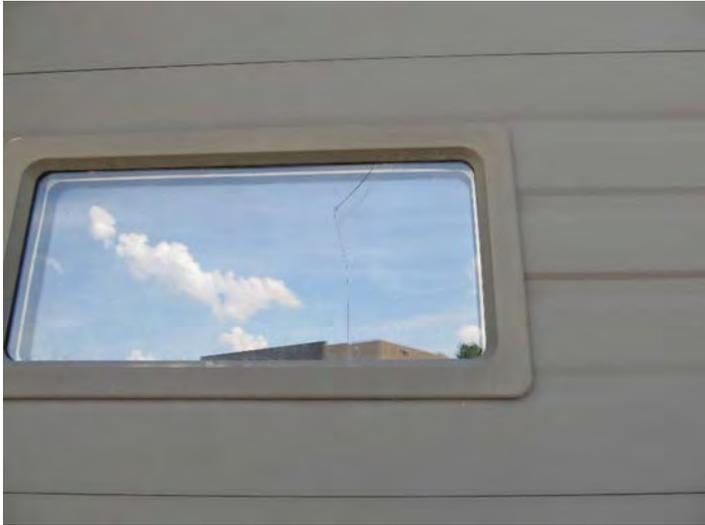
North Elevation, broken glass at an overhead door

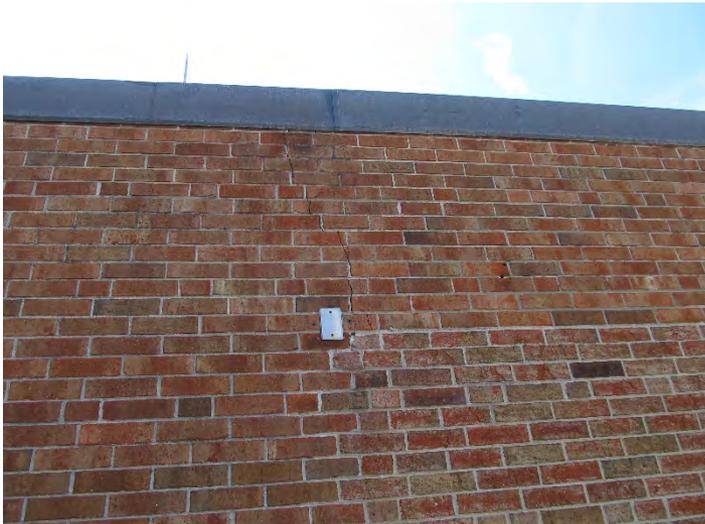
South Elevation, crack through brick and mortar joints

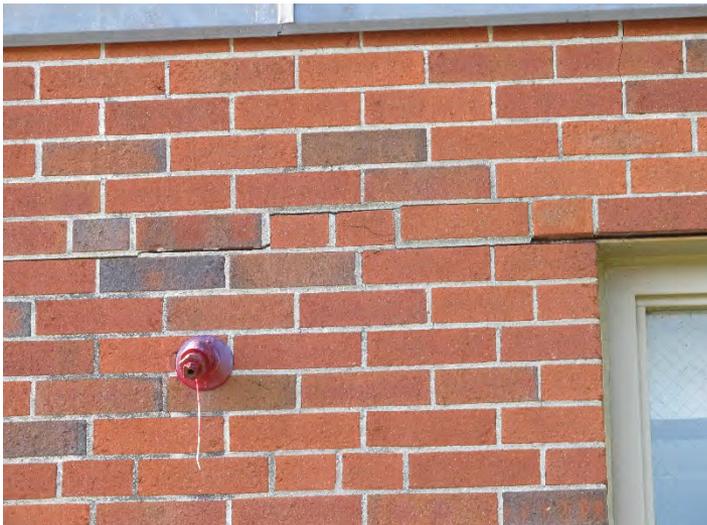
North Elevation, cracked mortar at a lintel

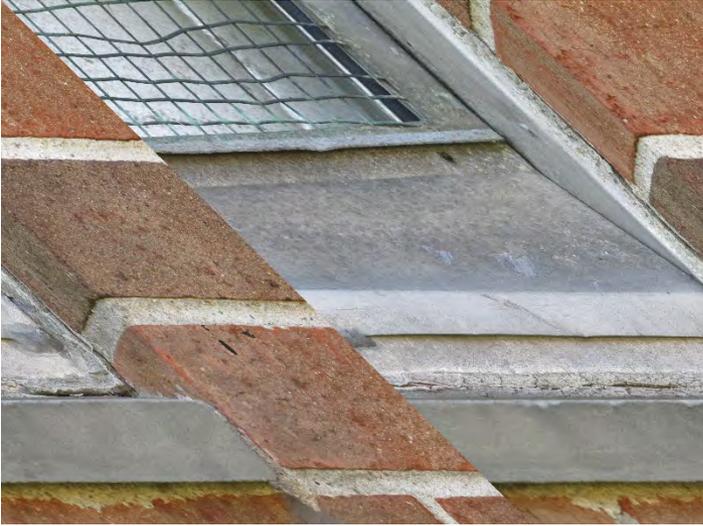
North Elevation, damaged louver and failed perimeter sealant

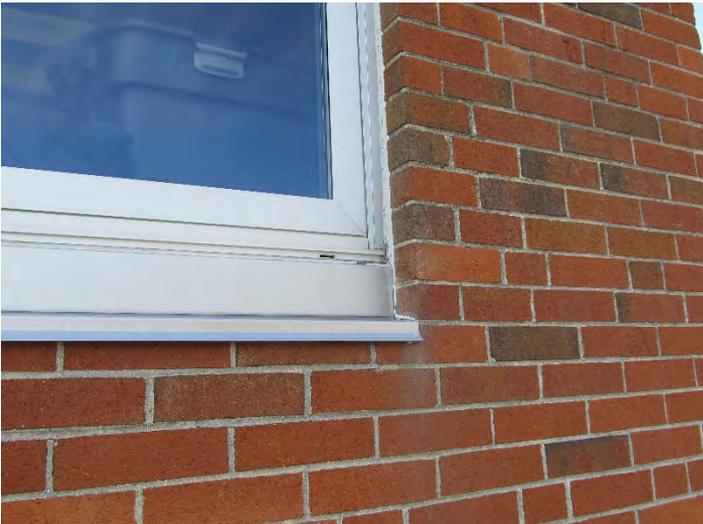
North Elevation, failed window perimeter sealant and stained masonry

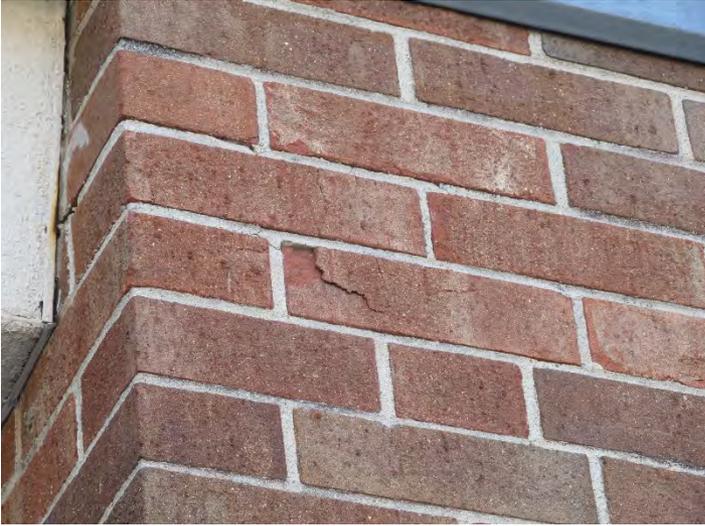
North Elevation, spalled brick; failed sealant at EIFS-to-brick juncture

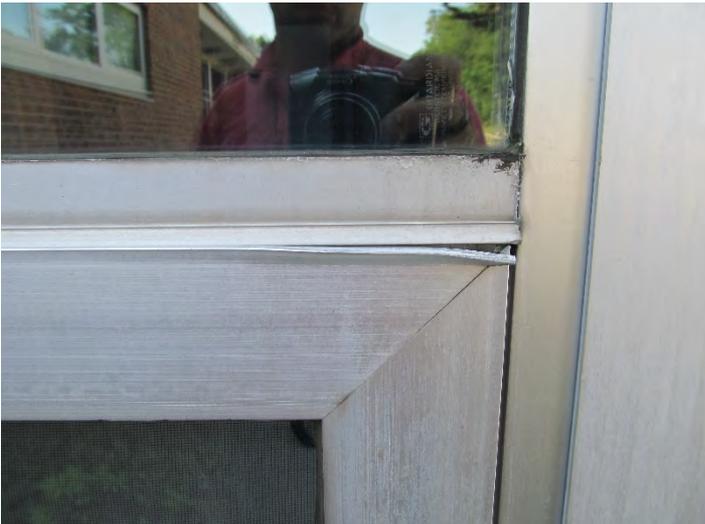
North Elevation, damaged window sash

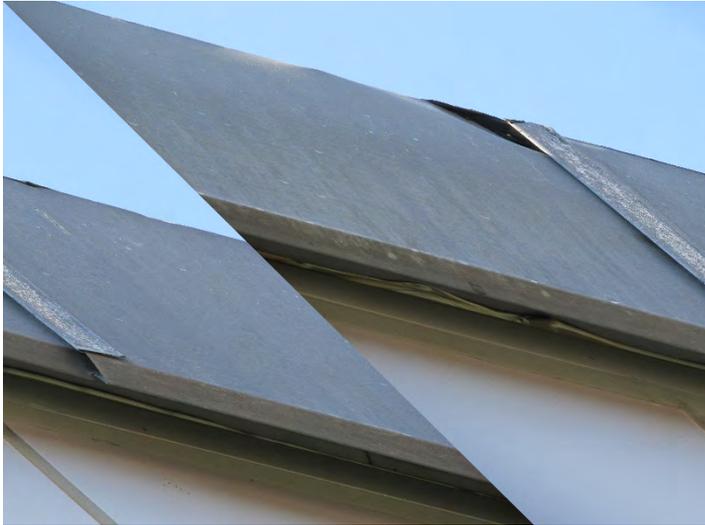
North Elevation, damaged roof coping

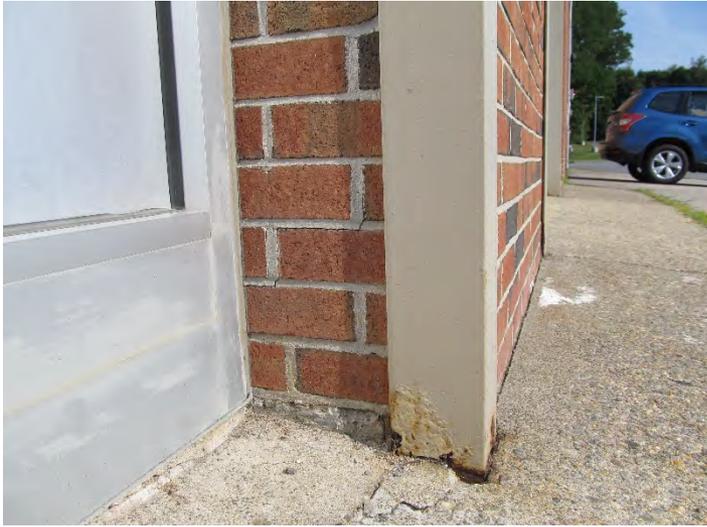
East Elevation, crack in mortar joints and corroded metal corner guard

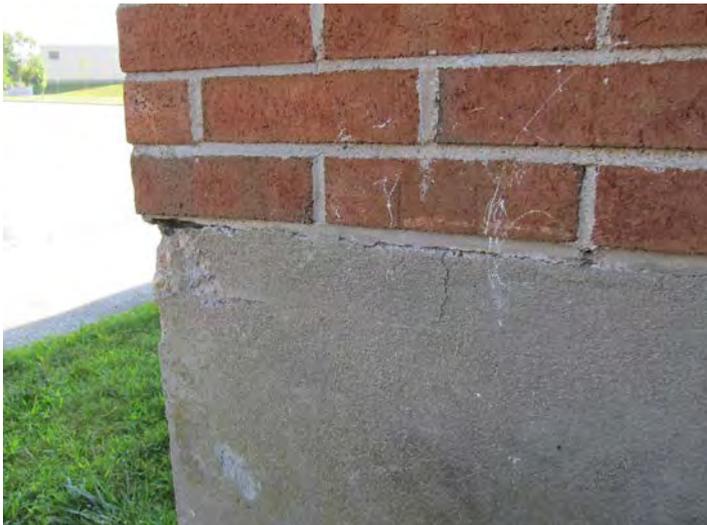
North Elevation, spall at foundation wall

- i. The brickwork is shifted and cracked from rusting steel lintels.
- ii. There is shifted and cracked brickwork caused by accumulated moisture growth.
- iii. Spalled foundation walls have been caused by dragging effects of expanding masonry.
- iv. The misaligned brick spandrels are caused by steel beam deflections.

- i. Replace all rusting embedded steel lintels.
- ii. Repair damaged exterior brick masonry.
- iii. Repair damaged concrete.

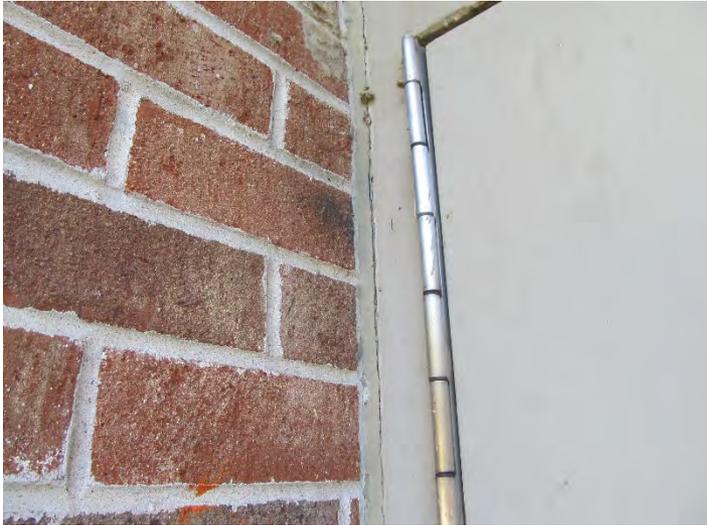
West Elevation, failed door perimeter sealant

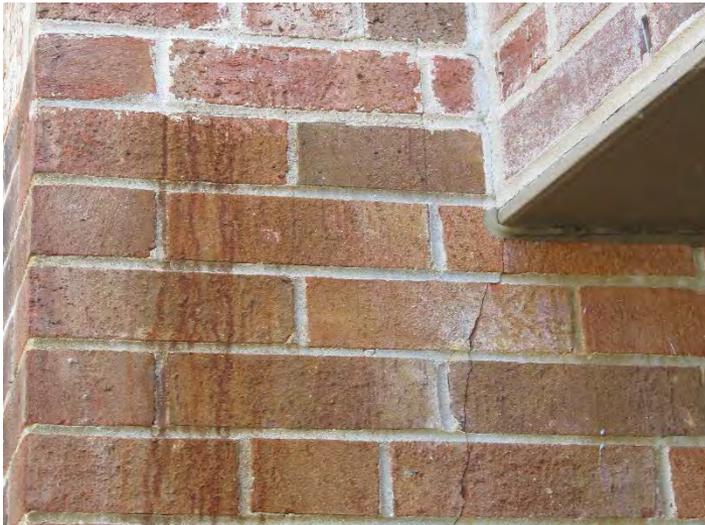
West Elevation, cracked brick, efflorescence on masonry

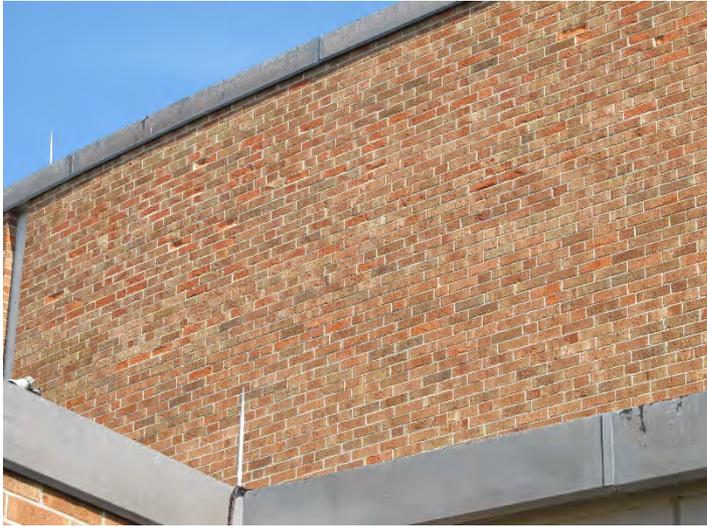
South Elevation at auditorium, spalled brick

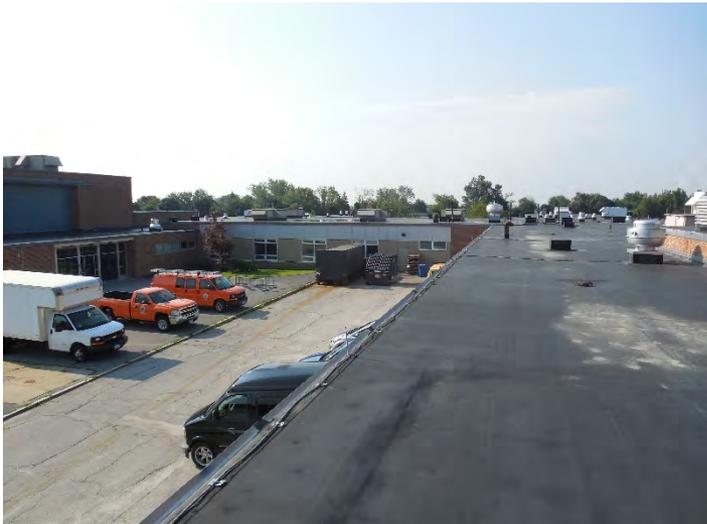
Main roof, partial view facing South; evidence of ponding

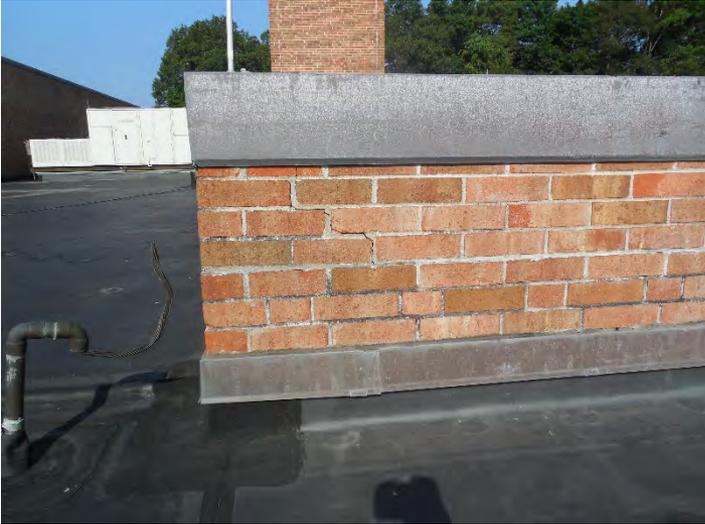
Northwest Wing roof, crack in brick and deteriorated mortar

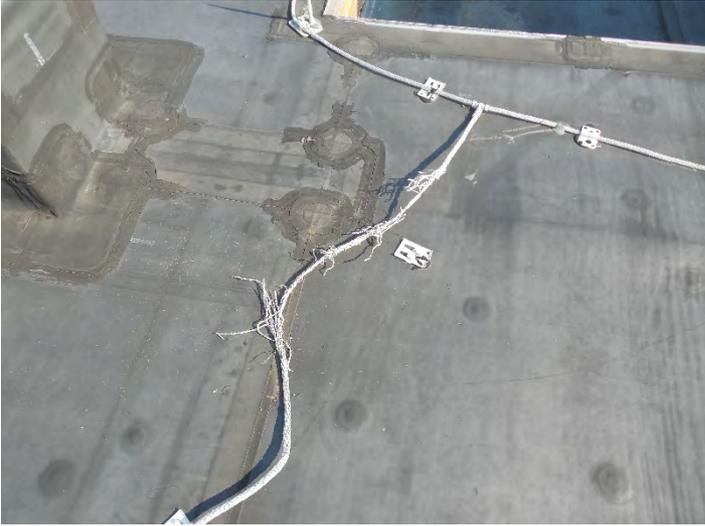
Northwest Wing roof, frayed lightning protection cable

vii. There is a lightning Protection System installed on the roof and appears to be in fair to poor condition.

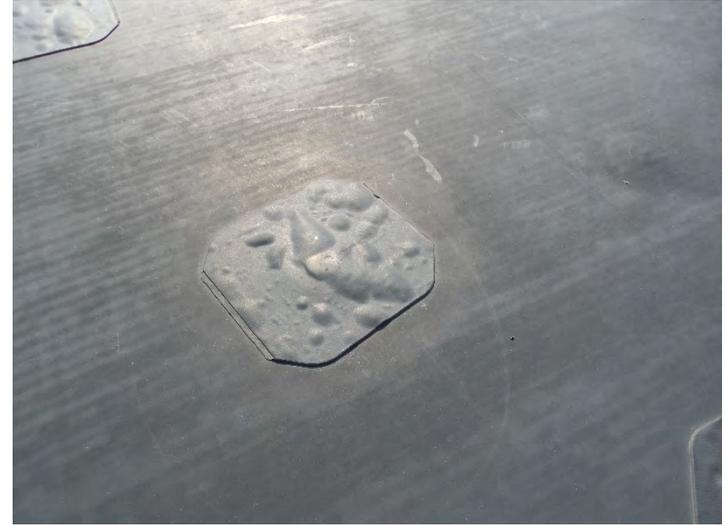
Northwest Wing roof, bubbled patches

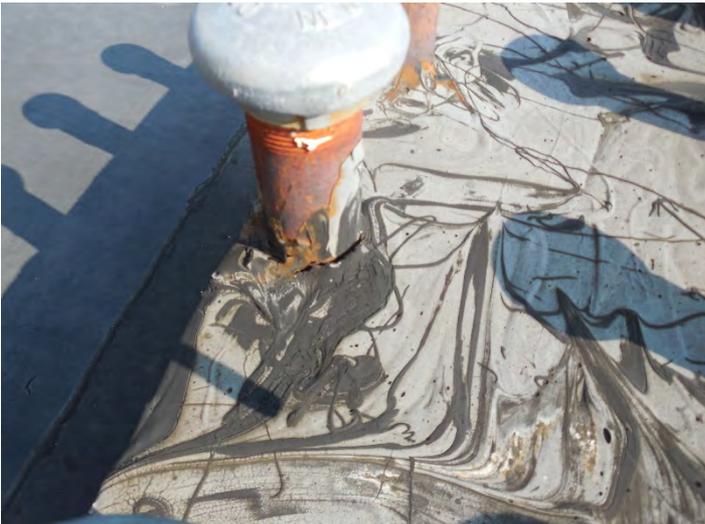
Northwest Wing roof, open pitch pocket

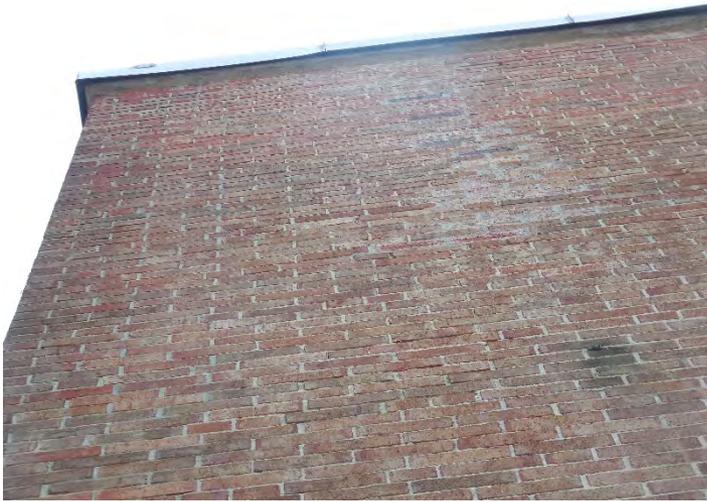
Northwest Wing, deteriorated mortar and possibly displaced brick

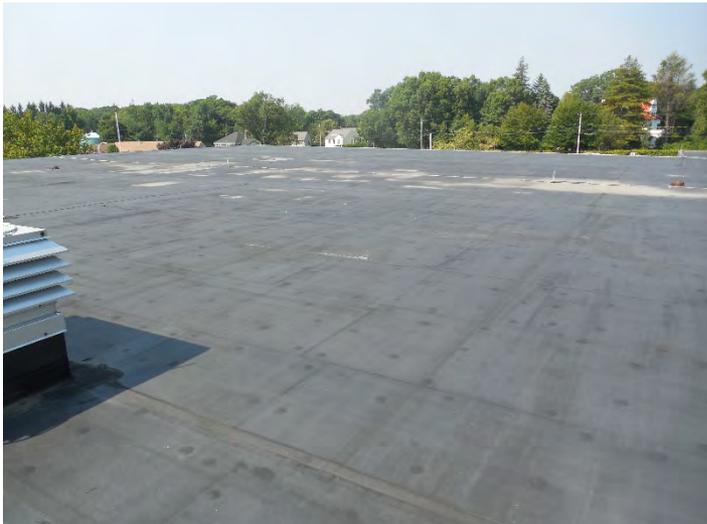
Auditorium roof, partial view facing Southwest; evidence of ponding

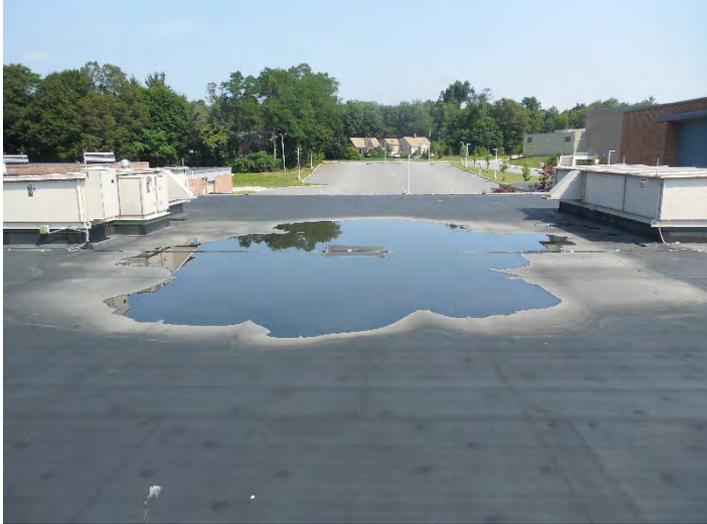
Main roof, facing North, ponded water

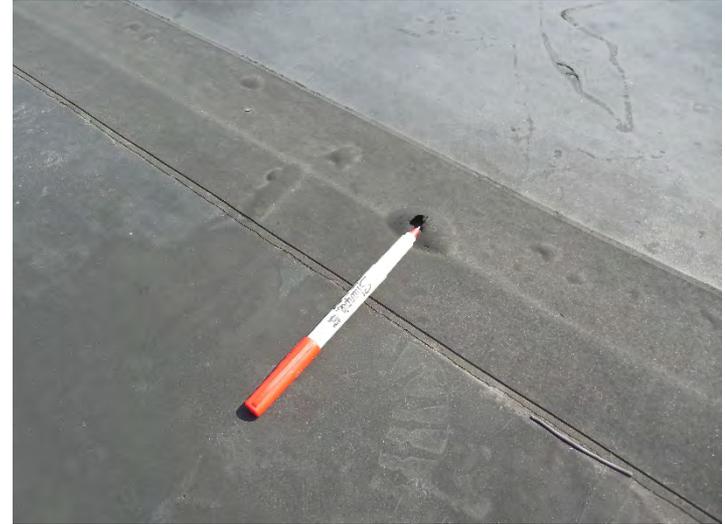
Main roof, hole in EPDM membrane

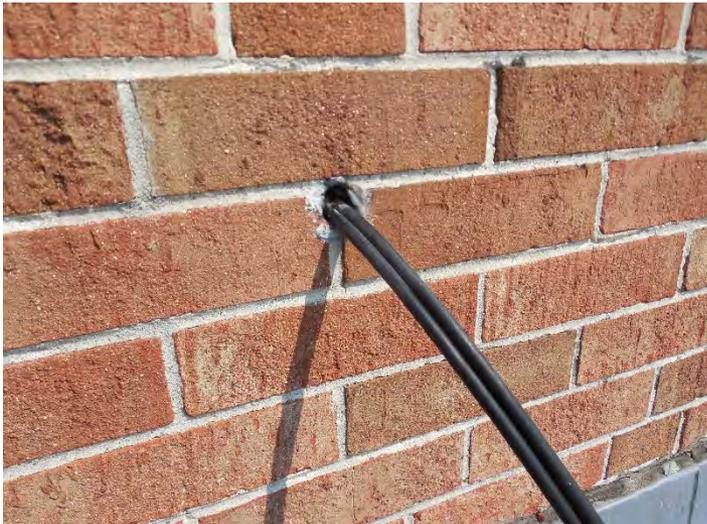
South auditorium wall, open penetration

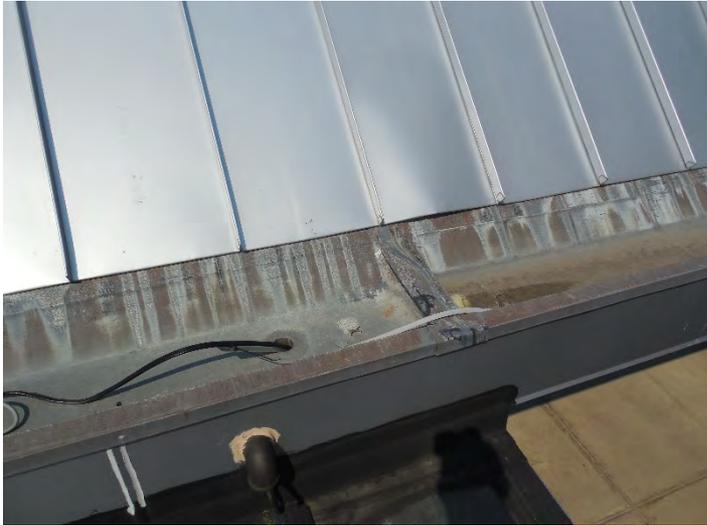
Metal entrance canopy gutter, cracks in soldered seams

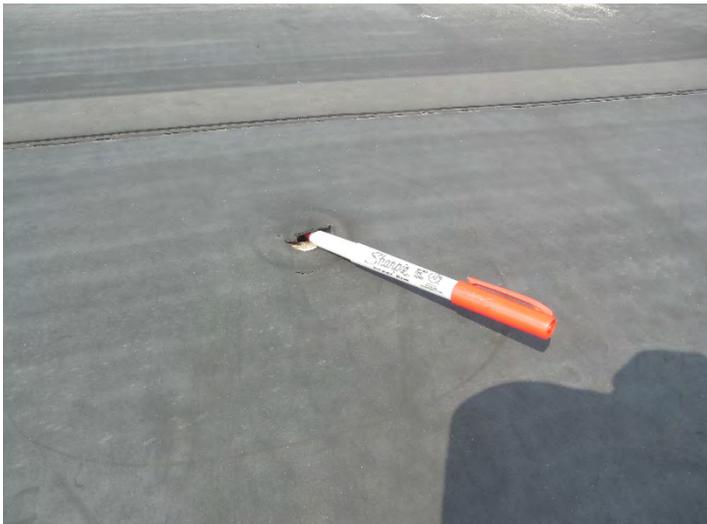
Main roof at West side, hole in EPDM membrane

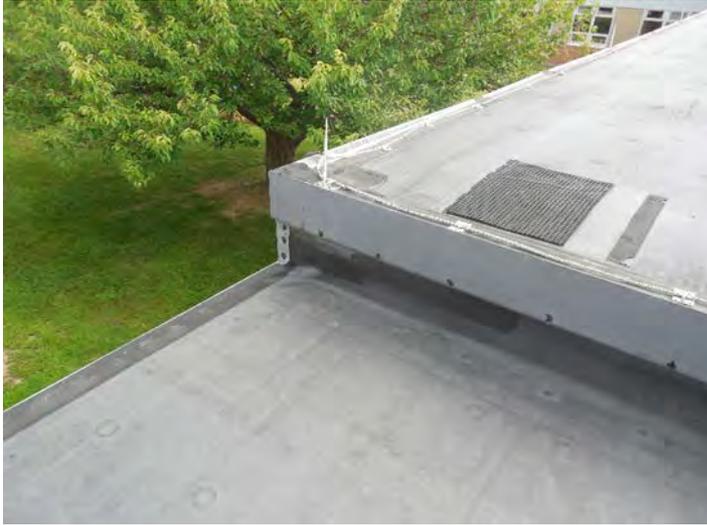
Southwest Wing roof, unadhered membrane at wall

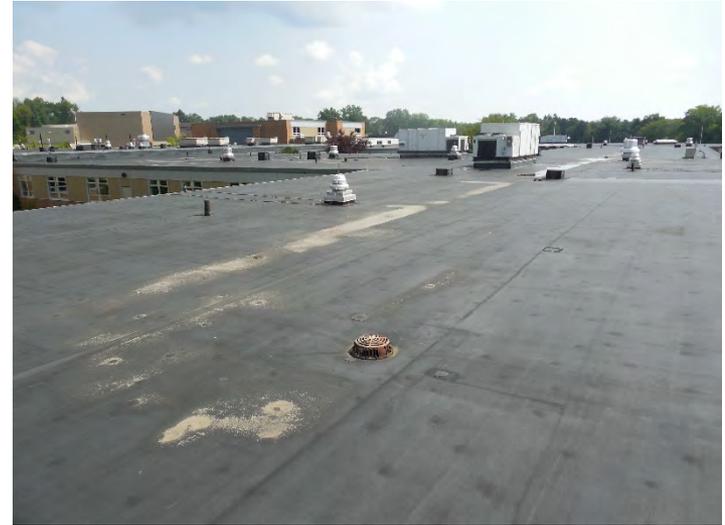
Southwest Wing roof, evidence of ponding

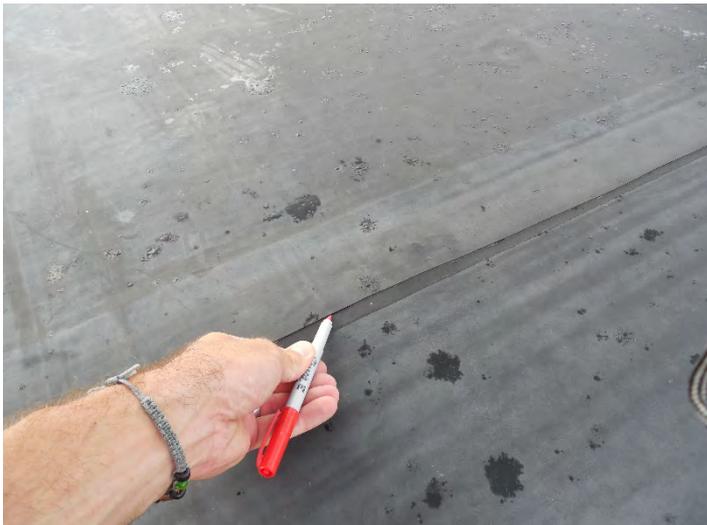
Main roof at South end of courtyard, seam beginning to open

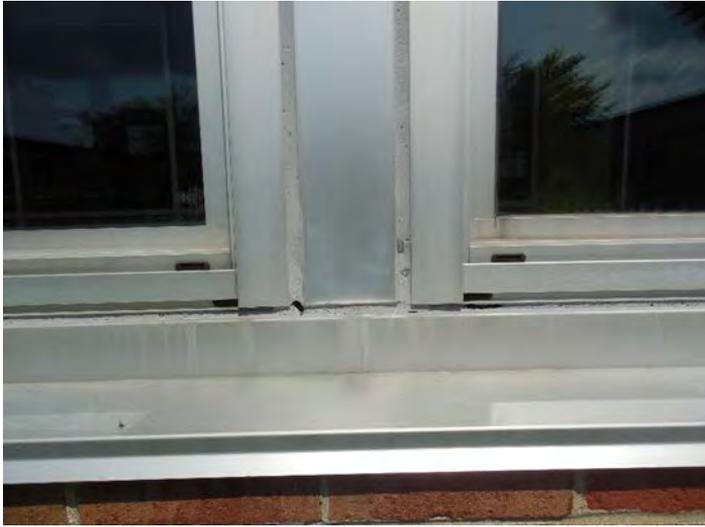
North Courtyard Elevation, failed window perimeter sealant

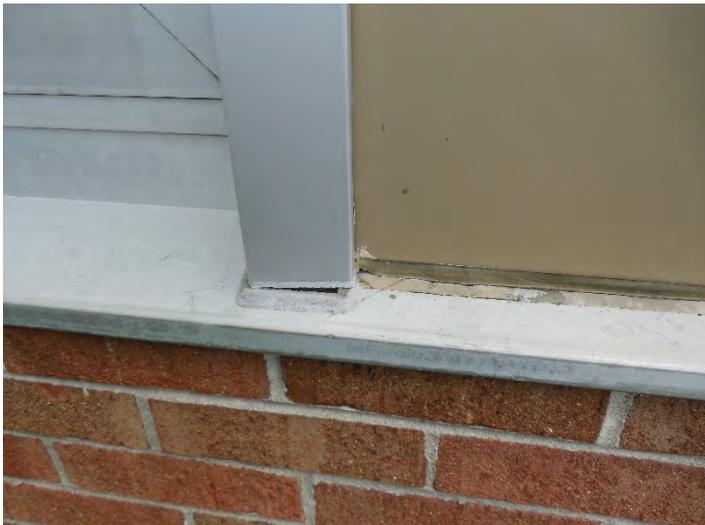
East Courtyard Elevation, failed sealant and damaged frame at a window perimeter

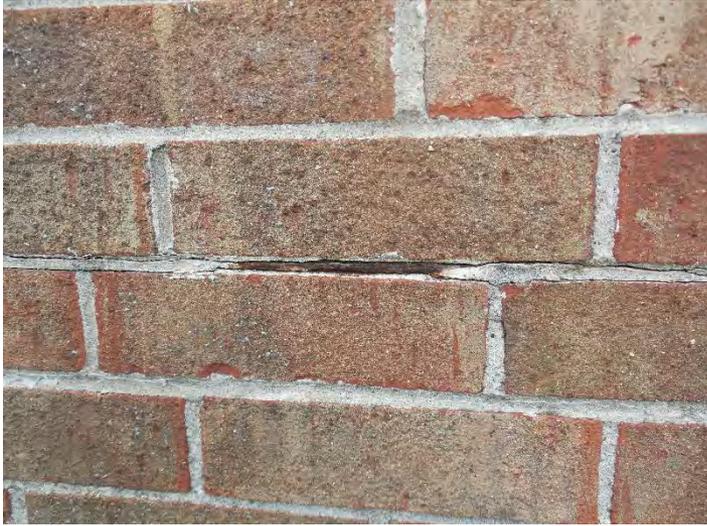
South Courtyard Elevation, corroded embedded steel and displace mortar

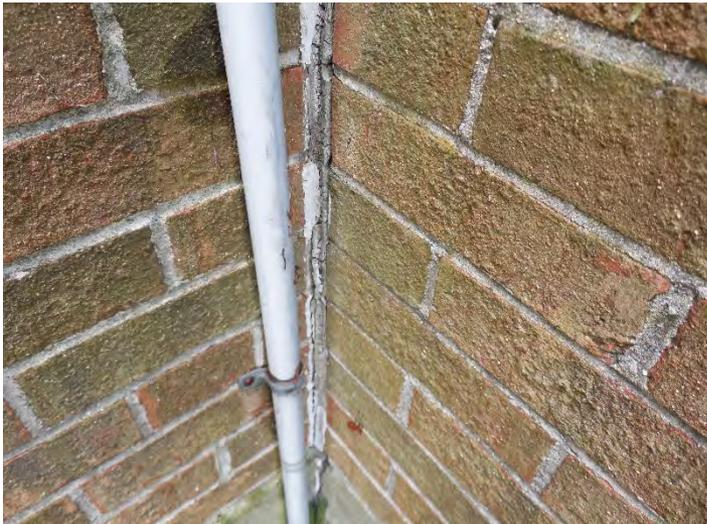
Southwest Courtyard Corner, failed sealant and stained masonry

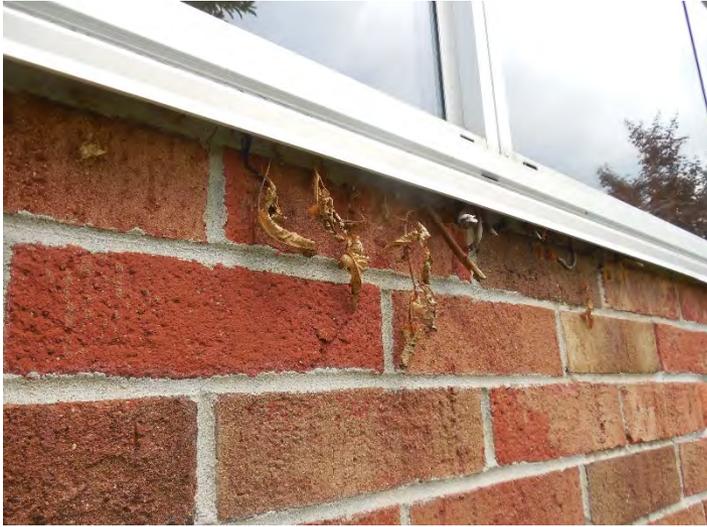
North Courtyard Elevation, vegetation under flashing

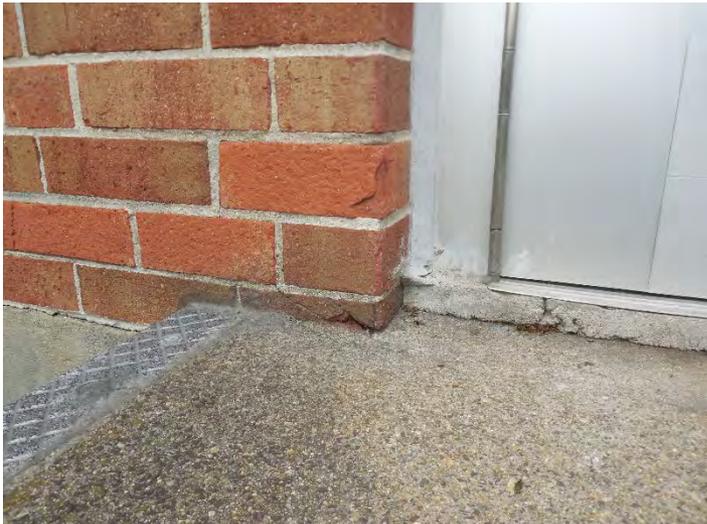
North Courtyard Elevation, cracked brick and failed sealant at base of wall

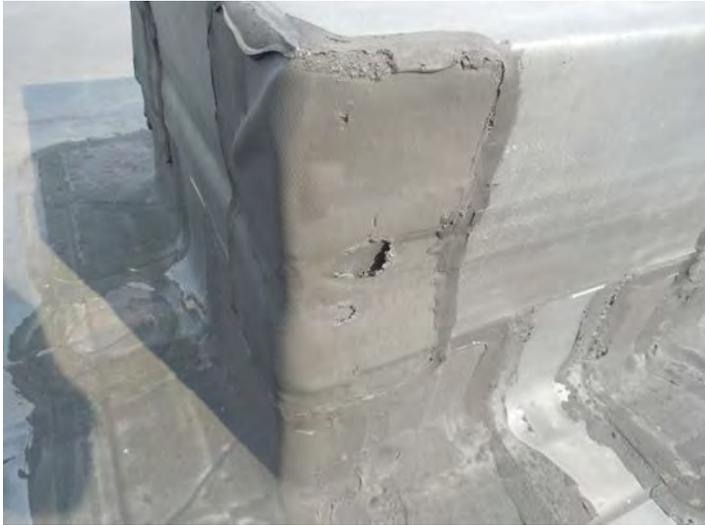
Southeast Wing roof, damaged base flashing

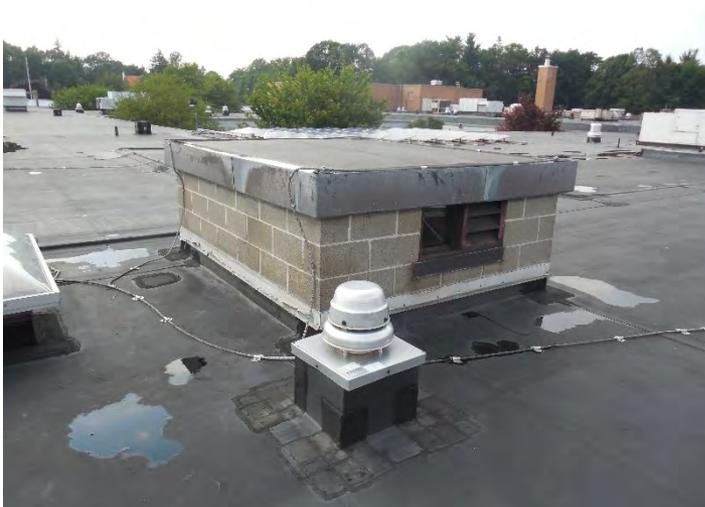
Main roof at East edge, peeling paint at counter-flashing

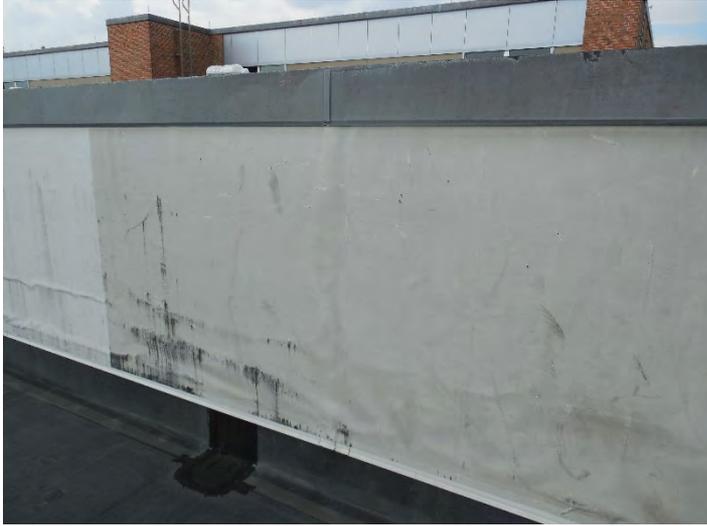
South wall of Gymnasium, unadhered Sarnafil membrane

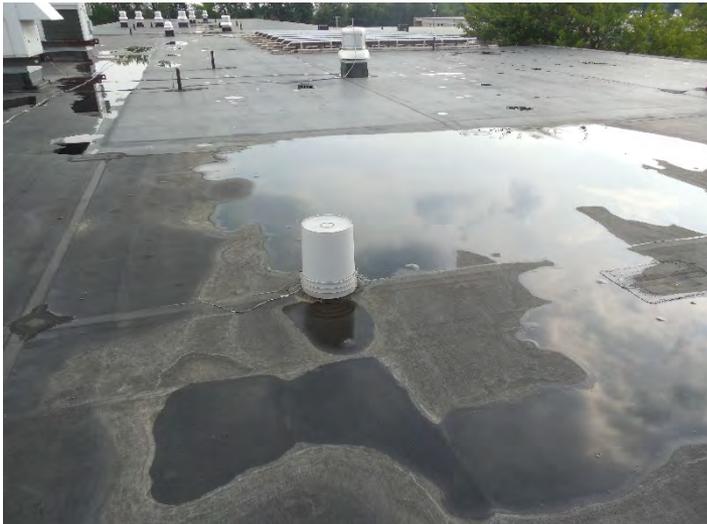
Main roof at East side, ponded water and bucket covering pipe

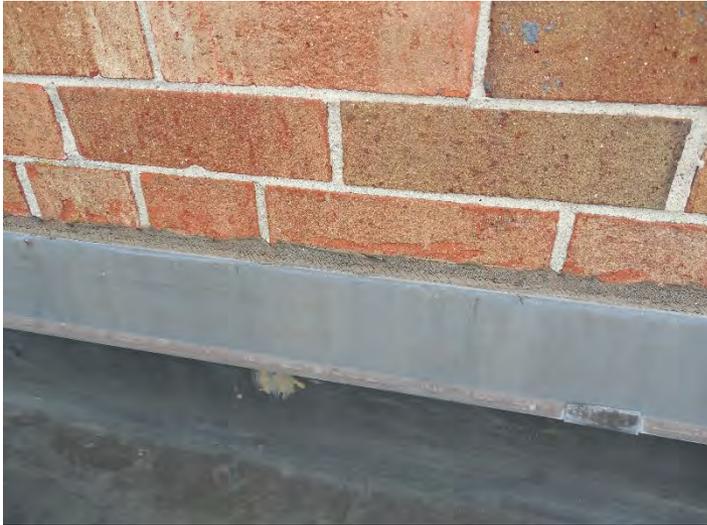
West Gymnasium wall, cracked sealant at counter-flashing reglet

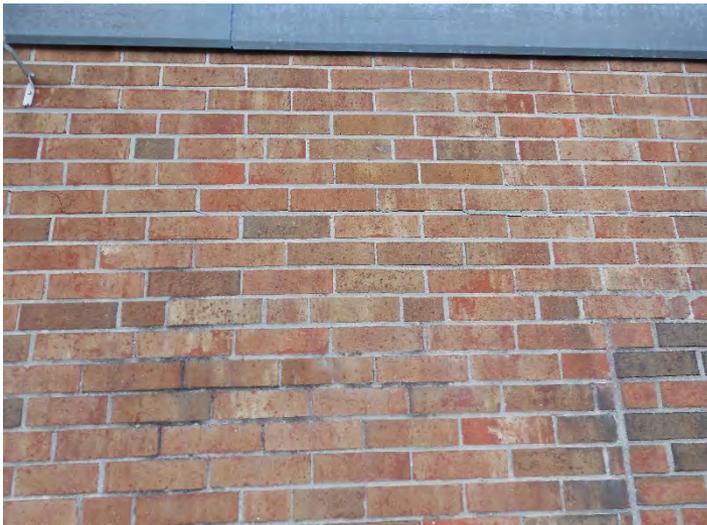
East Gymnasium wall, stained brick and cracked and deteriorated mortar joints

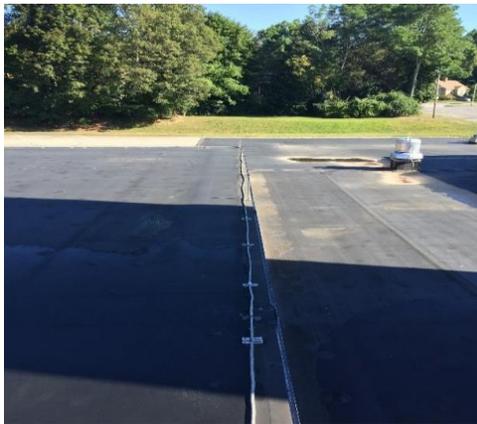
OMS E2 Lightning Protection System

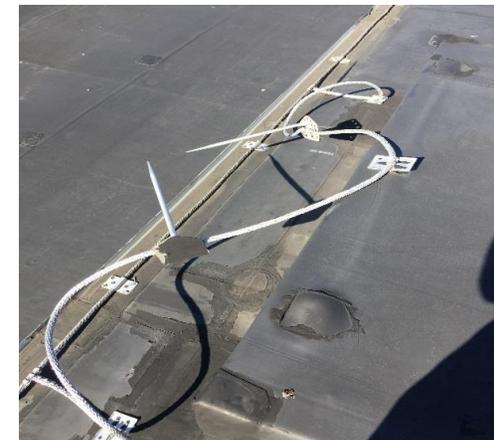
OMS E2 Lightning Protection Detached Cable
