TOWN OF SHREWSBURY
FACILITIES CONDITION ASSESSMENT
OF
TOWN BUILDINGS

FINAL REPORT

June 01, 2016

**Shrewsbury
Oak Middle School**

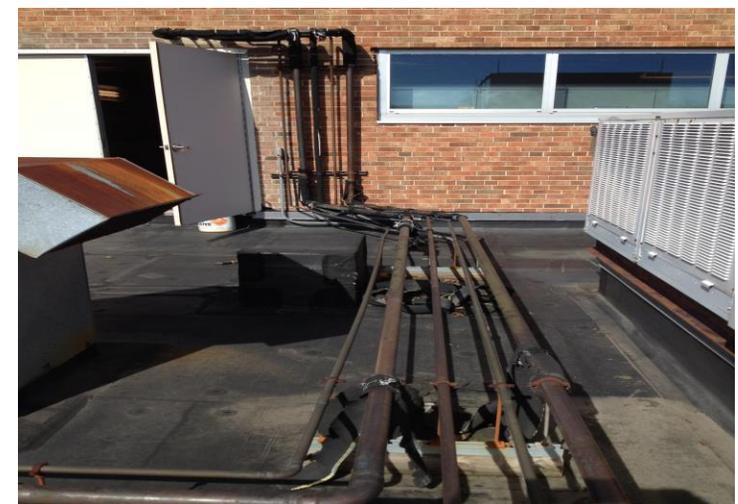
OMS M2 – Damaged Insulation
